Case Studies in Engineering Failure Analysis

Investigation on brittle fracture mechanism of a grade E cast steel knuckle

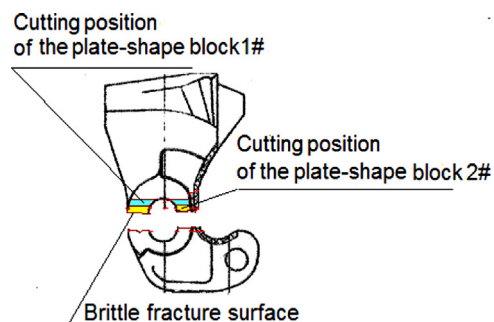
Fig. 2. Schematic diagram of cutting positions of two plate-shape blocks on the failed knuckle.

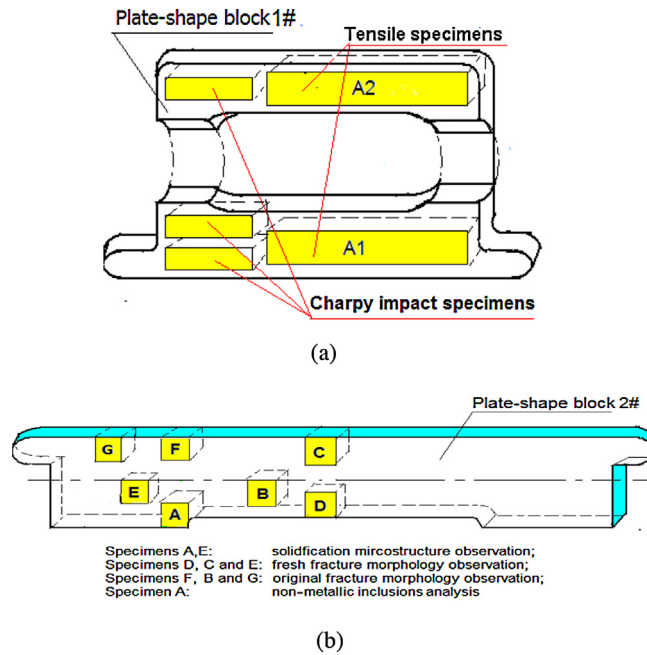
Fig. 3. Schematic diagram of sampling positions of specimens of the knuckle; for tensile and Charpy impact testing (a); for microstructure and fracture morphology observations (b).

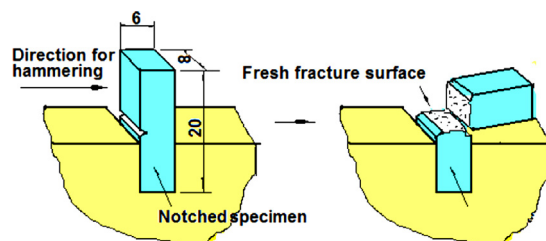
In order to avoid the misjudgment caused by interference of fracture surface pollution, firstly, the fresh fracture surface of the failed knuckle was used in present investigation. The preparation method of fresh fracture surface is described as follows: a shallow notch (depth ≤ 1 mm) was transversely machined at center dot of the axial line on the surface of a specimen with size of 8 mm \times 6 mm \times 20 mm; then this specimen was fractured along the notch by hammering. Thus a fresh fracture surface on the specimen was created, as illustrated in Fig. 7.

Fig. 7. Schematic diagram of fresh fracture surface preparation on the specimens.
