Case Study of the Performance of Prestressed Concrete Buildings During the 1985 Mexico Earthquake

The overall effects of the 1985 Mexico earthquake on buildings are summarized, with specific consideration of the performance of prestressed concrete buildings. Then, for five typical prestressed concrete buildings, results of analyses of the dynamic response, with due consideration of the soil-structure interaction, are presented. In general, the computed response of the buildings under the effect of a ground motion simulating the 1985 earthquake, corresponded reasonably well with their observed performance. Nevertheless, in some cases the analyses indicated that the buildings should have experienced a greater nonlinear behavior than the ones perceived from their level of damage. Some reasons for these differences are discussed. Recommendations on earthquake-resistant design of prestressed concrete buildings are given. The importance of providing lateral stiffness by shear walls or bracing, and of achieving ductility and continuity through mild steel reinforcement, is emphasized.

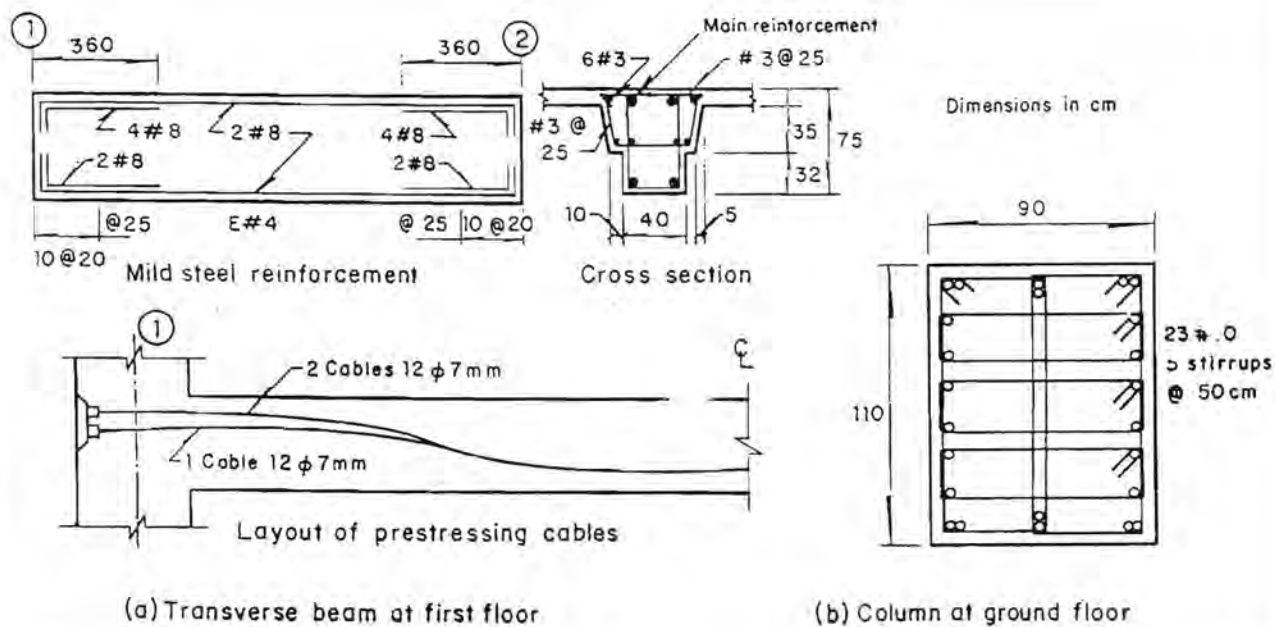
Fig. 8. Reinforcement details of structural members of the QRO Building.

staircase shafts. The building is founded on friction piles beneath a basement and a foundation box. Typical reinforcing details of structural members are shown in Fig. 8.

An inspection of the building after the earthquake revealed extensive cracking in the masonry walls around the elevator shaft and distortion and falling of some ceiling panels. No

cracks were found in the main structural members. The building showed a significant tilting in its short direction (corresponding to about 2 percent of the building height).

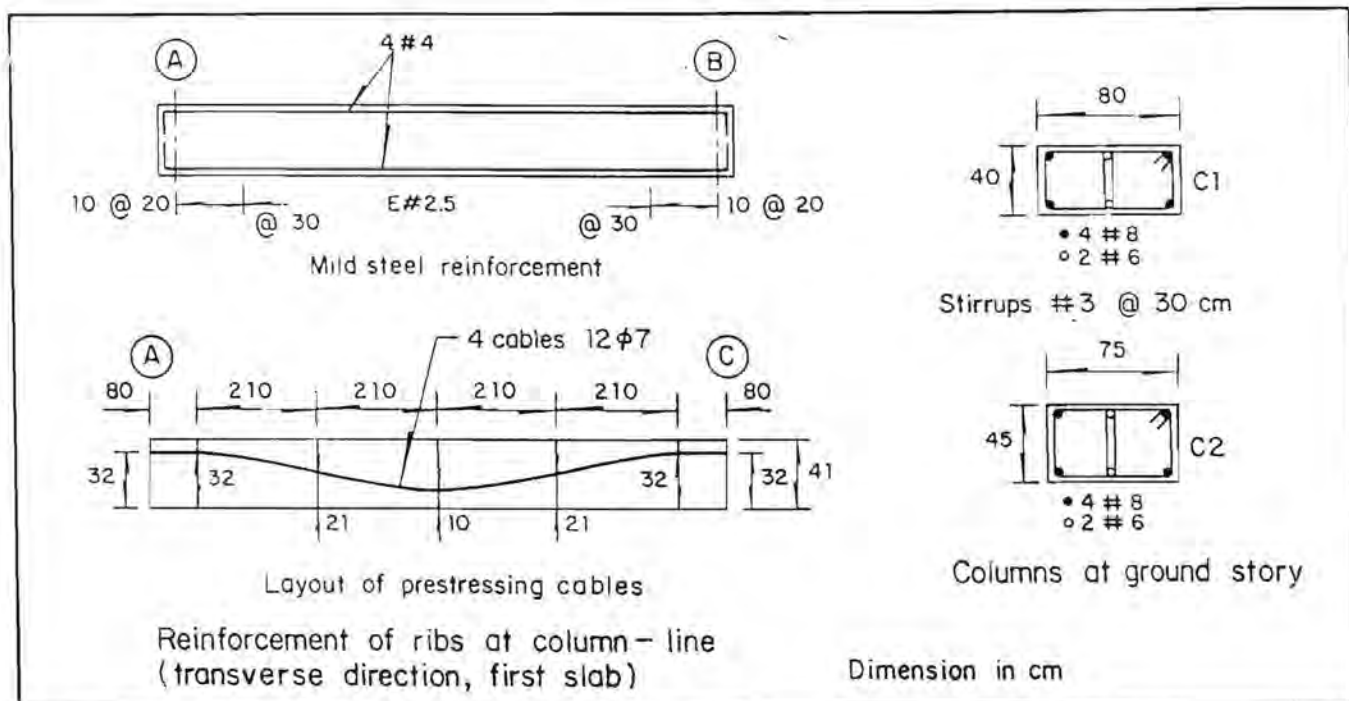
Fig. 14. Typical reinforcing details of structural members of the TAM Building.

Interior partitions are of flexible materials. The foundation is through point bearing concrete piles. A sketch of the structure is shown in Fig. 13 and the reinforcement of principal members is shown in Fig. 14. No evidence of

damage was found when the building was inspected. Tenants mentioned that large lateral displacements were felt and that light non-structural damage was caused by the earthquake.
