Causes and Repair of Deterioration to a California Bridge Due to Corrosion of Reinforcing Steel in a Marine Environment

I. Method of Repair

**M. W. GEWERTZ, Senior Bridge Engineer
California Division of Highways**

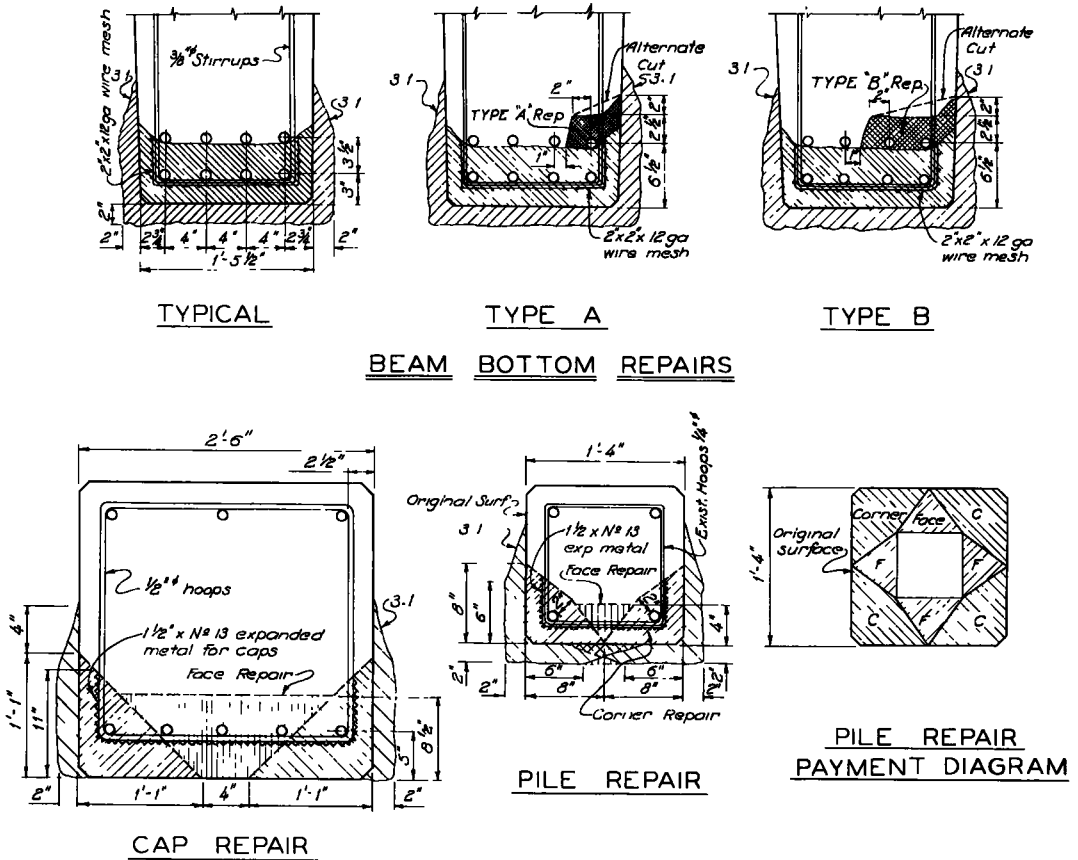
Figure 9. Typical cuts and details shown on contract plans.

ners and two faces of a pile, the basis of payment for such repairs is established as the length of single corner or single face repaired. The basis of what might be called the "unit-cut" method of payment is shown for the various types of members in Figure 9. The pile repair detail shows the repair for two corners. Similar details apply for any number of corners or faces. The payment diagram for pile repair indicates the concrete to be removed for any permissible combination of corners and faces. The cap repair detail shows a repair of two corners and one face. Similar dimensions apply also to repair of one corner only. The typical beam bottom repair detail applies to all beam bottoms requiring repair, whereas the Type A and Type B beam bottom repairs are superimposed on the typical repair to provide for repair of one to four bars in the second layer of beam reinforcement. On this basis of payment, if a pile is repaired around its complete circumference for a length of 2 ft along its axis the Contractor receives payment for four corners at 2 lin ft each, and four faces at 2 lin ft each, or a total of 8 lin ft of pile corner repair and 8 lin ft of pile face repair, at a unit price bid for each of these two types of repair. As the corner cuts and face cuts are defined on the plans it is impractical to remove a face without removal of both adjacent corners, as an undercut would be required at the side surface of the face cut against an unre-moved corner. It is therefore specified that where a face is to be removed both adjacent corners will be removed.
