CH-51450-A Oscilloscope Diagnostic Kit with NVH Released as Essential Tool

Techline News

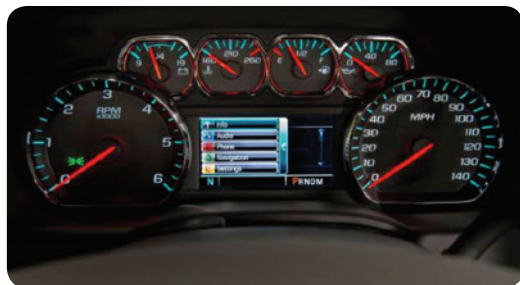
Instrument panel cluster

If the instrument panel cluster (IPC), which is on parts restriction, requires replacement on 2014 Silverado 1500, Sierra 1500; 2015 Silverado, Suburban, Tahoe, Si-

erra and Yukon models, authorization must be received from the Techline Customer Support Center (TCSC) or the GM Technical Assistance Center (TAC), depending on the reason or replacement (U.S. dealerships only).

If the vehicle came in with an instrument panel cluster condition, such as inoperative gauges or cluster display malfunctions, and normal diagnostics lead to instrument panel cluster replacement, contact TAC to review the diagnosis. If necessary, TAC will authorize instrument panel cluster replacement.

- Do not turn off the ignition. Check that all instrument panel cluster, DLC and programming tool connections are secure and the TIS terminal operating software is up to date.
- Attempt to reprogram the instrument panel cluster. Select programming process Replace and Program ECU in TIS2Web.

- If the instrument panel cluster can still not be programmed, turn off the ignition, disconnect the battery and wait for at least two minutes.
- Connect the battery, turn on the ignition, select programming process Replace and Program ECU, and attempt to reprogram the instrument panel cluster. The instrument panel cluster should program.

If the instrument panel cluster programming cannot be completed after following the recommended steps, contact TCSC for further assistance. If the instrument panel cluster is not able to be recovered, TCSC will authorize an instrument panel cluster replacement. GM TAC does not need to be contacted for authorization. After contacting TCSC, contact your ESC with the TCSC case number to order a replacement instrument panel cluster.

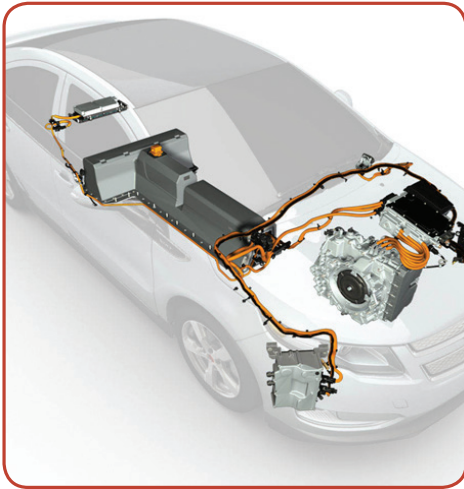
The high voltage system in the Volt, ELR and Spark EV is isolated from the vehicle. It has virtually no contact with the low voltage system or chassis of the vehicle. The high voltage battery and each high voltage device have both positive and negative cables or, in the case of the drive motors, three high voltage AC cables. The vehicle chassis is not used to supply a return path for high voltage at any time. During normal operation, high voltage should always be isolated from the vehicle chassis by a certain amount of resistance as a safety precaution.

A loss of isolation can be viewed simply as a short between the high voltage system and the chassis. The Hybrid/EV system monitors several high voltage components for attempted access and loss of isolation, which occurs if the positive or negative high voltage DC circuits or any of the high voltage AC phase circuits lose their isolation from the vehicle chassis. If such a condition were to occur, it may be intermittent and may be related to faults in the high voltage wiring, connections or components.

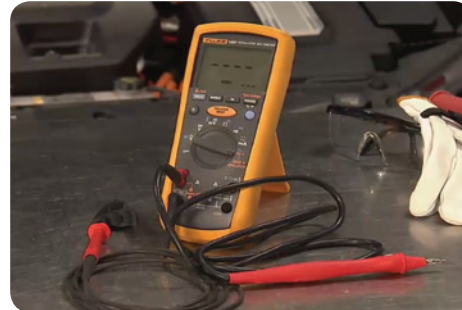
Insulation Multimeter (EL-50772)

Similar to typical 12V vehicle systems, loss of isolation can be as simple as a direct conductor-to-chassis short. However, unlike 12V systems, the potential within high voltage systems means that insulation breakdown is also a cause for loss of isolation. Insulation breakdown typically occurs only when high voltages and/or current is present.

Conditions such as insulation breakdown cannot be diagnosed with a typical digital multimeter (DMM) because high voltage is not used by the DMM when measuring resistance. An Insulation Multimeter (EL-50772), which uses its own built-in high

voltage, must be used to test the isolation capability of high voltage components and circuits.

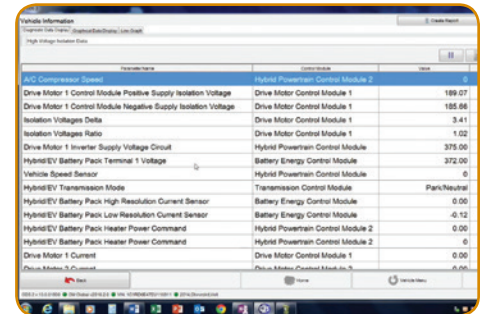
Vehicle Information Data Display

The Drive Motor 1 Control Module Positive Supply Isolation Voltage and Drive Motor 1 Control Module Negative Supply Isolation Voltage parameters provide a real-time indication of isolation status. The parameters will shift in respect to one another relative to the level of isolation loss. The greater the delta, or difference, between parameters, the less isolation exists between high voltage and the vehicle chassis.

Certain isolation loss concerns may only appear during high moisture environmental conditions. Driving the vehicle through an underbody spraying-style car wash while monitoring the delta between the Positive Supply Isolation Voltage and the Negative Supply Isolation Voltage scan tool parameters may reveal an isolation loss concern.
