INSPECTION SERVICES NORTHWEST

CONFIDENTIAL INSPECTION REPORT FOR THE PROPERTY LOCATED AT:

12314 Sample Dr E, Medina, WA

INSPECTION COMPLETED ON: AUGUST 8, 2017

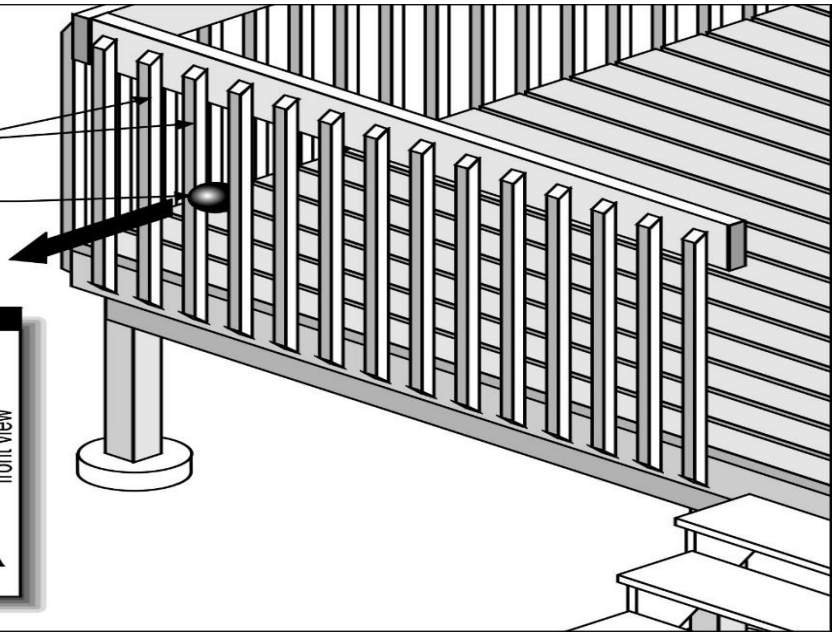
spindles should be spaced so that a 4" (6" in some areas) sphere cannot pass through the guard

spindles (balusters)
4" diameter sphere (6" in some jurisdictions)

INSTALL A PROPER GUARD RAILING AT THE TOP OF THE BRICK WALL AT THE REAR DECK AREA AS IS REQUIRED BY LOCAL CODE STANDARDS FOR SAFETY.
