CRASH TESTS  
OF  
FIVE-FOOT RADIUS PLATE BEAM GUARDRAIL

THE DEPARTMENT OF HIGHWAYS  
STATE OF MINNESOTA

TEXAS TRANSPORTATION INSTITUTE  
TEXAS A & M RESEARCH FOUNDATION

June 1975

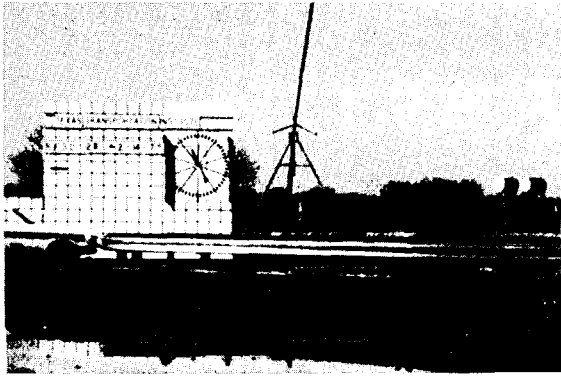
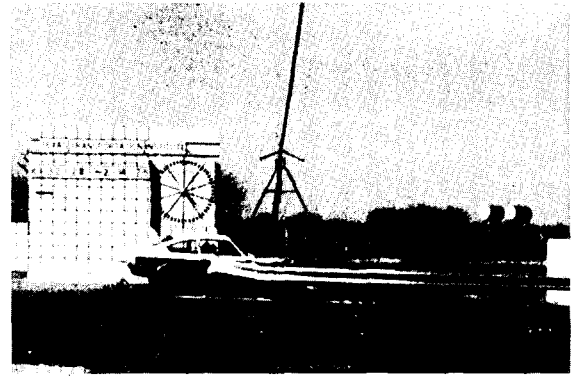
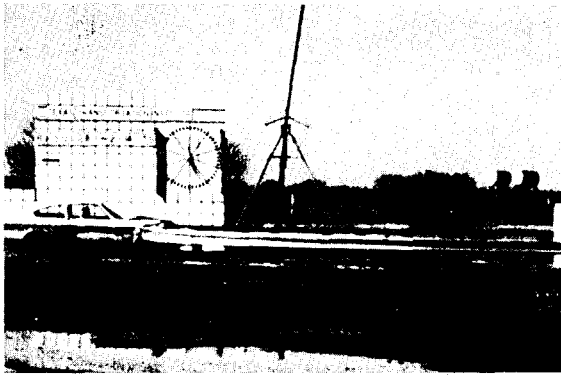
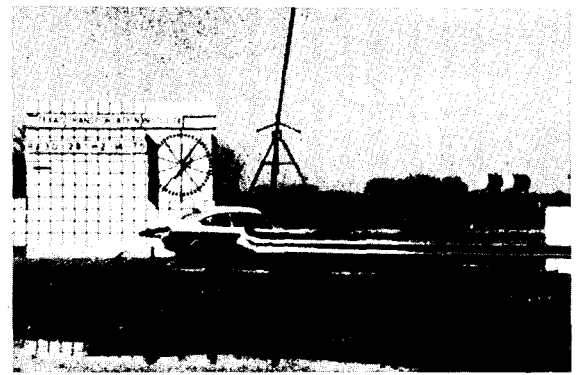
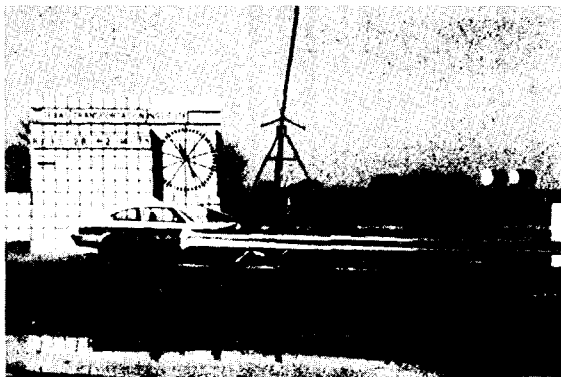
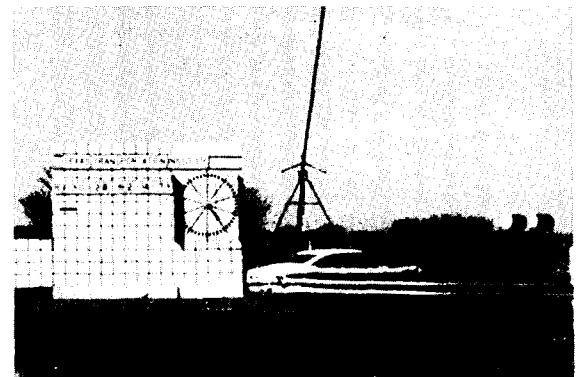
Figure B-1. Sequential Photographs of Test B1.

Time (sec)	Displacement (feet)	Comments
0.000	0.0	Impact - speed is average over 10 ft prior to impact.
0.014	1.3	Post No. 1 failed.
0.020	1.8	Hood began to open.
0.050	4.0	Restrained by Post Nos. 2 and 3.
0.089	6.7	Post No. 2 failed.
0.128	9.2	Hood opened about 15 degrees; yaw was -6 degrees.
0.182	12.3	Post No. 3 failed.
0.236	14.9	Post No. 4 failed; hood opened 30 degrees.
0.342	18.4	Left front impacted post No. 7.
0.374	19.4	Hood opened about 80 degrees; yaw was -25 degrees.
0.562	22.7	Maximum yaw, 47 degrees.
0.687	23.1	Maximum penetration.
1.044	22.8	All motion ceased.
