## **CUSTOMER SATISFACTION NOTIFICATION K39 TRANSMISSION SHIFTER INTERLOCK LEVER**

**MODELS: 2007 (LX) Dodge Charger, Magnum and Chrysler 300**

**2005 - 2007 (LX) Dodge Charger, Magnum and Chrysler 300**

March 8, 2011

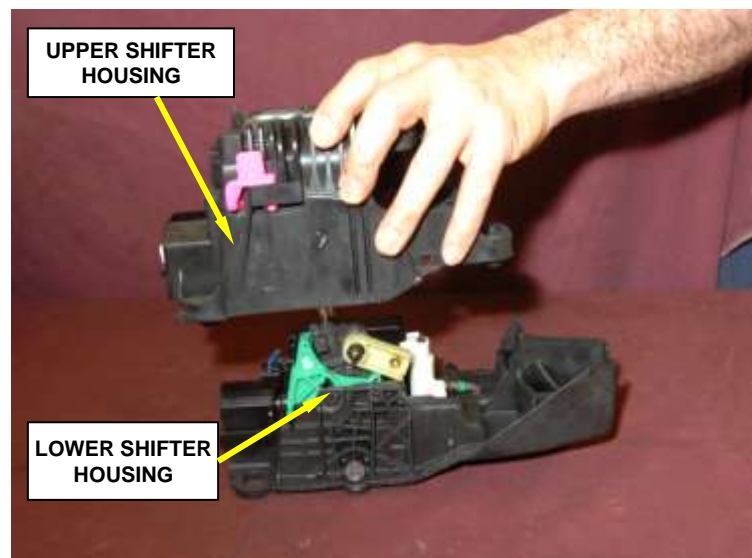
**Figure 5 – Separate Upper Housing from Lower Housing**

- The transmission gear shift lever interlock return spring hook on about 630 of the above vehicles may break. A broken interlock return spring hook will result in the inability to move the gear shift lever out of the “PARK” position.
- To correct this condition, a new interlock lever must be installed into the transmission gear shifter.

20. Partially separate the upper shifter housing from the lower shifter housing by prying on the three retaining tabs (Figure 4).
21. Disconnect the electrical connector located inside the shifter assembly.
22. Finish separating the upper shift housing from the lower shift housing (Figure 5).

23. Disconnect the interlock lever return spring at the pivot arm (Figure 5).
24. Remove and discard the pink interlock lever.
25. Install the new interlock lever onto the pivot shaft.
