Customer Satisfaction Program

N192265660 Rear Window Defroster Thermal Events - US Only

Release Date: March 2020

Revision: 01

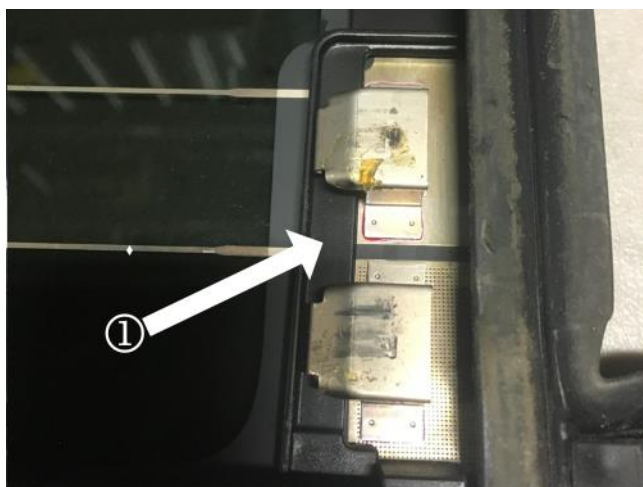
5423197

NOTE: Both the left and right buss bar covers need to be replaced if the old-style cover is installed on the passenger side of the vehicle. The new covers are made of a revised material and they must be replaced in pairs. If the new style cover is installed on the passenger side of the vehicle, both existing covers are made of the correct material and no action is required.

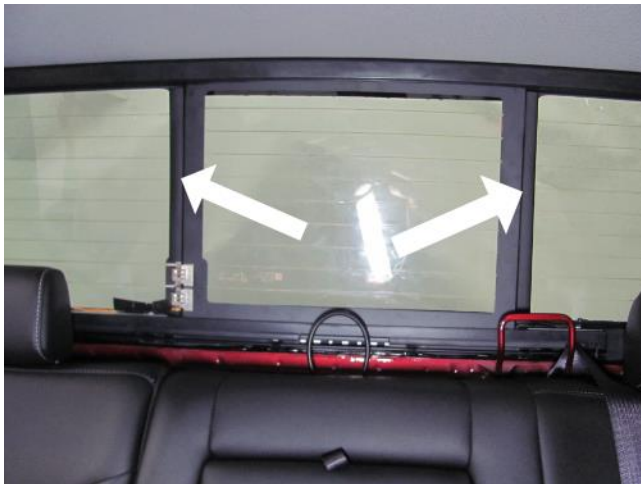
5423201

6. Inspect the rear window defroster buss bar covers and determine if the old or new style of buss covers are installed. The old-style buss bar cover will have a tab under the terminal pedestal area (1). The new style buss bar cover ends at the top of the terminal pedestal area (2).

- If the new style rear window defroster buss bar covers are installed, proceed to step # 9.
