DESIGN AND REPAIR OF A POWER INTAKE GATE SEALING SURFACE UNDER CHALLENGING CONSTRAINTS

Mike Carney, PE¹
Don Thompson, PE²
Roland Lwiindi³
Eli Lundberg, PE⁴
Joshua Phillips, PE⁵

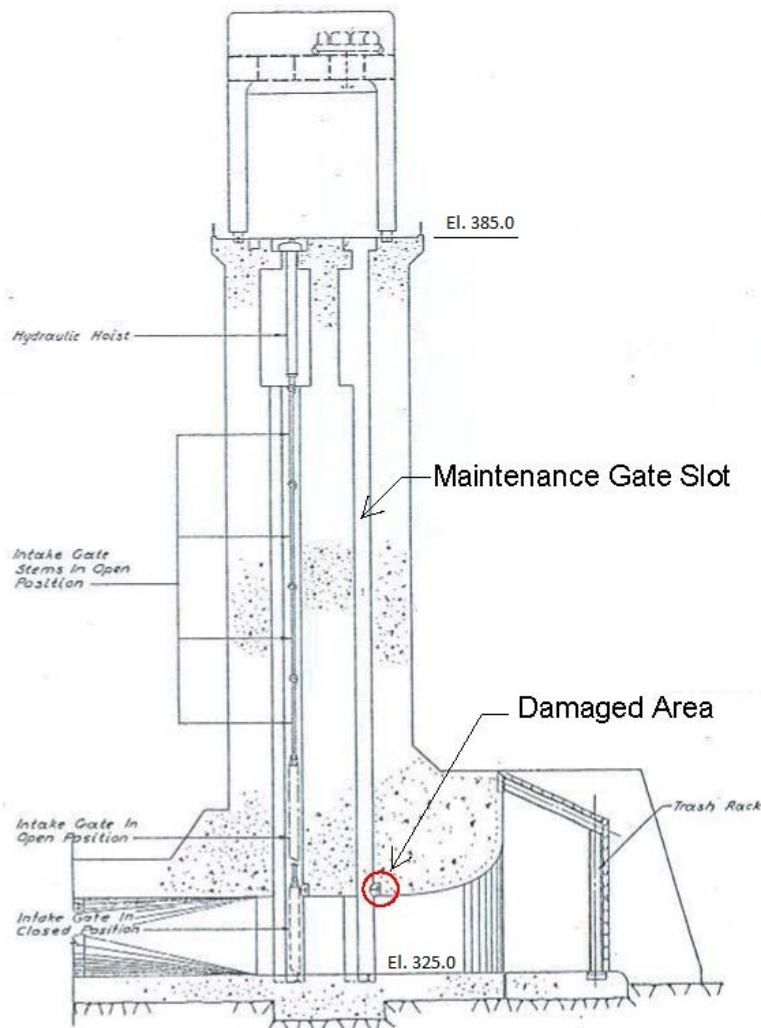
Figure 1. Intake Cross Section

slots for deploying a maintenance gate 5 meters upstream of each service gate as shown in Figure 1. A single maintenance gate, interchangeable with the service gates, is used for all four units. All gates are designed as upstream sealing gates to eliminate construction of a separate vent shaft, reduce downpull forces and therefore hoist capacity, and allow more frequent dry inspection of the gate members. Each 6.3-meter diameter concrete encased steel penstock is approximately 300 meters in length over a head range of 57 meters.
