# Elderberry Park Master Plan Assessment of Existing Conditions

Municipality of Anchorage

With assistance from Earthscape, LLC

2/6/2015

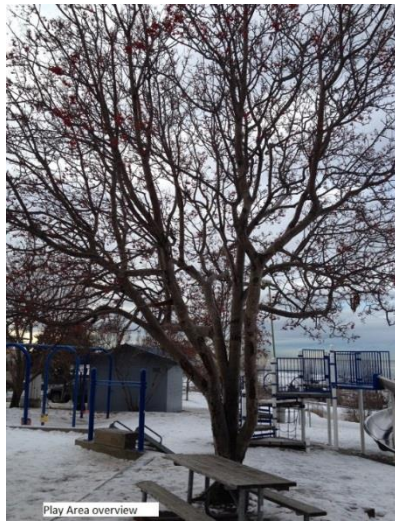
Figure 3 Mountain Ash trees near playground

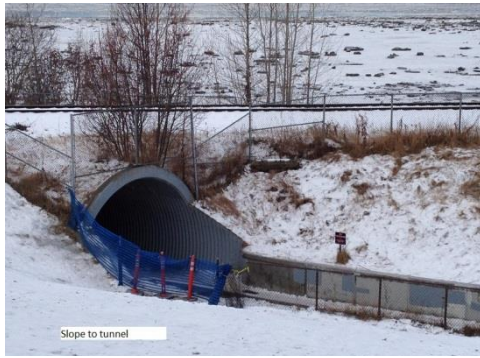
Figure 4 Tunnel allows passage of coastal trail under railroad tracks

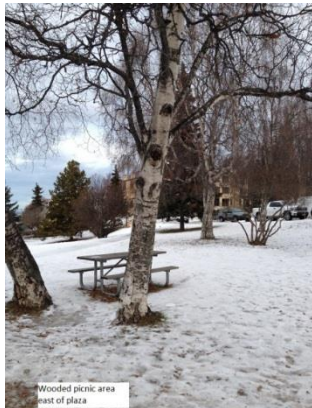
Figure 5 Open area in eastern portion of park

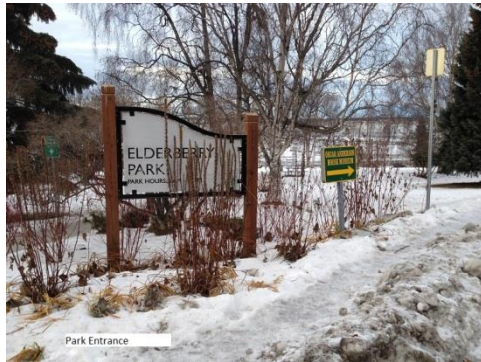
Figure 2 Park entry at 5<sup>th</sup> Avenue/M Street

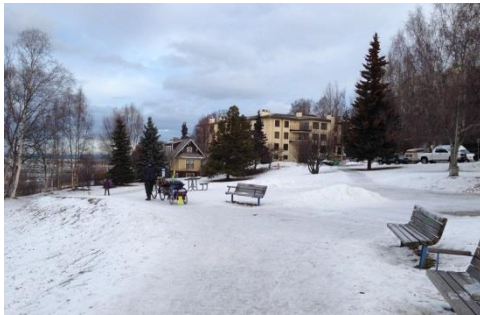
Figure 3 Central walkway

**Weaknesses:** The park in its current configuration is now 30 years old and the walkways are in various stages of degradation. The central walkway has been repaired but other walks are not in good shape for the most part. There is not a fully “accessible route” through the park that provides access to the Tony

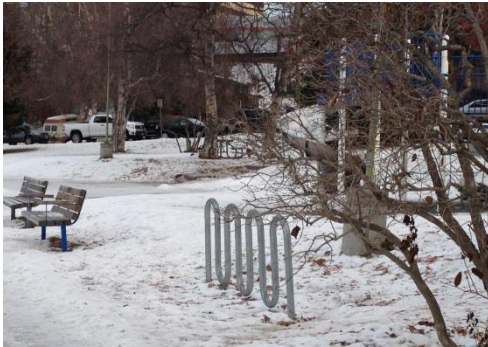
Figure 4 Amenities along central trail

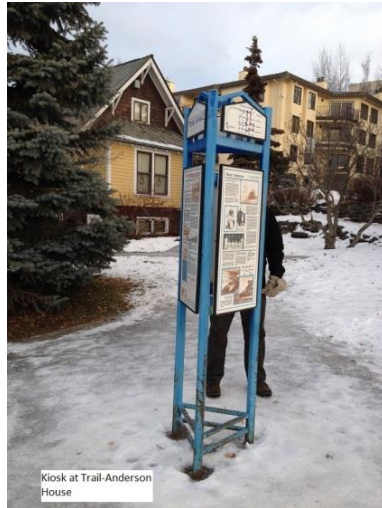
Figure 5 Kiosk near Oscar Anderson house

**Weaknesses:** Other than the Oscar Anderson House interpretive material, the other interpretive pieces present lost opportunities. The Planet Mars kiosk is not viewed since it is not on a main walkway. The Tony Knowles Coastal Trail map is directly adjacent to the trail and those viewing the map often cause congestion at a location where people are watching for multiple trail users, some of which are unseen and around the corner as cyclists near the tunnel. Benches are directly adjacent to the trail and do not offer much separation for those sitting on them from trail users. Picnic tables have no sense of permanence and appear scattered as opposed to logically placed. The whale structure seems unassociated with other park features.

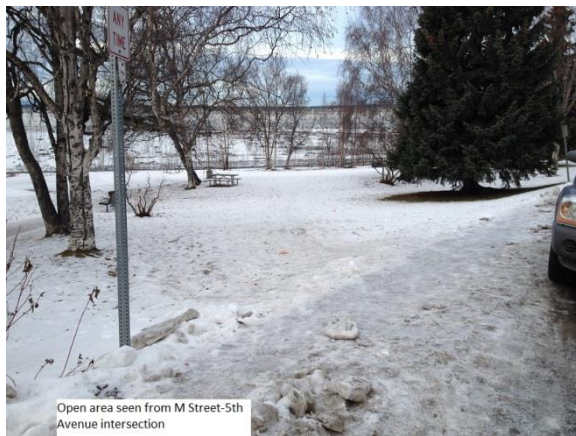
2. The 5<sup>th</sup> Avenue and M Street intersection provides views into the park which is good for security and entices people into the park.

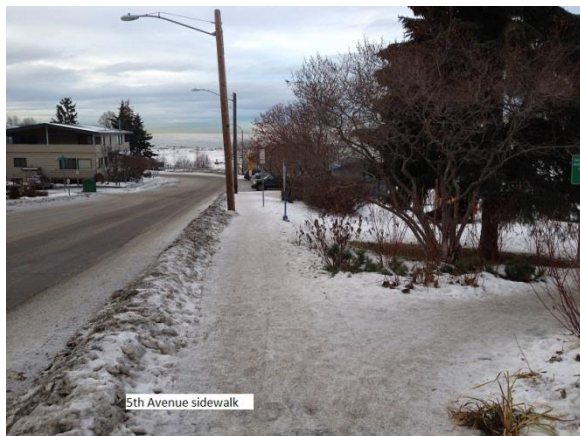
3. The sidewalk along 5<sup>th</sup> Avenue is against the back of curb. Traffic volumes are generally low and traffic speed is relatively slow.

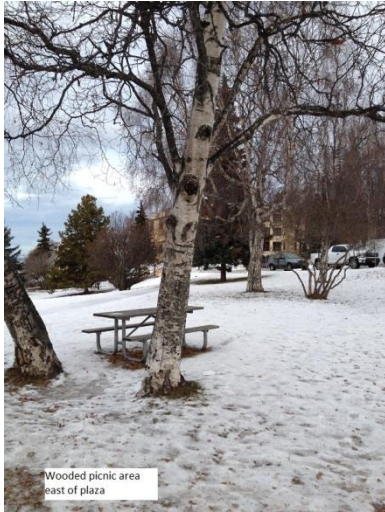
11. View of picnic area located near 5<sup>th</sup> Avenue and M Street intersection, above (east of) central plaza and walkway.

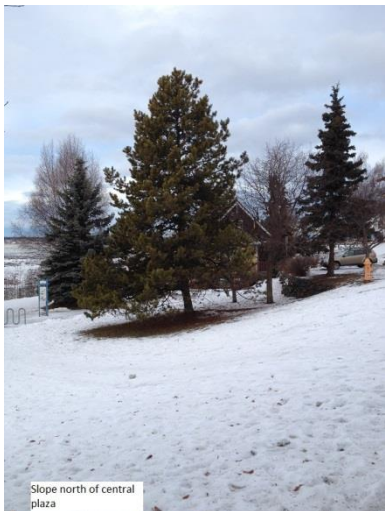
12. View of slope north of the plaza. It is primarily used for viewing Cook Inlet and sunning on sunny summer days.

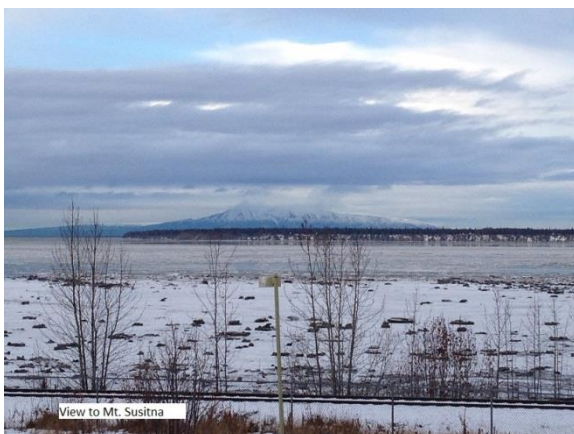
13. View to Mt. Susitna from central plaza and walkway. This view entices many residents and tourists to visit the park and enjoy the view.

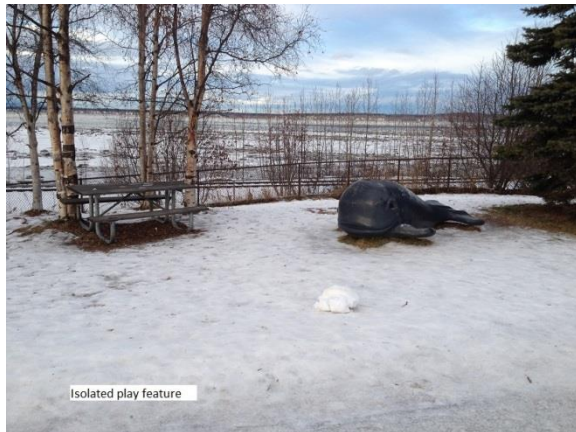
14. A picnic table and “whale play element” are located near the intersection of the main walkway and the Tony Knowles Coastal Trail, near Oscar Anderson House.

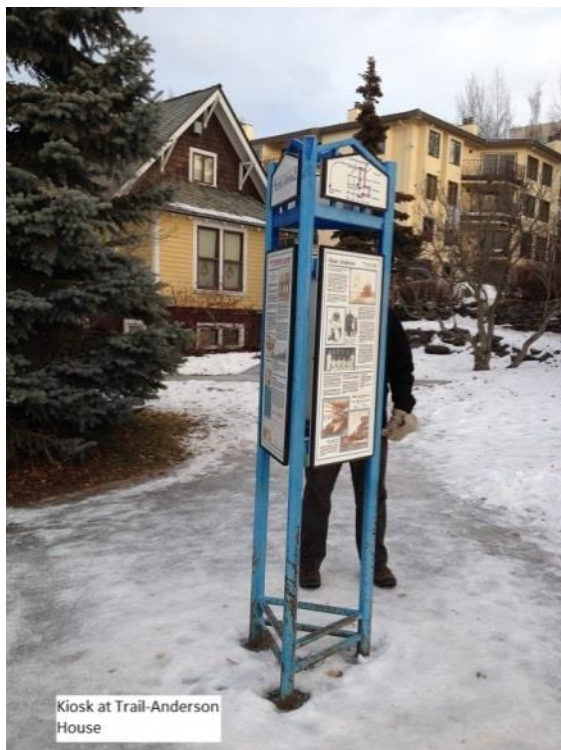
15. A kiosk provides information about Oscar Anderson and his family’s residence, as well as other historical information.

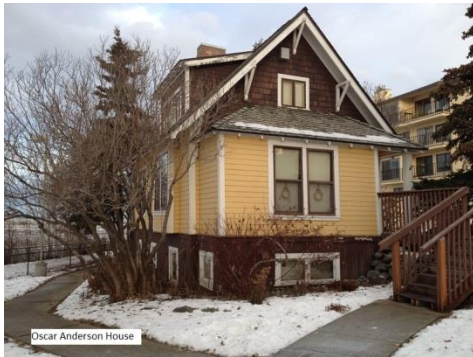
Oscar Anderson House

17. The Historical Oscar Anderson House. The main entrance is to the right. Stairs provide access down the slope. The walkway in view on the left side of the photo provides access to the basement which serves as an office for the Alaska Association for Historic Preservation. That walkway also provides access to the northern end of M Street.
