**Electrospark Deposition for the Repair of  
Army Main Battle Tank Components**

**ARL-TR-3849**

**July 2006**

**Victor Champagne, Marc Pepi, and Brian Edwards  
Weapons and Materials Research Directorate, ARL**

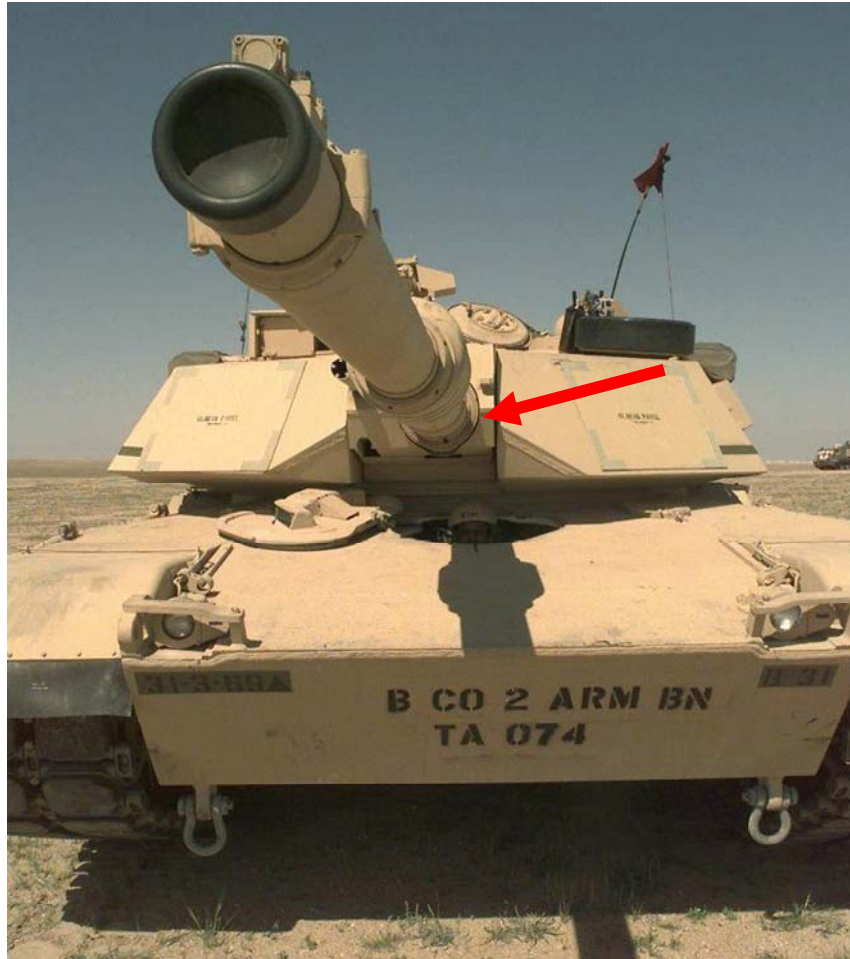
Figure 1. M1A1 main battle tank cannon cradle (arrow).

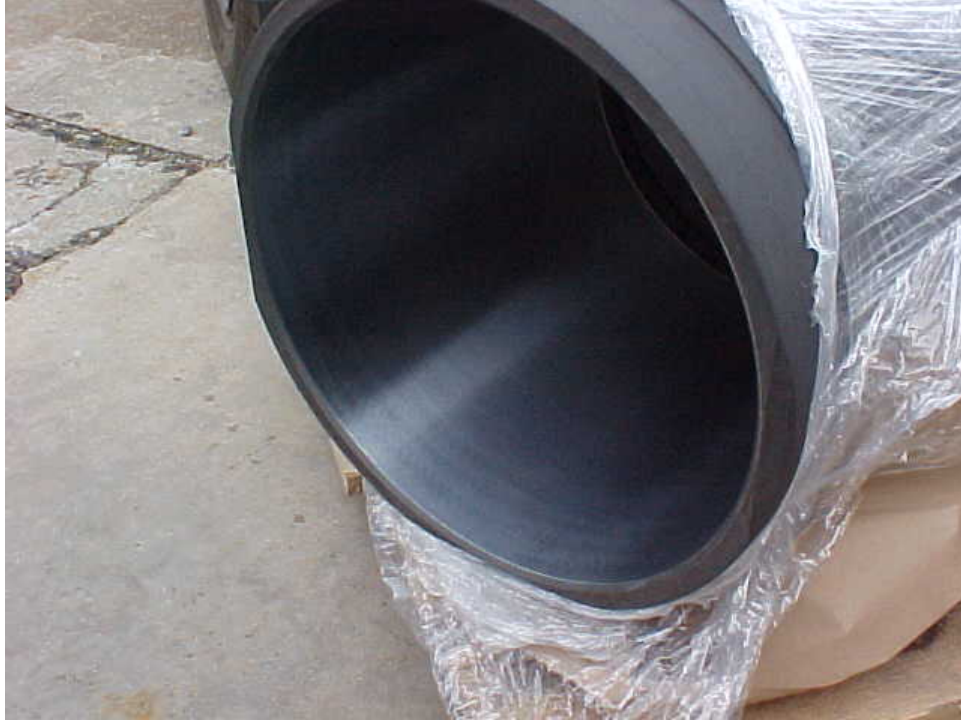
Figure 2. Cannon cradle disassembled from tank.

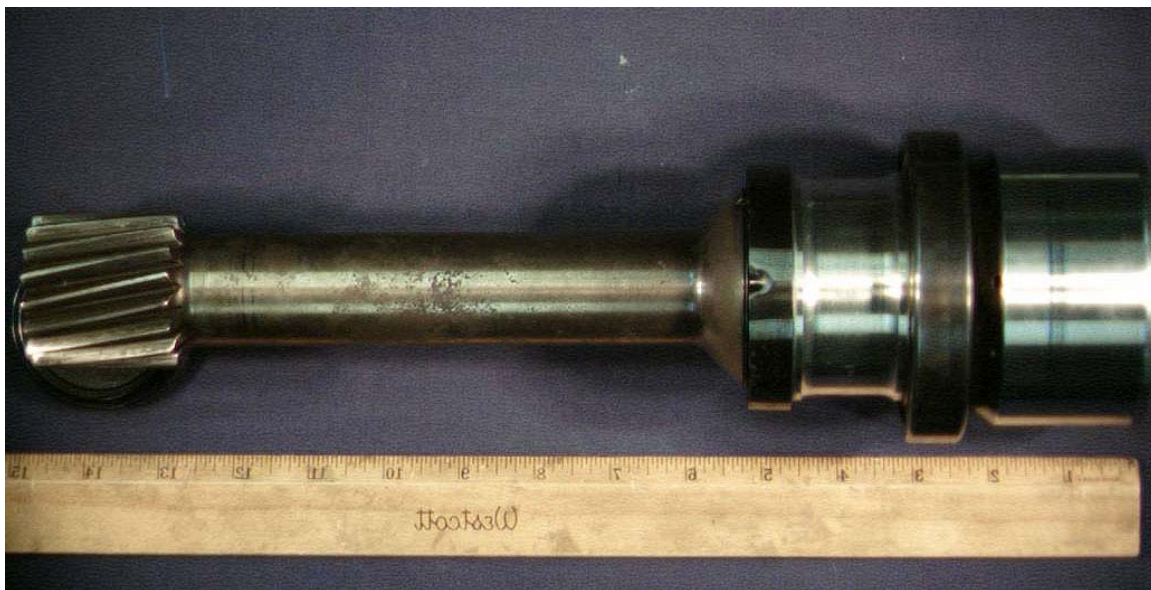
Figure 5. Photomicrograph of an M1A1 helical gear shaft (reduced 60%).

The M1A1 main battle tank components presented in this report were fabricated from alloy steels. After years of service, large corrosion pits ( $1/8 \times 3/8$  in and 0.060 in deep) and wear formed (figure 8). Systems were dead-lined based on surface anomalies discovered during inspection. Insufficient replacement parts were available. There was no approved repair procedure for these components, and conventional weld repair technologies had been eliminated at Anniston Army Depot (ANAD) to repair these large pits. Approximately 8% of the components overhauled at ANAD in 2003 were determined to be defective and were removed from the systems and put in storage.

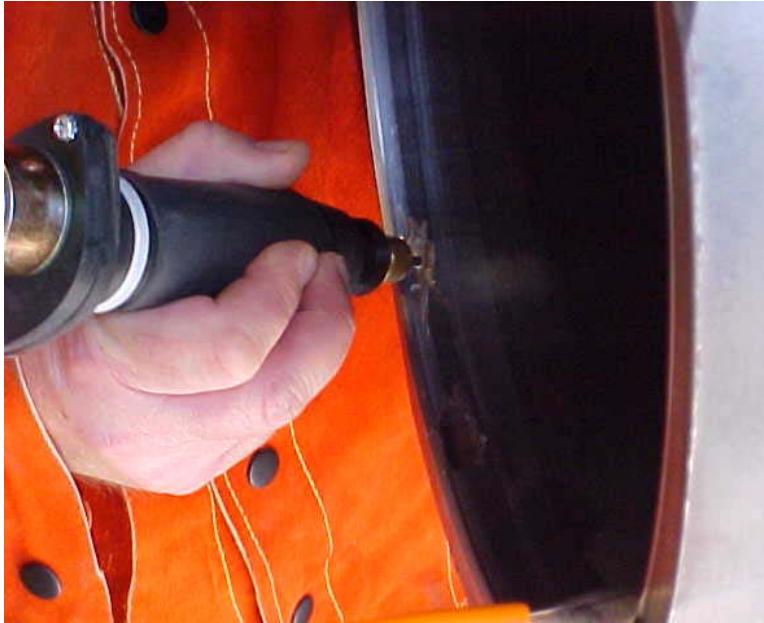
Figure 7. Photo showing ESD torch applying deposit on the inside diameter of a cradle with a rotating electrode.

distortion; shrinkage and high residual stresses can be avoided.<sup>2</sup> Figure 7 shows the application of an ESD deposit. This provides extremely rapid solidification, resulting in a nanocrystalline structure or, in some cases, an amorphous surface layer that is extremely dense, forming a metallurgical bond to the substrate. The low heat input eliminates deleterious thermal stresses or changes in metallurgical structure, otherwise known as the HAZ, allowing it to be considered for heat-sensitive applications. ESD can be used for applications requiring corrosion and wear resistance as well as the build up of worn or damaged areas on parts. ESD is also an environmentally friendly process, and the deposition of toxic materials can be accomplished with the use of a fume hood to capture any dangerous gases that may evolve. ESD operators require no specialized safety protection other than eyewear and a dust mask in some cases. The only major disadvantage is that the ESD electrode is relatively small (~0.125 inches in diameter), making the repair of large surface areas impractical and expensive.

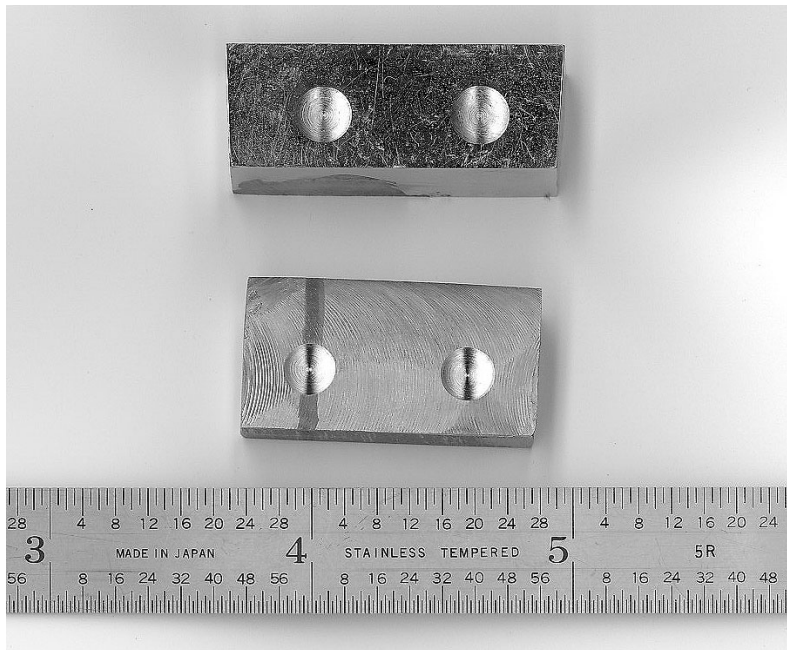
Figure 9. Test samples used for ESD process parameter optimization for the M1A1 helical gear shaft repair. Top block is chrome plated, and bottom block is uncoated AISI 9310 steel (magnified 1.5 $\times$ ).

The ESD repair procedure was developed and proved out at ARL for the gear shaft. Numerous ESD trials were conducted at ARL in order to determine the optimal set of process parameters that would result in a dense, adherent deposit. These trials were performed on coupons representing the material of the sun gear (chrome-plated AISI 9310 steel). Defects were machined into test samples (figure 9), and subsequently filled using ESD. Table 1 summarizes the iterative process utilized for each of the six defects, while figure 10 shows a representative scanning electron micrograph (SEM) of a section of each defect. Condition 4 was considered to exhibit the optimal coating characteristics and is highlighted in table 1.

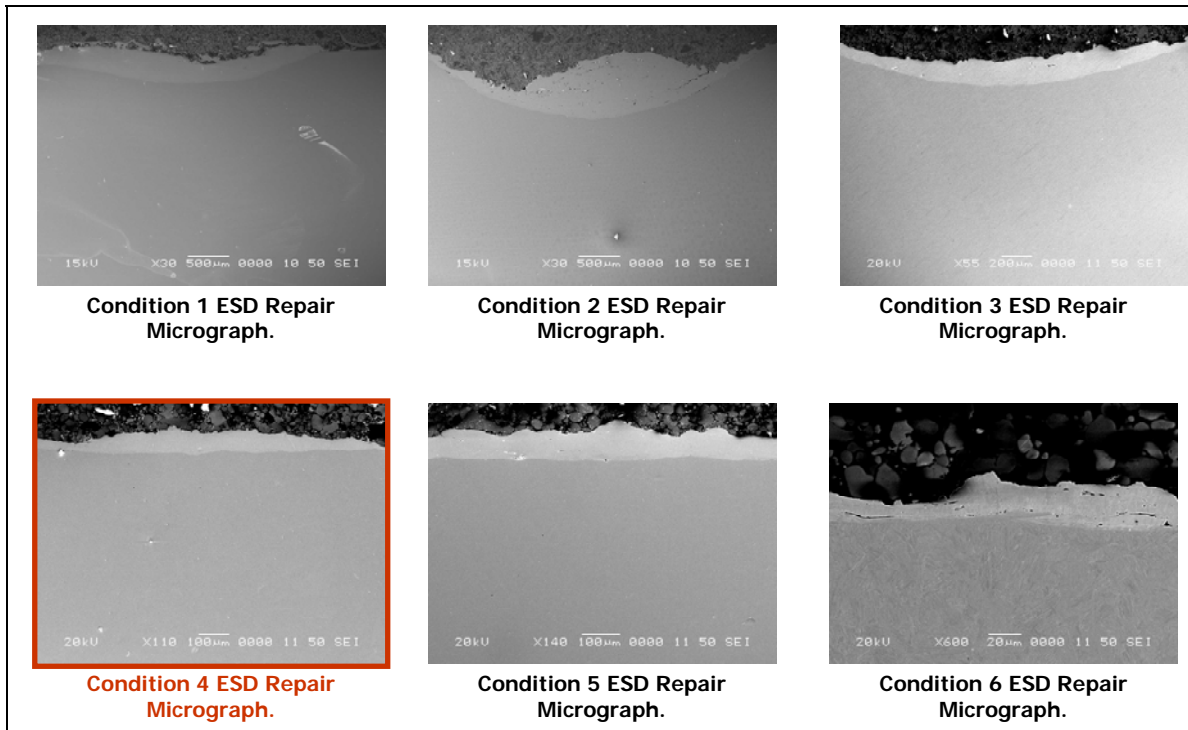
Figure 10. The ESD parameters chosen for condition 4 were selected as optimal.

The parameters used in condition 4 were chosen to be used for the repair of the helical gear shaft. These parameters were chosen for the uniformity and density of the coating, the clean interface between the coating and substrate, and the lack of voids and intergranular sites. Figure 11 shows an optical macrograph of two ESD-filled defects, as well as an unfilled defect, while figure 12 includes an SEM micrograph of the surface of condition 4. Figure 13 shows an SEM micrograph of a cross section of condition 4.

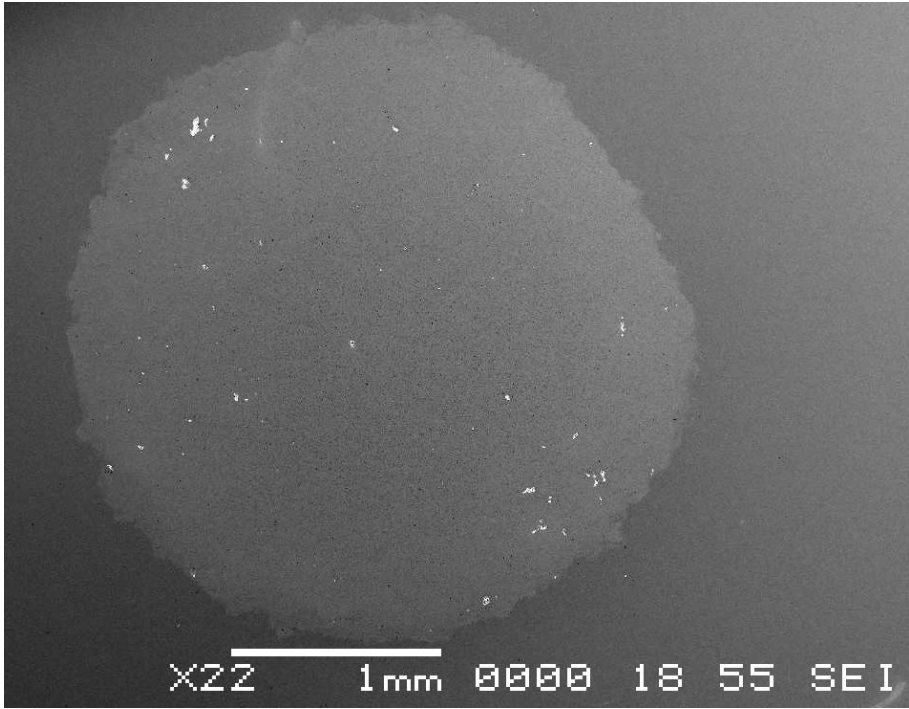
Figure 12. SEM micrograph of the surface of condition 4 after ESD repair (magnified 22×).

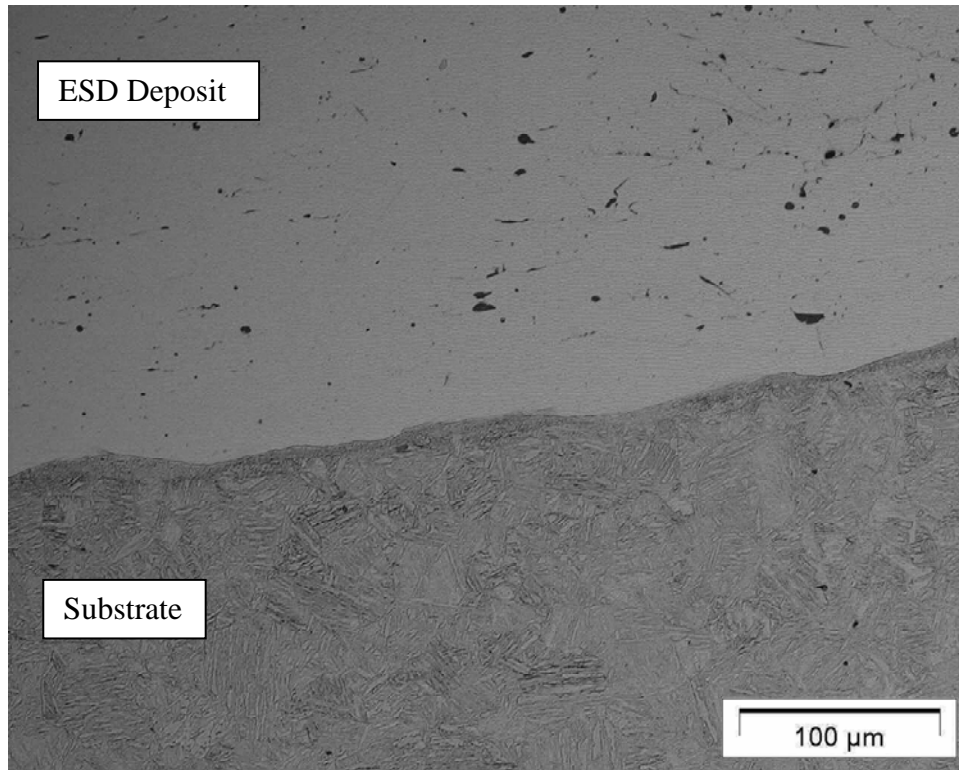
Metallography was utilized to examine test pieces that had defects filled with ESD to ensure that the deposit did not contain significant voids, porosity, or cavities. This would give an indication that the adhesion to the substrate material was adequate. Specimens were sectioned through the deposit and mounted in phenolic powder. The mounted specimens were subsequently rough polished using silicon carbide paper ranging in grit size from 240 to 2400. Final polishing was accomplished with 1- $\mu$ m diamond followed by 0.05- $\mu$ m alumina. For the most part, the interface between the substrate and the ESD deposit was determined to be acceptable (figure 15, representative); however, areas of surface porosity were sometimes encountered with the chrome plated samples (figures 16 and 17, representative). Advanced Surfaces and Processes (ASAP), Inc., describes this phenomenon as, “small defects (named the “halo effect”) where ESD meets the chrome.”<sup>3</sup> ASAP, Inc. indicated that improvements are seen in reducing/eliminating this effect specifically when the ESD equipment parameters were maintained at low energy while

Figure 15. Photomicrograph showing interface between deposit and substrate. Substrate was AISI 9310 steel etched with 2% nital (magnified 200×).

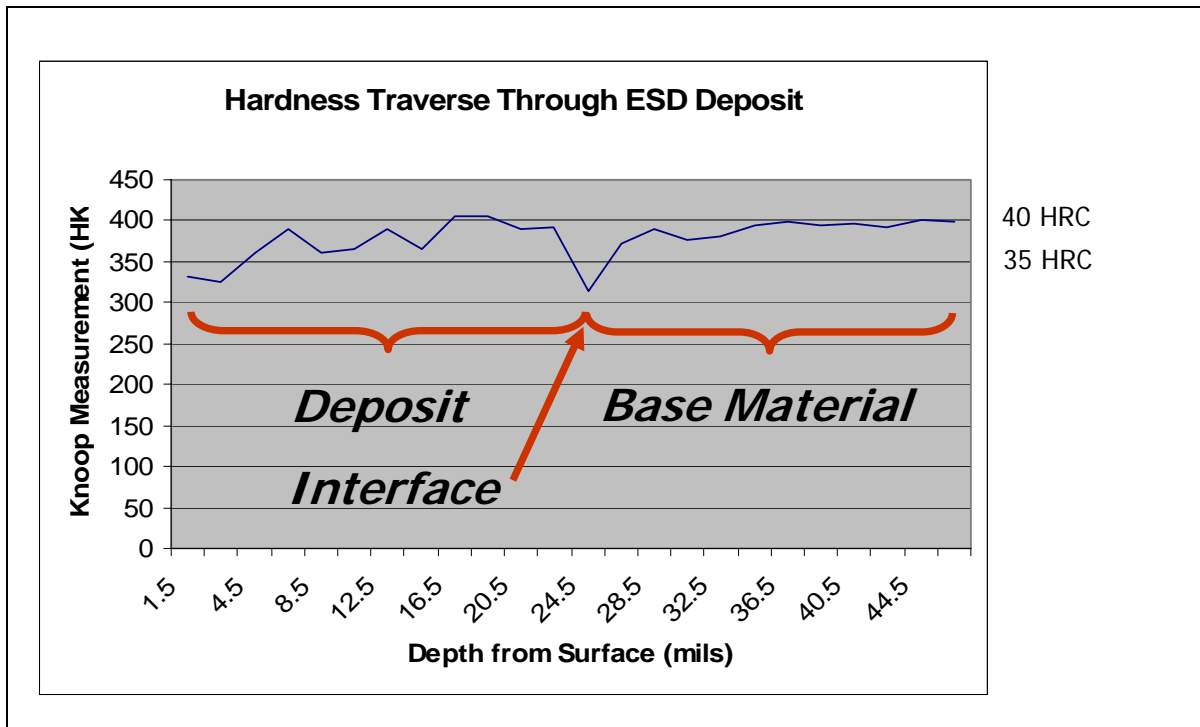
The Knoop microhardness scale (with a major load of 500 gmf) was utilized to assess the hardness of the deposit and the substrate, even though it has been shown that the ESD process has little to no deleterious effect on the substrate.<sup>4</sup> The substrate was AISI 9310 steel heat treated to a hardness of ~40 HRC, as the results in table 3 show. The hardness of the deposit and the base metal was essentially the same. In addition, the hardness of the base metal was not altered as a result of the ESD process. Figure 20 shows a graph of the hardness data, and figure 21 includes a micrograph of the hardness indents through the deposit into the base metal.

Figure 20. Plot of hardness through ESD into the base metal, showing similar hardness values.

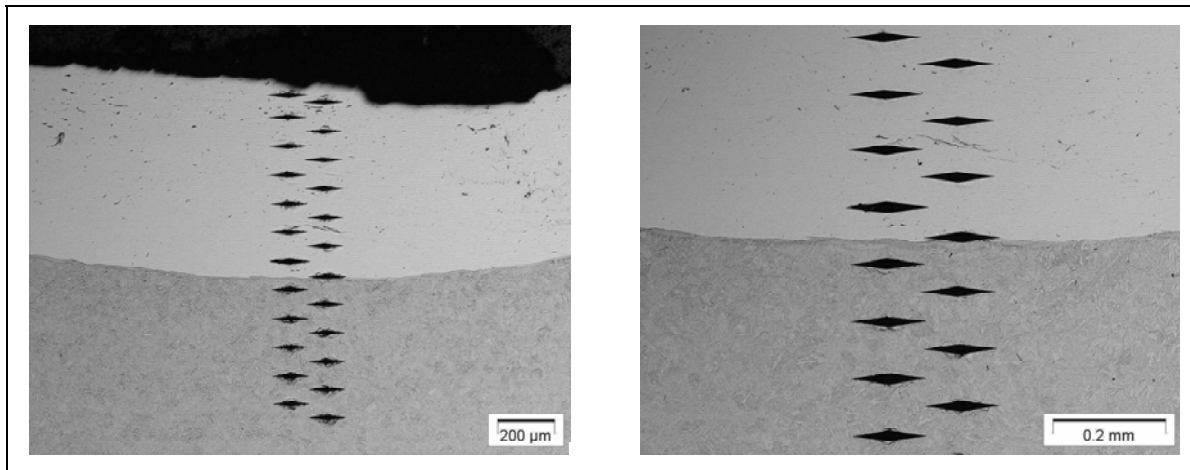
Figure 21. Micrographs of Knoop microhardness indents through the ESD into the base metal. Base metal etched with 2% nital (magnified 50× [left] and 100× [right]).
