EVALUATION OF CROSS MEDIAN CRASHES

Final Report

February 2005

Rowan University
Department of Mechanical Engineering
Glassboro, NJ 08028

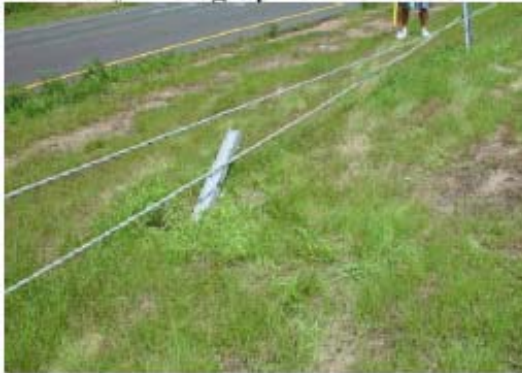
Post 3 bent, tire tracks visible
