# Failure Analysis of a Kaplan Turbine Runner Blade by Metallographic and Numerical Methods

**Abstract:** The paper presents the results of the failure analysis of a Kaplan turbine runner blade from a hydropower station in Romania. In order to determine the causes that led to the crack, the authors carried out metallographic investigations on a sample obtained from the damaged blade. They led to the conclusion, that the cracking of the blade was caused by fatigue, initiated by the numerous non metallic inclusions, which were discovered in the vicinity of the blade surface. The results obtained by metallographic investigations were completed by numerical analysis regarding the resistance of the blade and service life estimations. The calculations showed that the cracking of the blade started and developed from the stress concentrator placed between the blade and blade flange. In order to avoid further damages, the blade geometry and the number of blades have to be reconsidered.

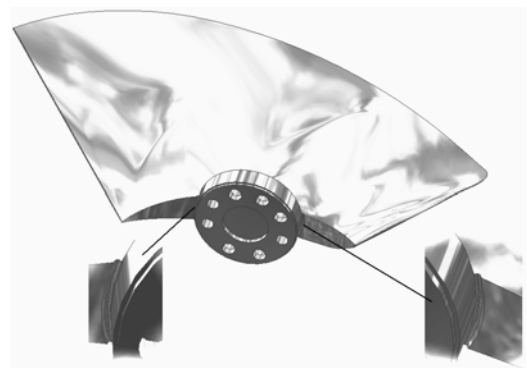
**Fig.8** The solid model of the blade with stress relieve groove R8x20

- extensions of blade's surfaces: the previous surfaces must be extended to the hub and periphery direction to obtain the surfaces of the complete blade;
- intersections of the blade surfaces with radial planes, disposed at imposed angles, which will generate a number of closed loops disposed on radial planes;
- generation of the solid model of the blade, based on the previous closed loops;
- completion of the 3D solid geometry of the blade with the flange and stress relieve groove with different geometry, Fig.8 and Fig.9.

From the Haigh diagram results that, for stress relieve groove R8x20, the blade cracks should be obtained between  $10^9 \div 10^{10}$  of the fatigue cycles. To reduce the stress concentrator values, a number of different stress relieve groove geometry were studied. The optimal solution was obtained for stress relieve groove R20x50, where the stress values were reduced in the range between 45...60 MPa (see

The metallographic investigations and the calculations carried out led to the conclusion that the cracking of the blade started and developed from the stress concentrator placed between blade and blade flange on the leading edge direction.

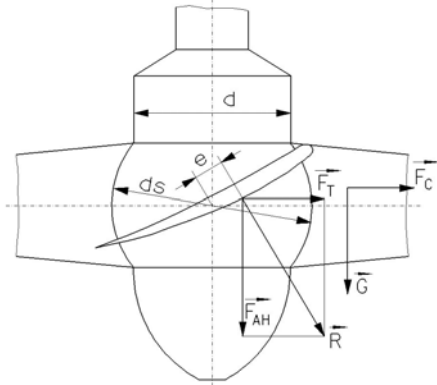
**Fig.10** The hydrodynamic loads applied to the runner

The hydrodynamic loads applied on the axial runner are presented in Fig.10:

- the gravity load  $\vec{G}$ ;
- the centrifugal force  $\vec{F}_C$  for the runner speed 115.4 rot/min;
- the axial thrust  $\vec{F}_{AH}$ , resulted from the measurements on model;

- the tangential force  $\vec{F}_T$ ,
- $\vec{R}$  is the resultant of the hydraulic force on the blade
- “e” is the distance to the blade axis.

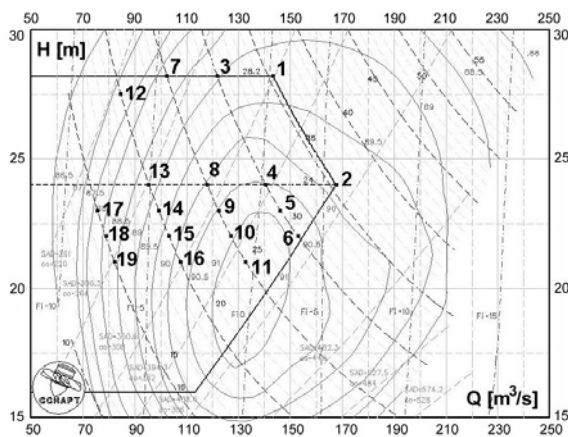
**Fig.11** The placement of the operating points in the prototype hill chart

The operation points considered for resistance calculus correspond to the following power values: 35.5 MW, 30 MW, 25 MW, 20 MW and 15 MW at different head values. The axial thrust and tangential forces were calculated for 4 and 6 runner blades. The placement of the operating points in the prototype hill chart is shown in Fig.11.

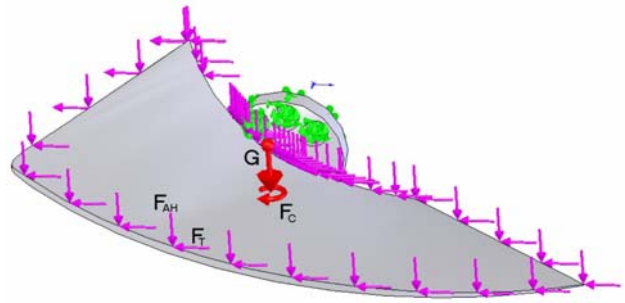
**Fig.12** Loads and restrictions applied to the blade

Fig.12 shows the loads and restrictions applied to the blade:

- Fixed type constraints applied to the flange holes, which impose 0 value for the translations and rotations of the selected entities; axial thrust  $F_{AH}$ ;
- tangential force  $F_T$ ;

- centrifugal force  $F_c$ ;
- blade gravity  $G$ .

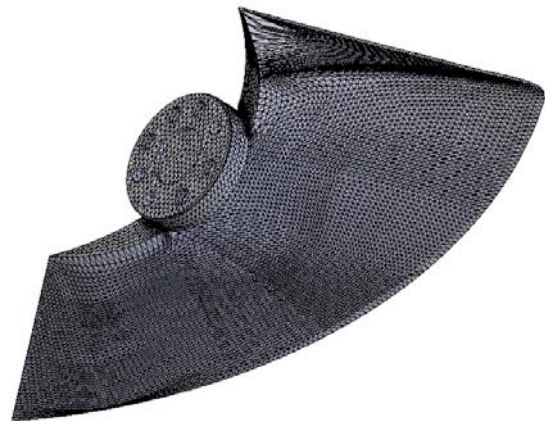
**Fig.13** The blade mesh

Because the blade cannot be generated as a surface with constant thickness, for finite element analyse, only solid mesh (parabolic tetrahedral solid elements) can be used. The mesh is shown in Figure 13. For original stress relieve groove R8x20 a local fine mesh was used, Figure 14. The results are presented numerically in Table 1, and graphically in Figure 15 and Figure 16, only for operating point no. 1.
