Failure Analysis of Dielectric Breakdowns in Base-Metal Electrode Multilayer Ceramic Capacitors

Ronald J. Weachock
Dell System Federal Government, Inc.
NASA Goddard Space Flight Center
Greenbelt, MD 20771
Ronald.j.weachock@nasa.gov

David (Donhang) Liu
MEI Technologies, Inc.
NASA Goddard Space Flight Center
Greenbelt, MD 20771
Donhang.liu-1@nasa.gov

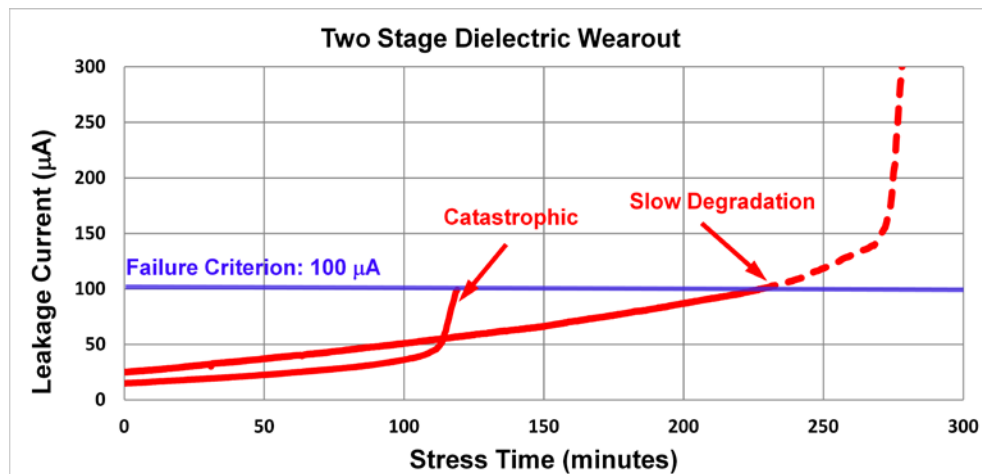
Based on the FA results, the failure mechanism in BME capacitors with a BaTiO_3 dielectric might be better described by a two-stage dielectric wearout that initiated with a slow dielectric degradation, characterized by a gradual leakage current increase against stress time, followed by a thermally dominated catastrophic breakdown (either ABD or TRA). When the failure criterion is set with respect to a leakage current level ($100\mu\text{A}$ in this study), some BME capacitors will reach the failure level with a catastrophic failure, and some will fail prior to the occurrence of a catastrophic breakdown. This modified two-stage dielectric breakdown model for BME capacitors with X7R dielectrics is illustrated in Figure 20.

Figure 20. Two-stage dielectric wearout failure modes is proposed for describe the dielectric breakdown behaviors in BME capacitors.
