# **FAILURE BEHAVIOR OF PIPING SYSTEMS WITH LOCAL DEGRADATION UNDER EXCESSIVE SEISMIC LOAD**

## **Abstract**

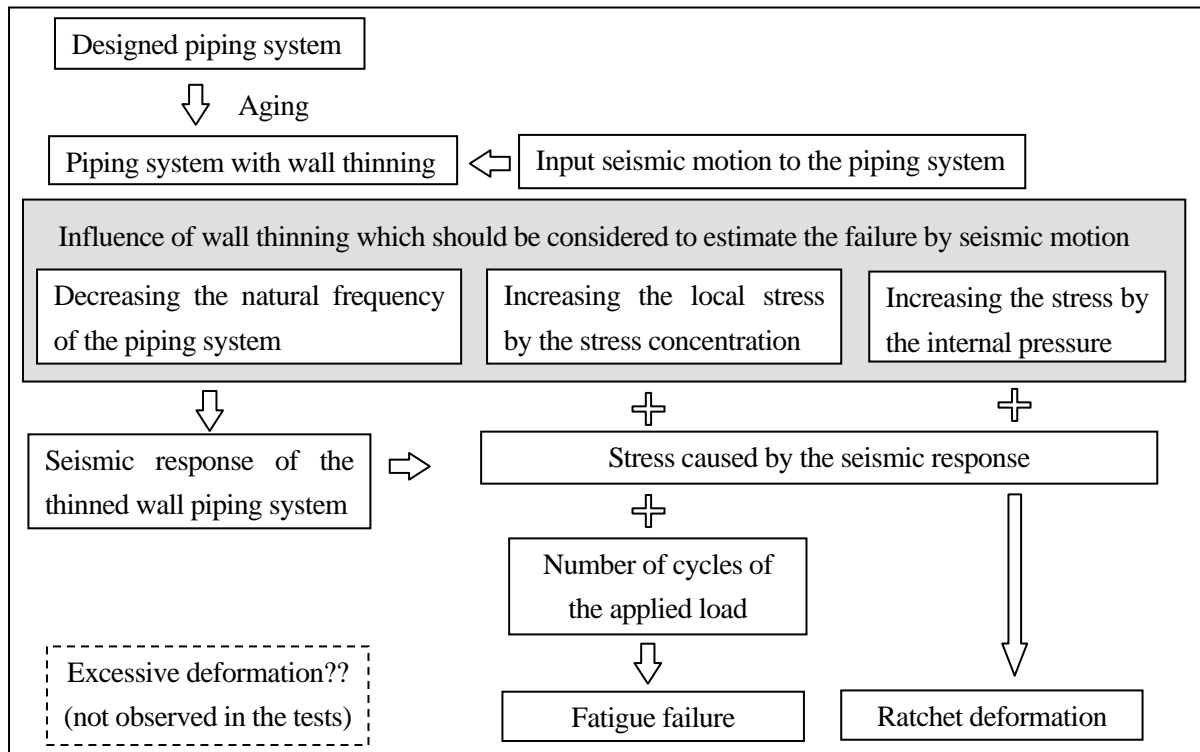
**Fig.14 The effect of wall thinning on the estimation of the seismic safety of piping system**

At present, the effects of wall thinning on the seismic safety shown in Fig.14 are considered qualitatively. For example, test results show that the dominant frequency of the piping system is affected by the wall thinning, but the influence of wall thinning on the system's dominant frequency varies depending on the configuration of the piping system, its vibration mode, wall thinning condition, etc. Thus more investigation and tests should be done to estimate such effects quantitatively and to determine the acceptable wall thinning configuration under seismic load. The FEM analytical model established in
