FAILURE OF A TRACTOR WHEEL -

ANALYSIS BY

ROBERT H. WAGONER AND GERALD S. FRANKEL

March 28, 2010

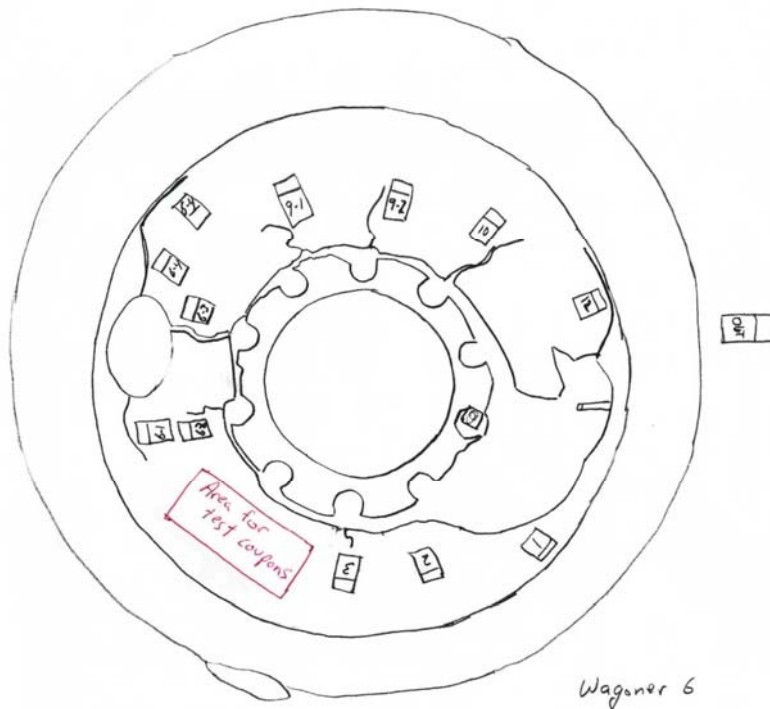
Figure 2-1. Wagoner 6 DSC01053 Scanned Marked

Figures 2-1 and 2-2 show the overall crack pattern on the subject wheel, and the numbering system used to identify them. (Figure 2-1 is the same as Figure 1-5, but the crack paths and original labels have been darkened using a felt marker and the figure was then scanned. This figure was used at the inspections to identify locations.

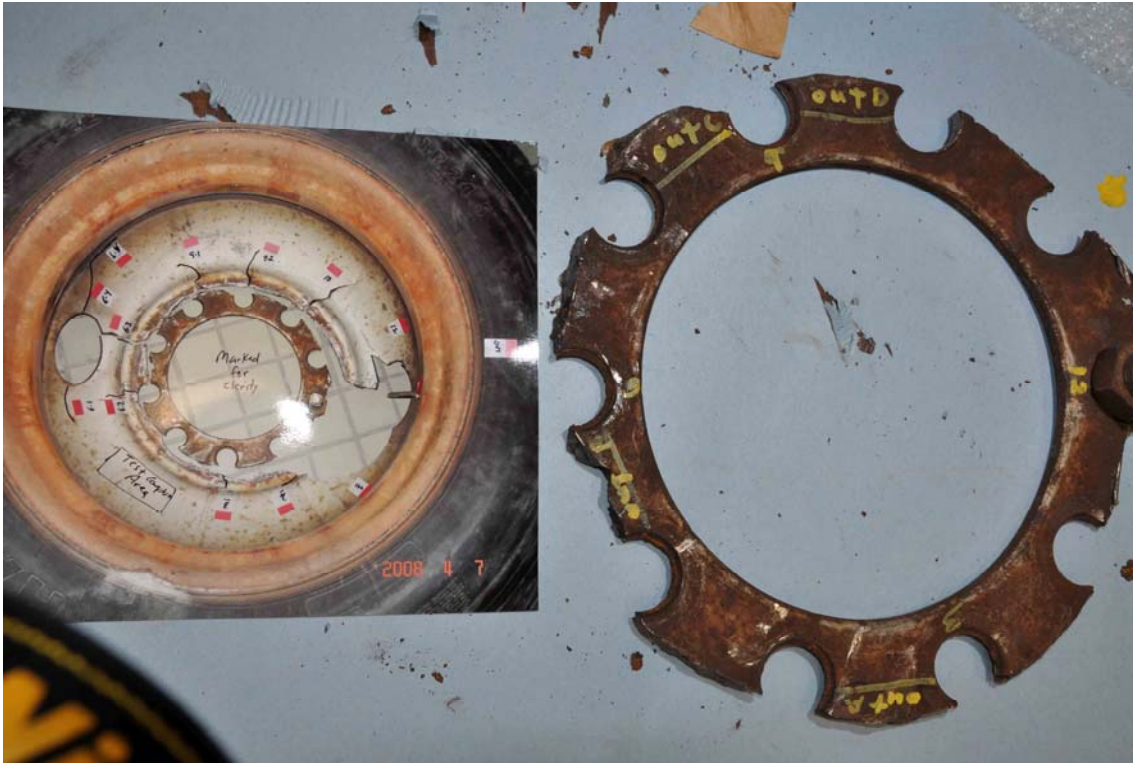
Figure 3-1. DSC_0062 LowRes.jpg

The orientation of the spider relative to the wheel is shown in Figure 3-1, along with the labeling of areas B, C, and D of the spider. The sectioning of these areas and the scale is shown in Figure 3-2.

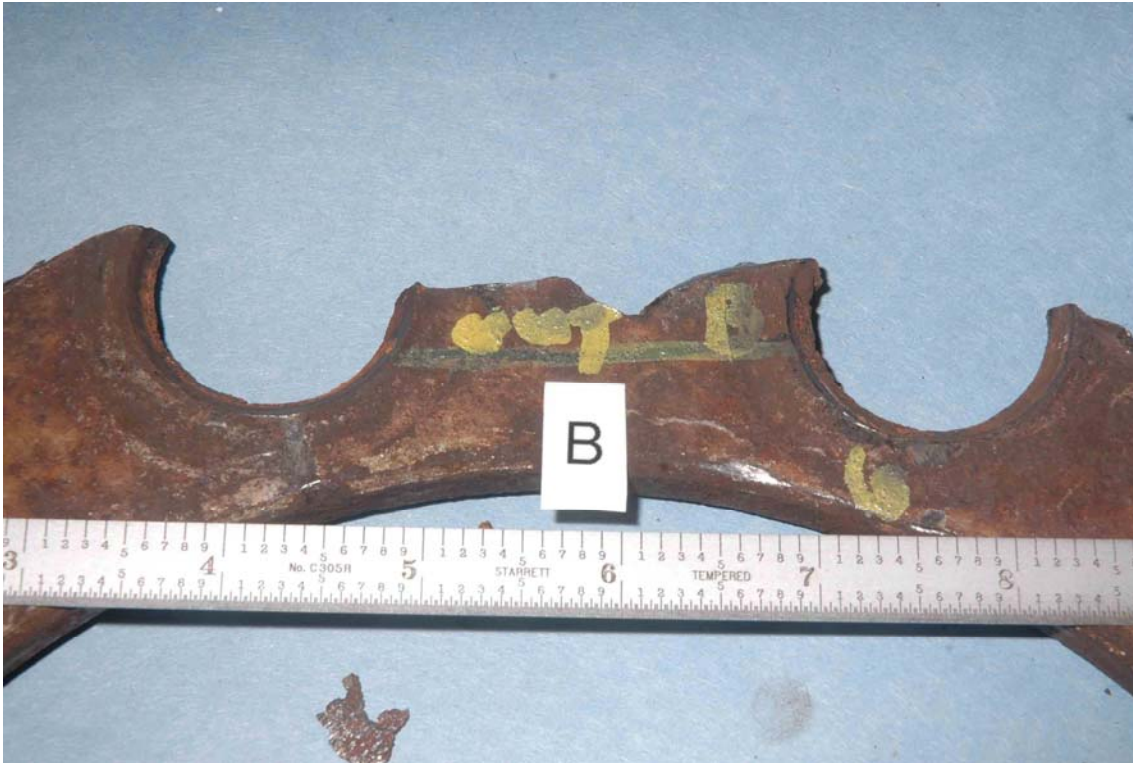
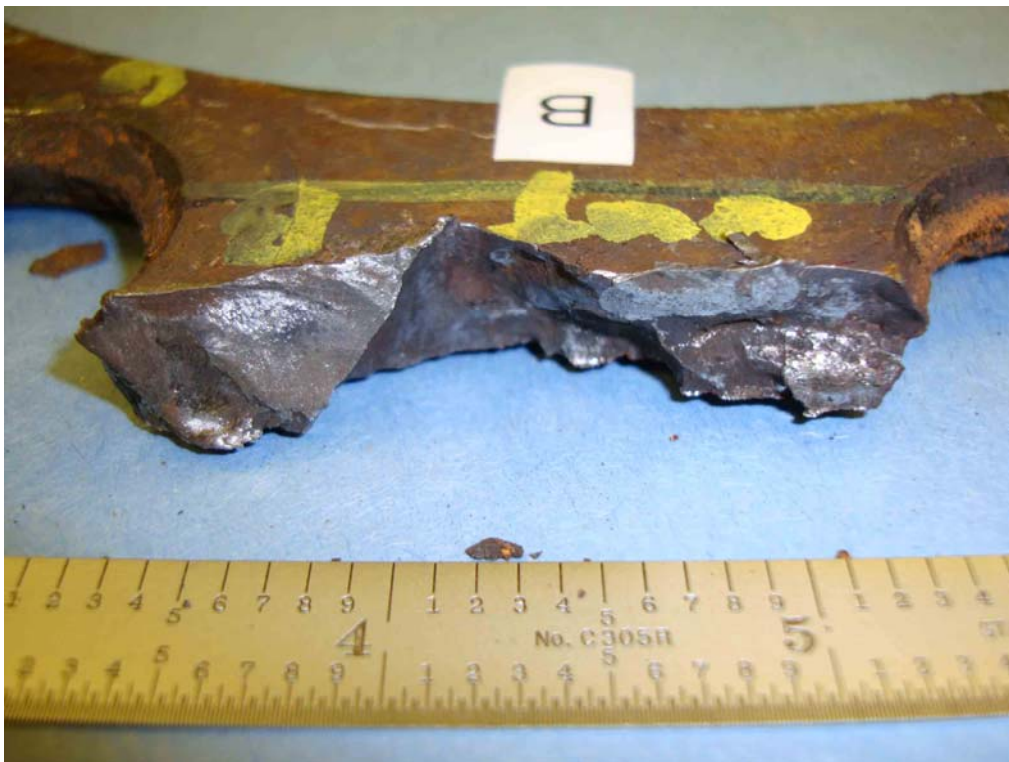
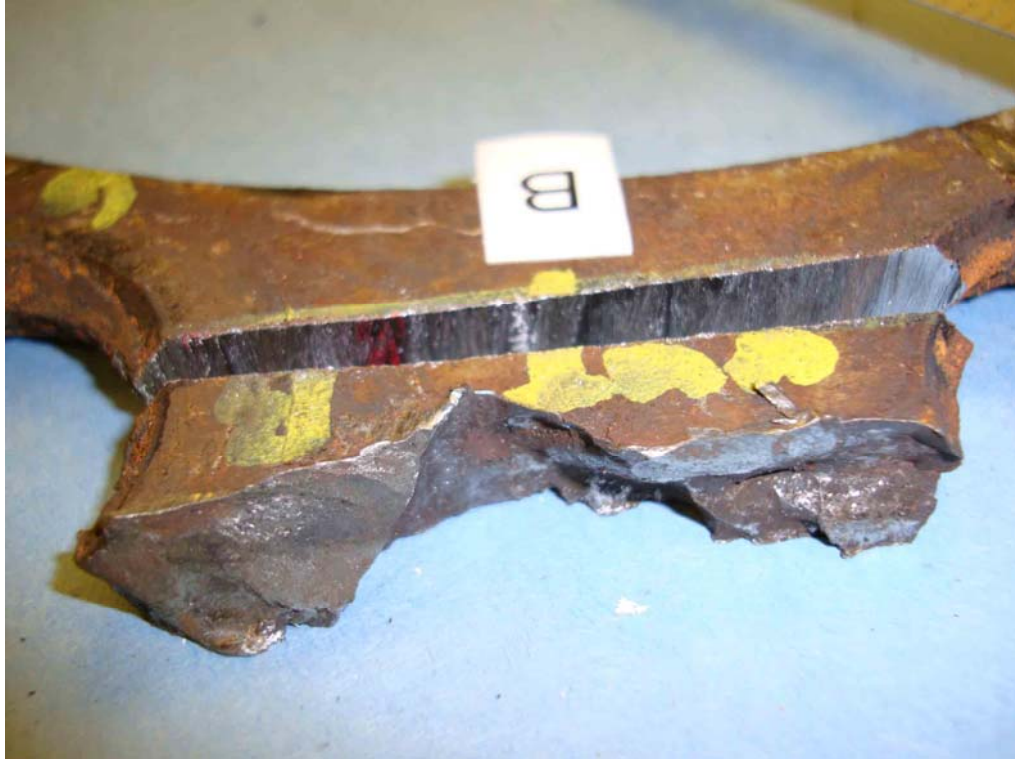
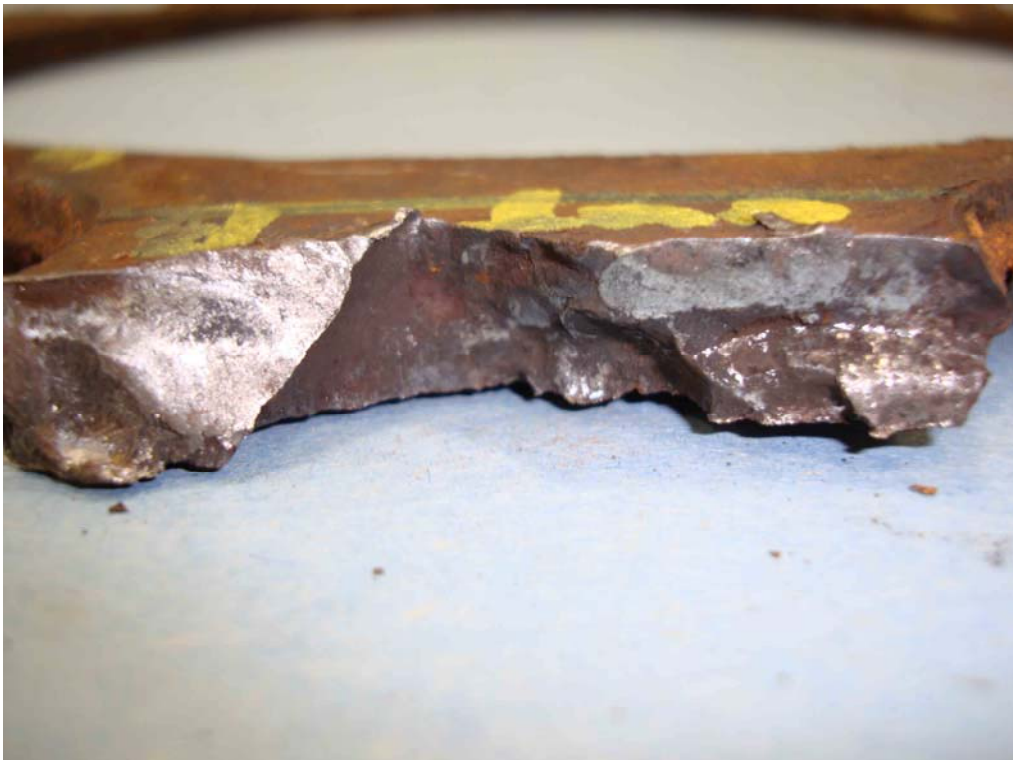
The Spider B hole is shown in progressively higher magnification and detail in Figures 3-3 to 3-8, and other, similar holes at earlier stages (non-perforating) can be seen on other parts of the circumferential crack, Figure 3-9. The Spider B hole is today represented by a cone-shaped region not consistent with a fracture surface through which the circumferential crack propagated. The current configuration thus represents approximately half of the hole before fracture. The conical region is about 10 mm in diameter at the inner surface of the wheel and about 4 mm in diameter at the outer surface of the wheel.

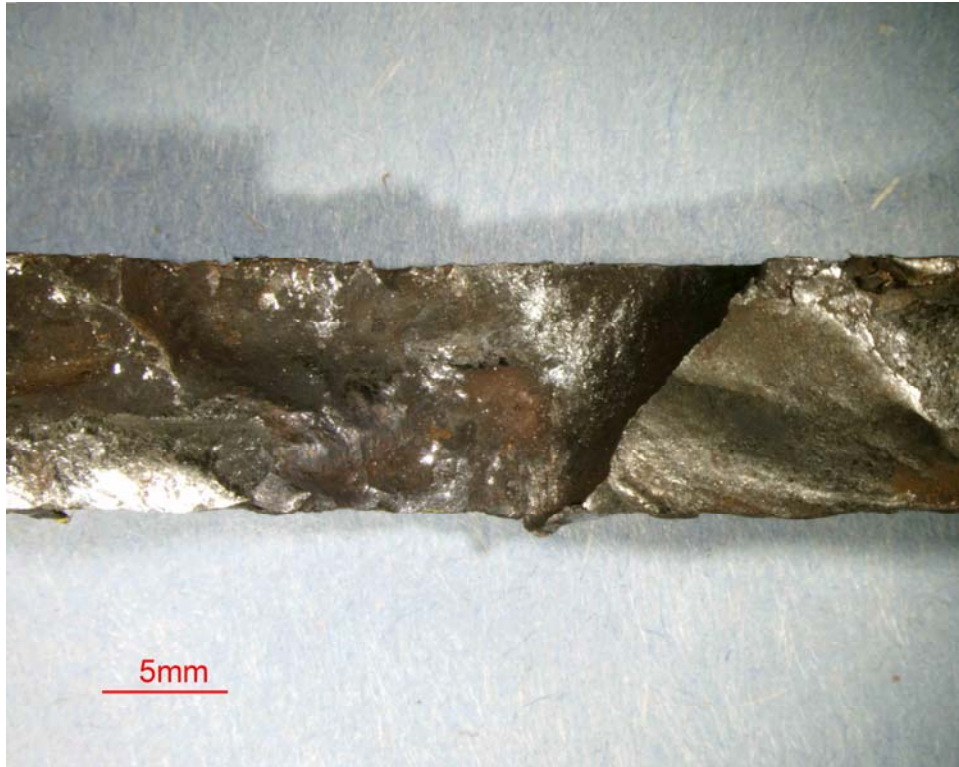
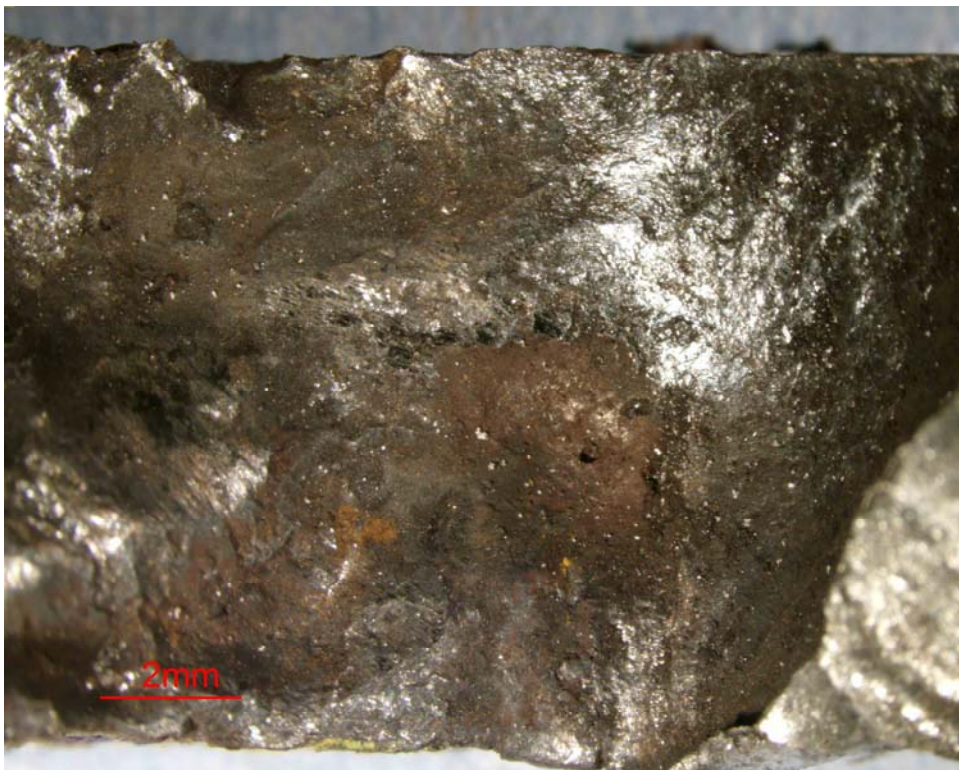
Through-thickness perforation of the thick wheel entails more metal removal and thus requires longer corrosion exposure than Crack 12, although it was not possible to find and retain the oxide layer during preparation of the hole surface in order to quantify the age more precisely. It probably developed through preferential corrosion in the vicinity of an inclusion in the steel. The appearance of the surface of the hole is similar to Crack 12 except that corrosion pits are visible on the surface of the hole, Figures 3-7 and 3-8.

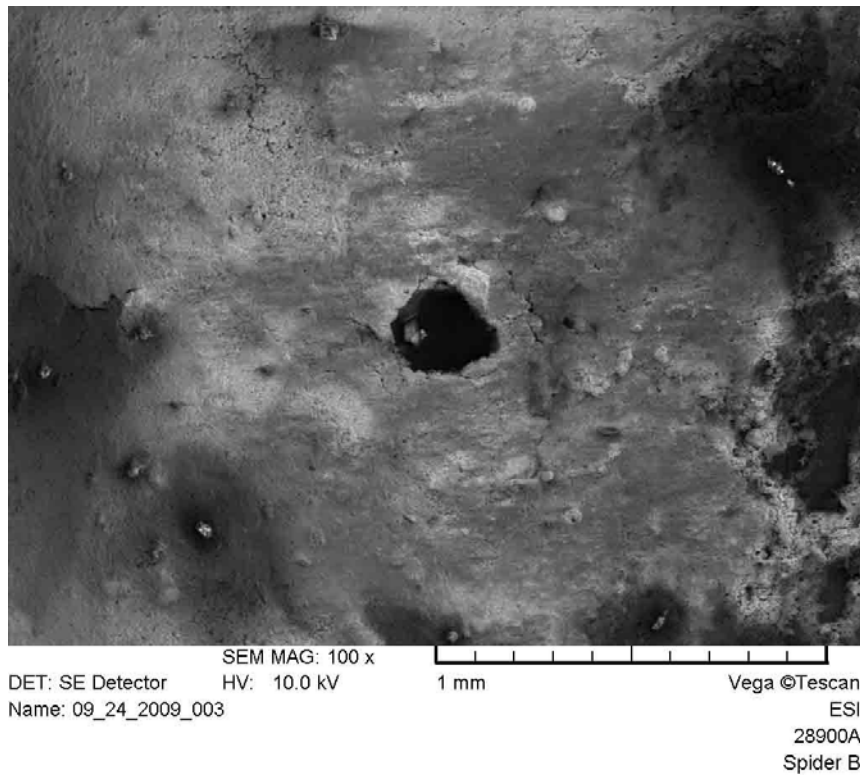
Figure 3-10. 09_24_2009_003 LowRes.jpg

One deep pit had a diameter of 0.2mm (200 μm), Figure 3-10, thus indicating metal removal during its formation of 100 μm in thickness. Thus, the age of the pit, which formed after most of the hole had already developed, can be estimated using methods similar to those for Crack 12:

$$100 \mu\text{m} / 80 \mu\text{m}/\text{y} = 1.3 \text{ years (15 months)}$$

Note that these ages are only for the pit, which formed after the major part of the hole. Thus, it can be concluded that the hole is likely considerably older than these estimates, and thus older than Crack 12.

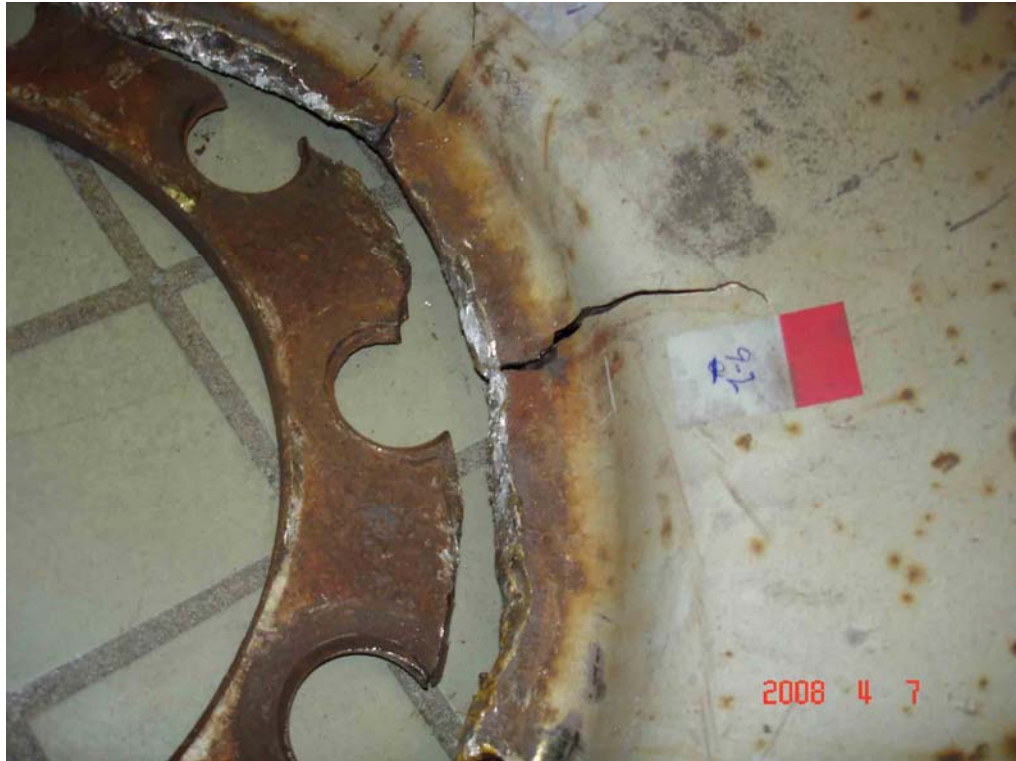
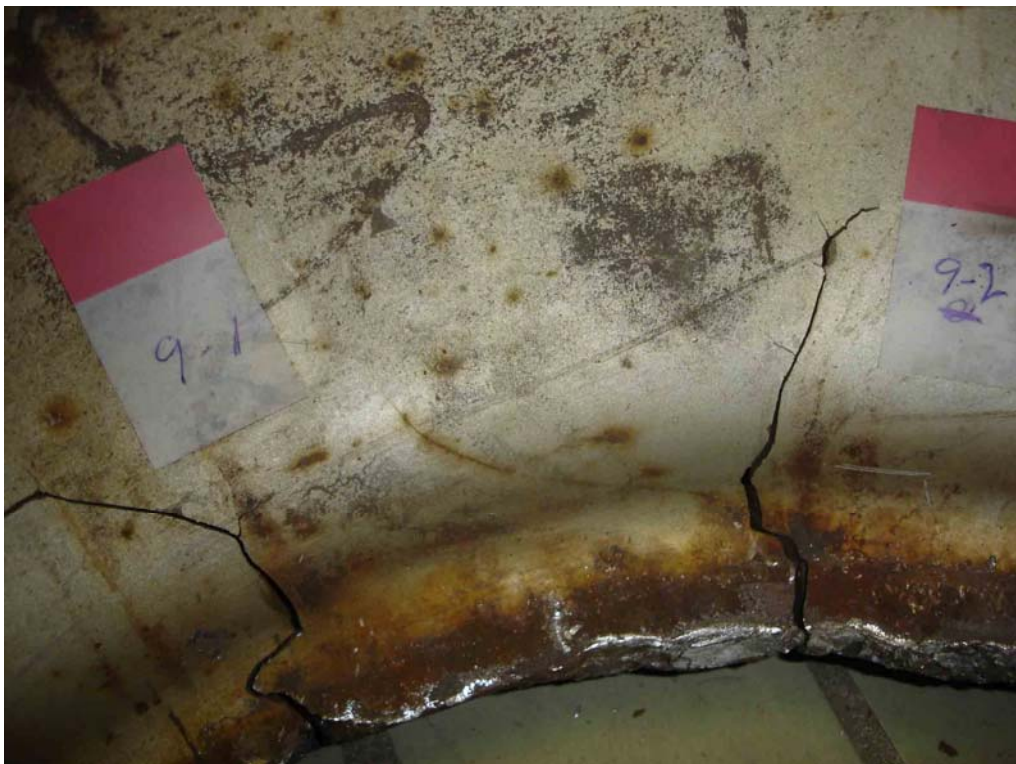
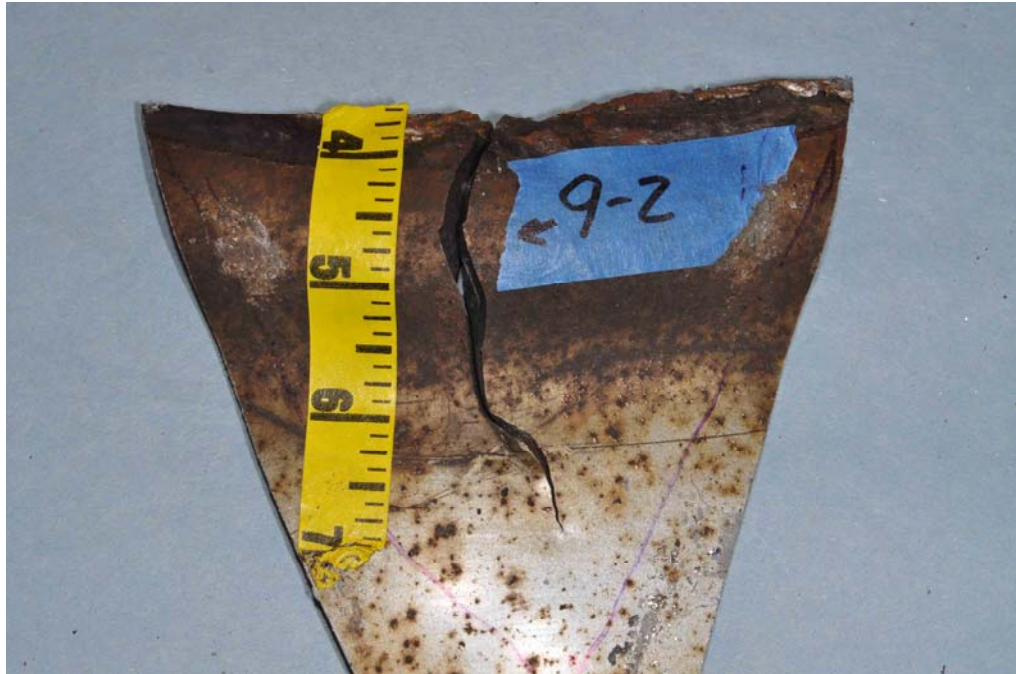
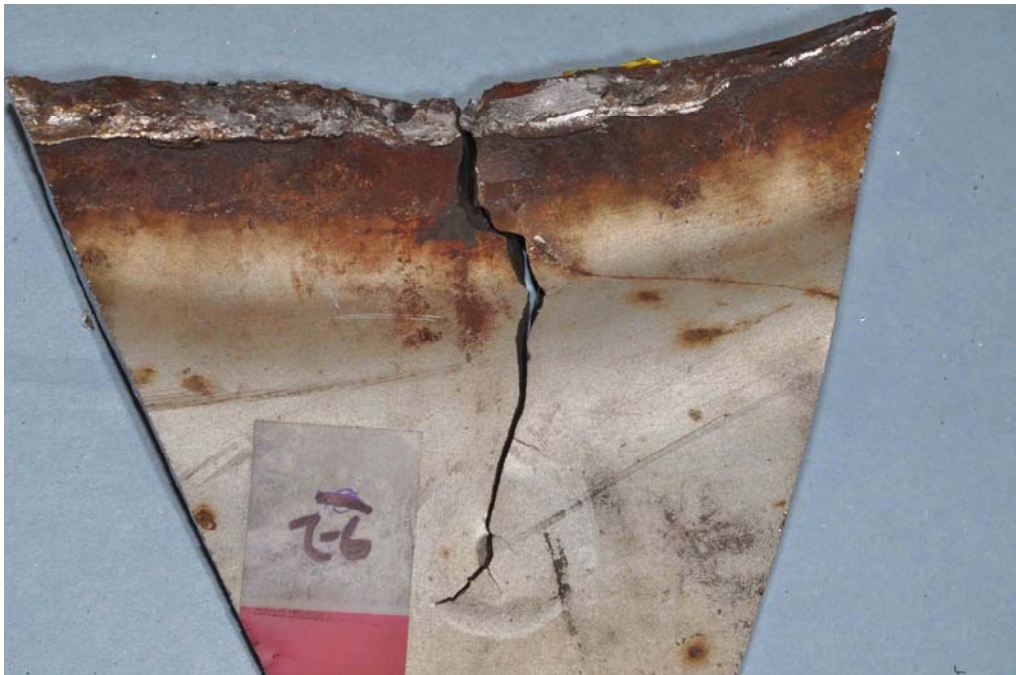
The ages of Crack 12 and spider hole B were determined as outlined in Opinions 2 and 3. Crack 9-2, shown in Figures 4-1 to 4-4, has a dark, corroded appearance. It was sectioned as shown in Figure 4-5, with lower and higher magnification SEM images shown in Figures 4-6 and 4-7. Figure 4-8 shows a manual measurement of the oxide thickness, 34 μm . As with other, similar crack surfaces, the oxide appears in recessed, concave regions, indicating that oxide has been removed by rubbing in adjacent areas and probably even in the recessed area.

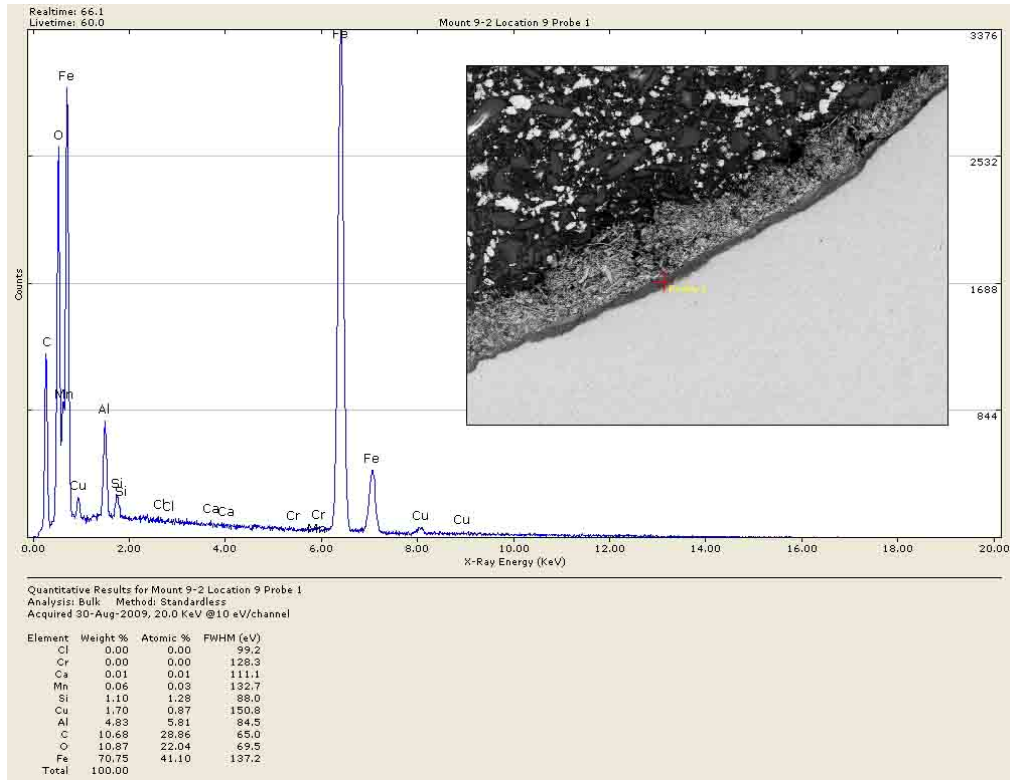
Figure 4-9. Mount 9-2 Location 9 Probe 1 LowRes.jpg

The identification of the oxide layer was confirmed using EDS, Figure 4-9 and Table 4-1. The ratio of atomic oxygen to oxygen plus iron is 35%. This layer has an appearance distinct from the metal surface which appears white, from the mounting material which is white and black, and the polishing debris layer which looks like a bundle of needles.

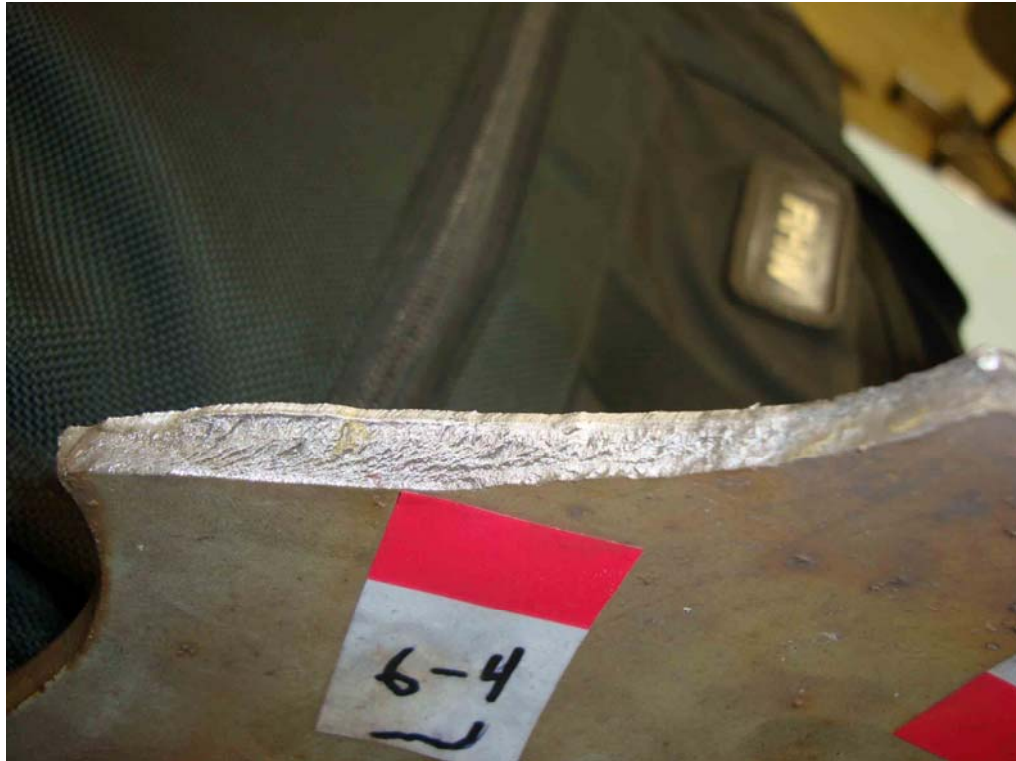
Figure 4-15. DSC00344 LowRes.jpg

The “young” cracks can be identified visually by their shiny appearance and finely textured surface, i.e. without smearing or rub marks. The hub surface of Crack 6-4 is an example of a fresh crack surface. It is nearly uniformly shiny, in spite of a clearly rubbed surface in a narrow band at its edge (seen at the top of Figure 4-11) that occurred during or just preceding the violent wheel detachment. Figures 4-13 and 4-14 illustrate the shininess of the hub surface of Crack 6-4, relative to other nearby cracks and the hub-rim surface of Crack 6-4. Figure 4-15 confirms the nearly equal shininess of the rubbed and unrubbed parts of the hub surface of Crack 6-4.

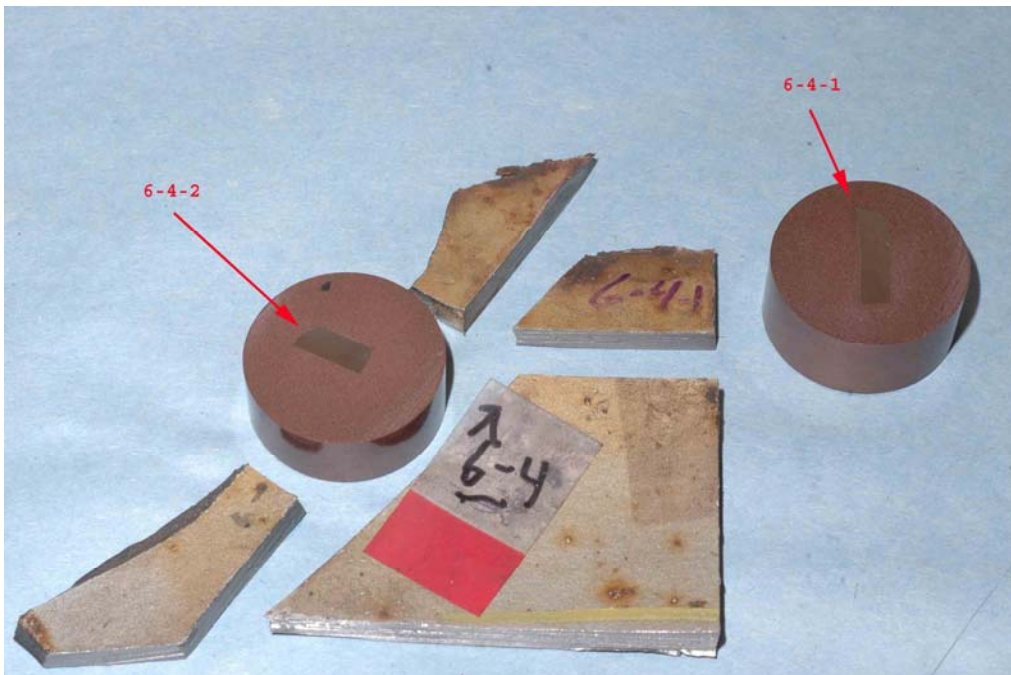
Figure 4-16. Specimen_Locations LowRes.jpg

Crack 6-4 was sectioned as shown in Figure 4-16 for further examination. A mounted section is shown in Figure 17. No oxide can be seen.

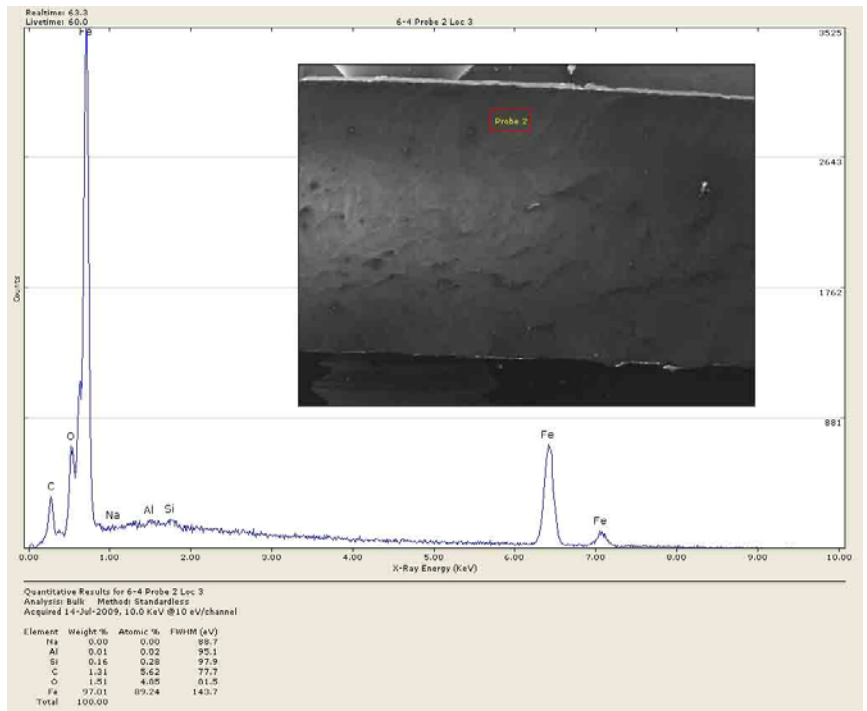
Figure 4-18. 6-4 Probe 2 Loc 3

Hub surface, Crack 6-4 (rubbed area), Figure 4-18:

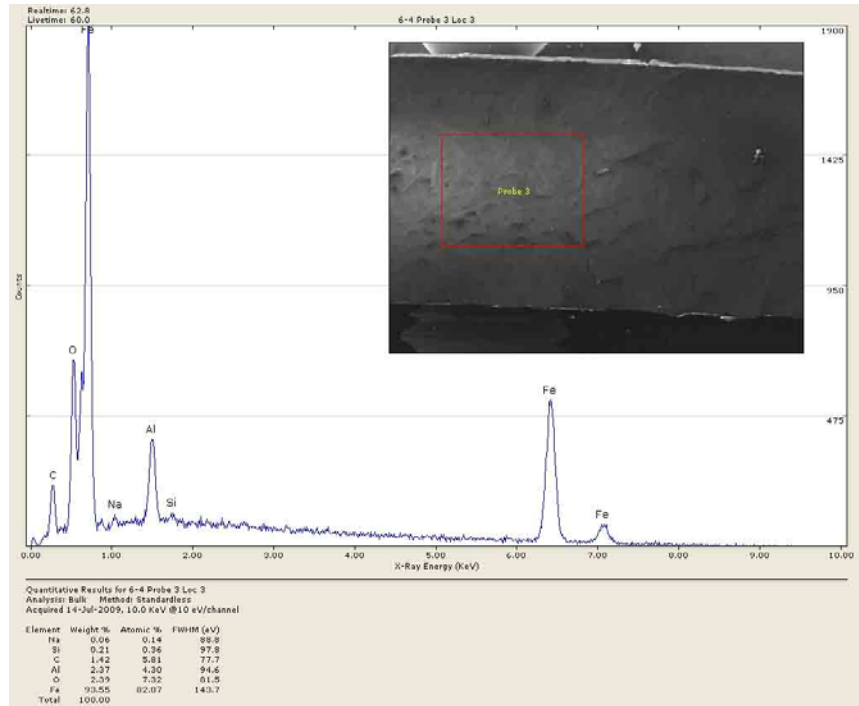
Figure 4-19. 6-4 Probe 3 Loc 3 LowRes.jpg

Hub surface, Crack 6-4, (unrubbed area), Figure 4-19:	8%
Hub surface, Crack 6-4 (overall), Figure 4-20:	9%
Hub-rim surface, Crack 6-4 (overall), Figure 4-21:	18%
Fresh saw cut (Table 1):	0%
Rust chip (Table 1, Figures 2-12, 2-13):	48%

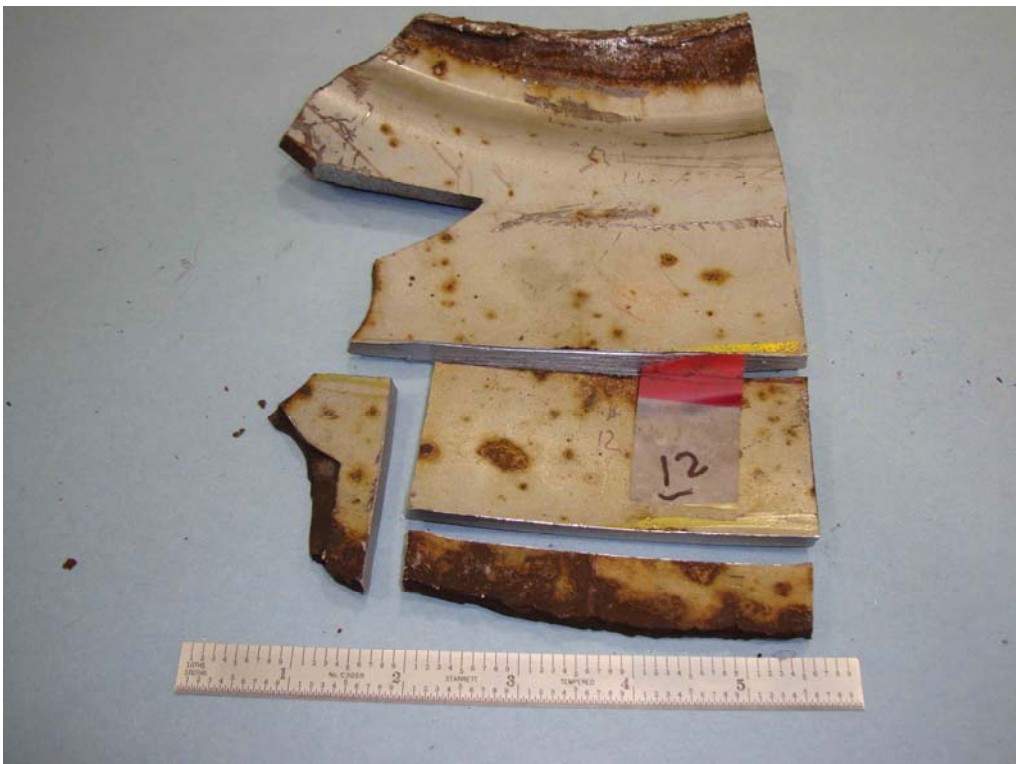
Figure 5-2. DSC00368 LowRes.jpg

Figures 5-1 and 5-2 illustrate the accessibility and the scale of the hub-rim section of Crack 12, which is the top, gently curved section shown in the Figure 5-1 (or at the bottom of Figure 5-2). Note that the hub-rim section of the crack is rougher and with a heavier oxide layer than the two sections of the crack that propagated in the hub. This is consistent with the hub-rim section of Crack 12 being older than the hub sections of Crack 12.

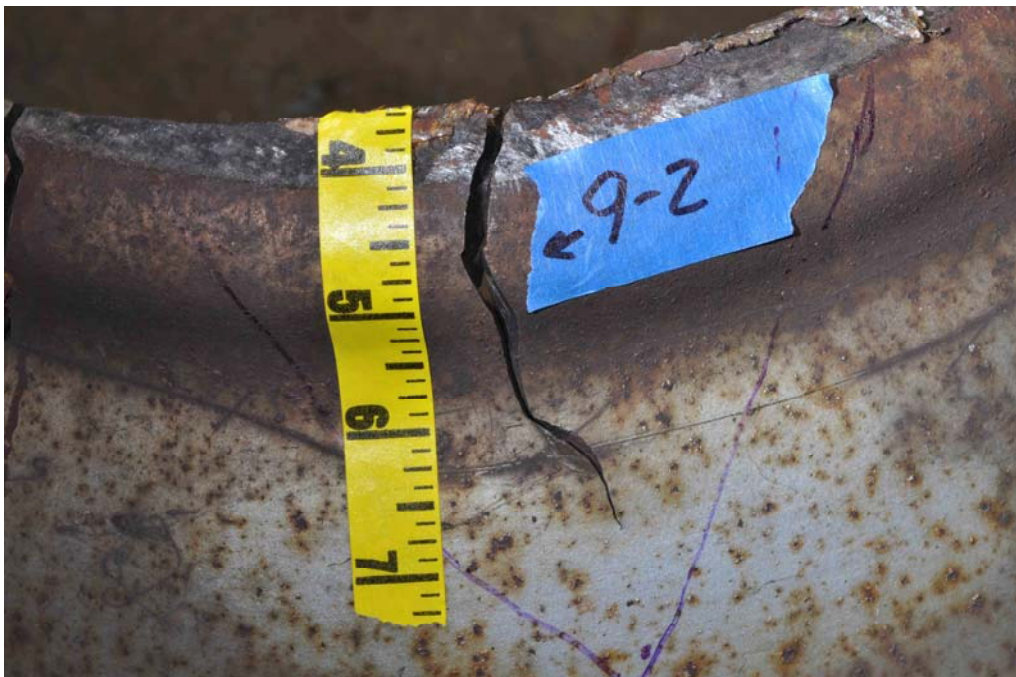
Figure 5-4 DSC_0031 LowRes.jpg

Figures 5-3 and 5-4 illustrate the accessibility and the scale of Crack 9-2. Note that Crack 9-2 originates from either a bolt hole or from a section of the circumferential crack. In the first case, Crack 9-2 was longer than shown today because it extended to the bolt hole. In the second case, the portion of the

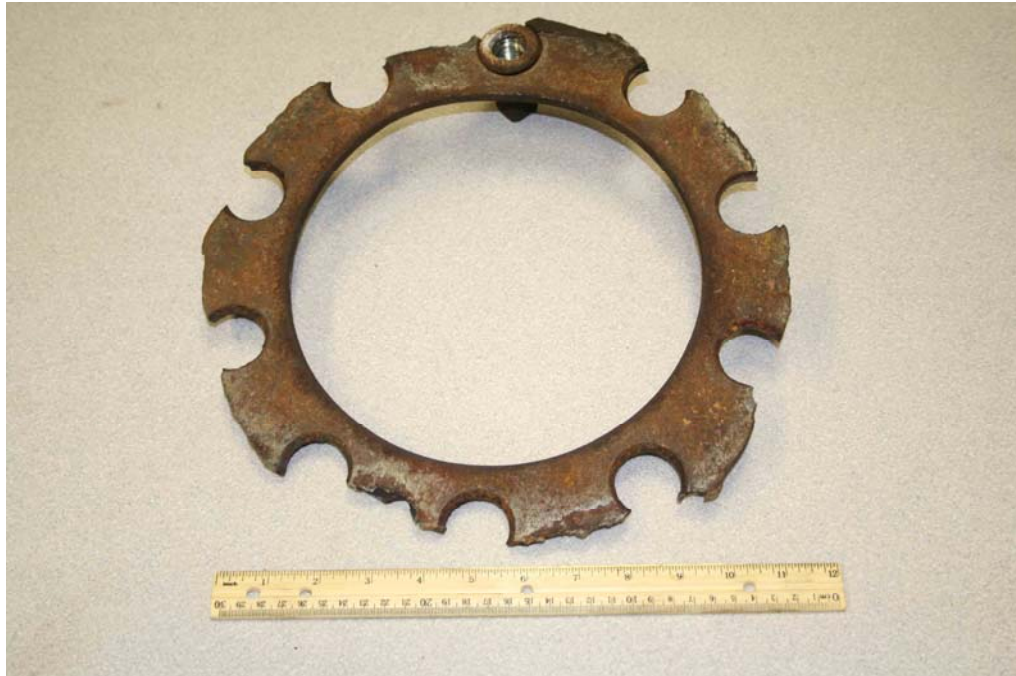
Figure 5-5. Wheel IP IV 1 LowRes.jpg

Figures 5-5 and 5-6 provide an overview of the spider and one surface of the circumferential crack. Figure 5-5 is a view from the inside direction, before subsequent handling and sectioning. Note the spider hole area near the bottom of the spider in Figure 5-5 (Spider B), and slightly to the left. Also note the area two lug holes counter-clockwise (Spider C). Figure 5-6, a view from the outside of the wheel, shows the marking of these same areas for sectioning. Note that the spider hole B (Figure 5-7) is clearly visible from the inside and outside of the wheel, and also that the portion of Spider C that can be clearly seen as an old crack (the left-hand rusty surface, as shown in Figure 5-8) is much larger than any visible limit.

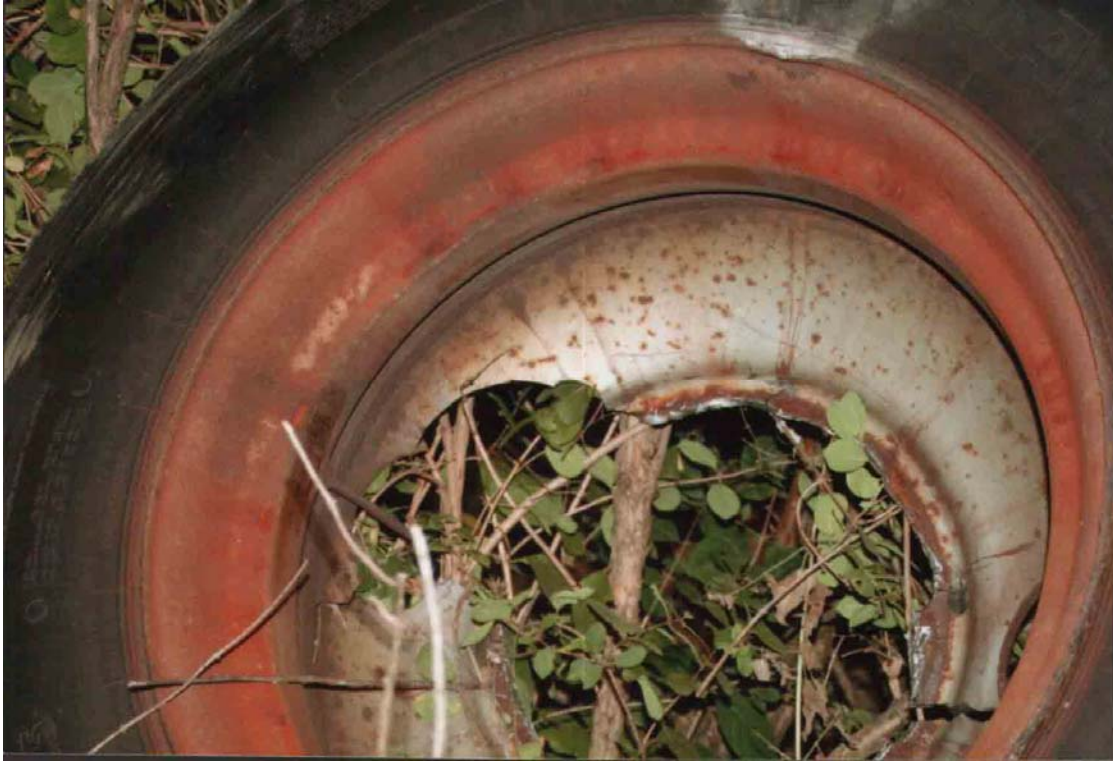
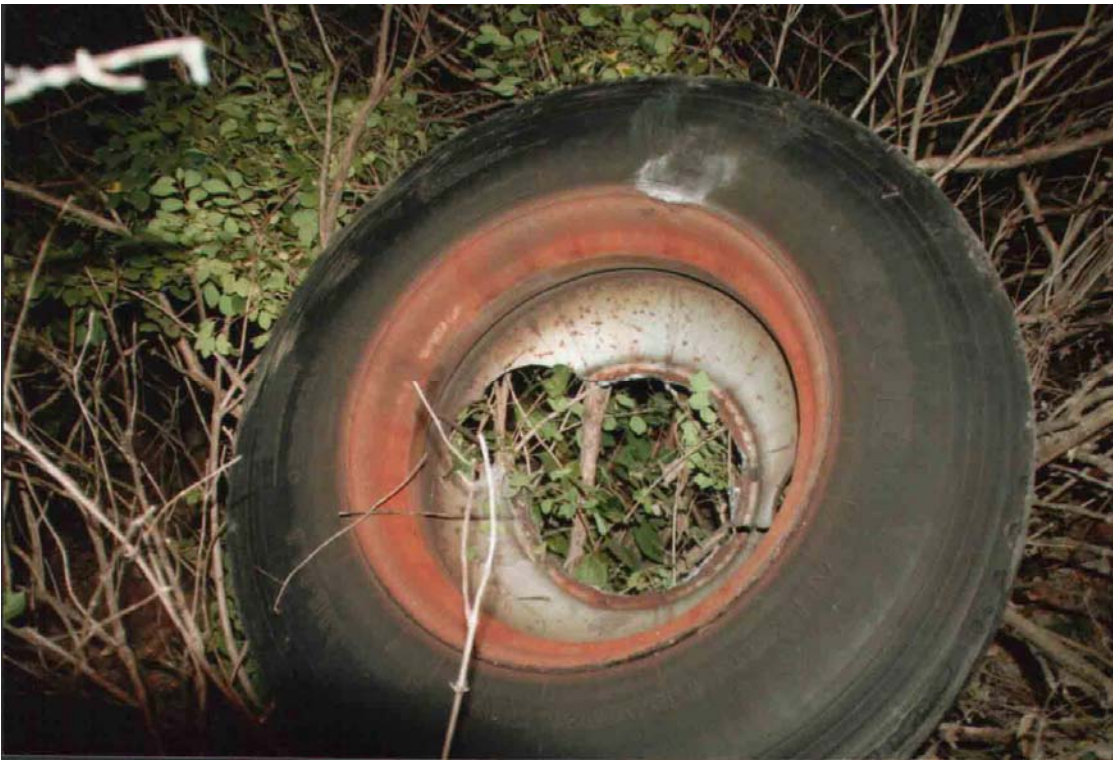
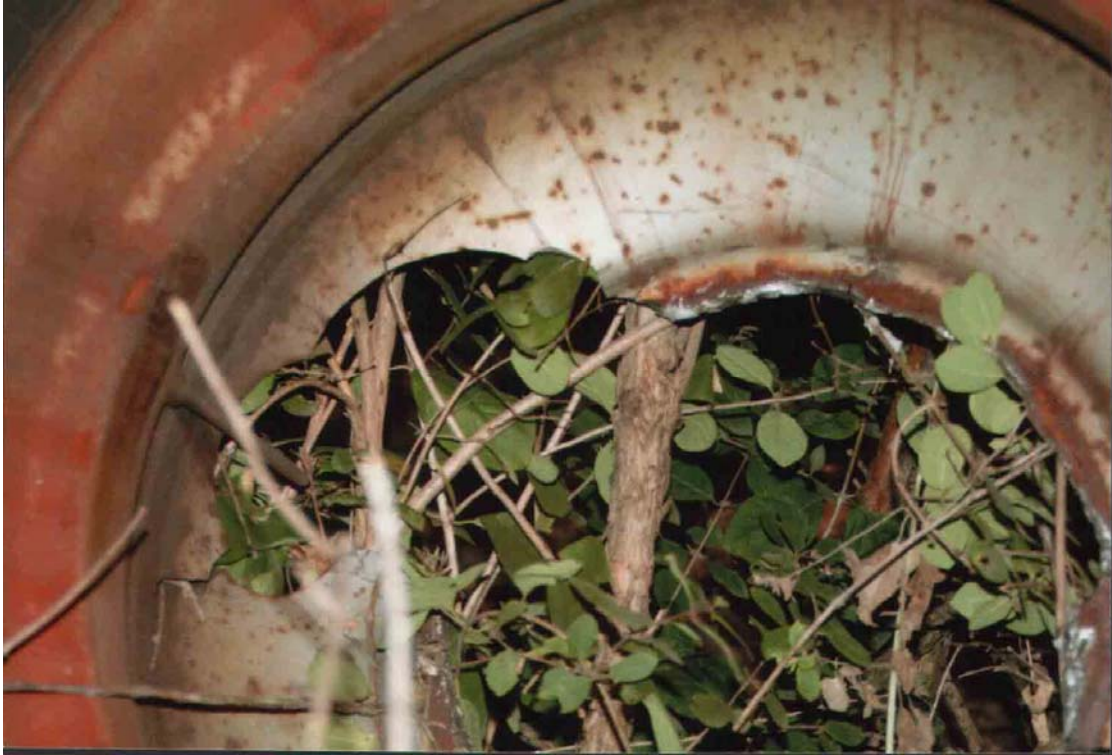
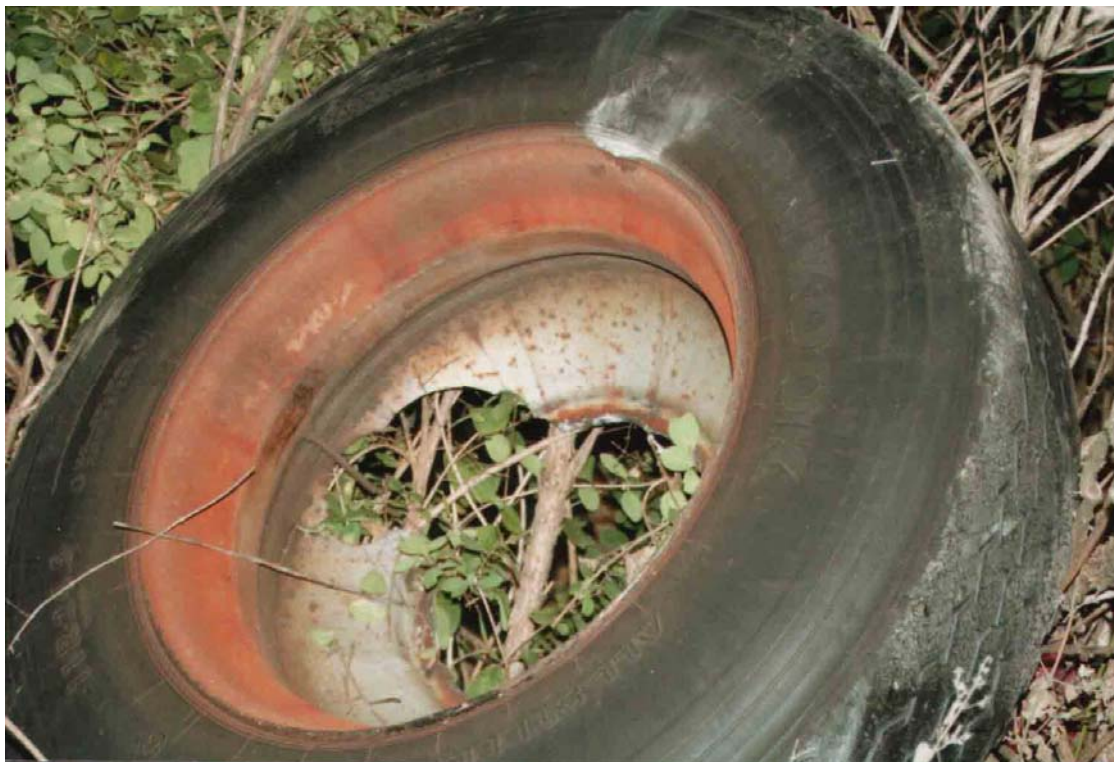
Figures 6-1 to 6-4, taken at the scene of the detachment on the day of the detachment, show cracks and associated rust streaks.
