FAILURE OF A TRACTOR WHEEL -

ANALYSIS BY

ROBERT H. WAGONER AND GERALD S. FRANKEL

March 28, 2010

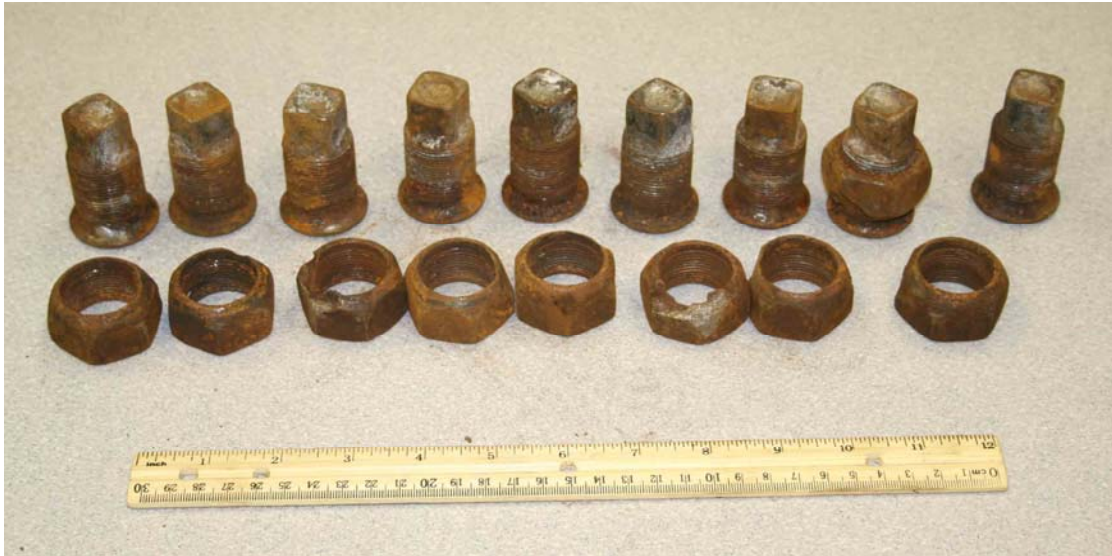
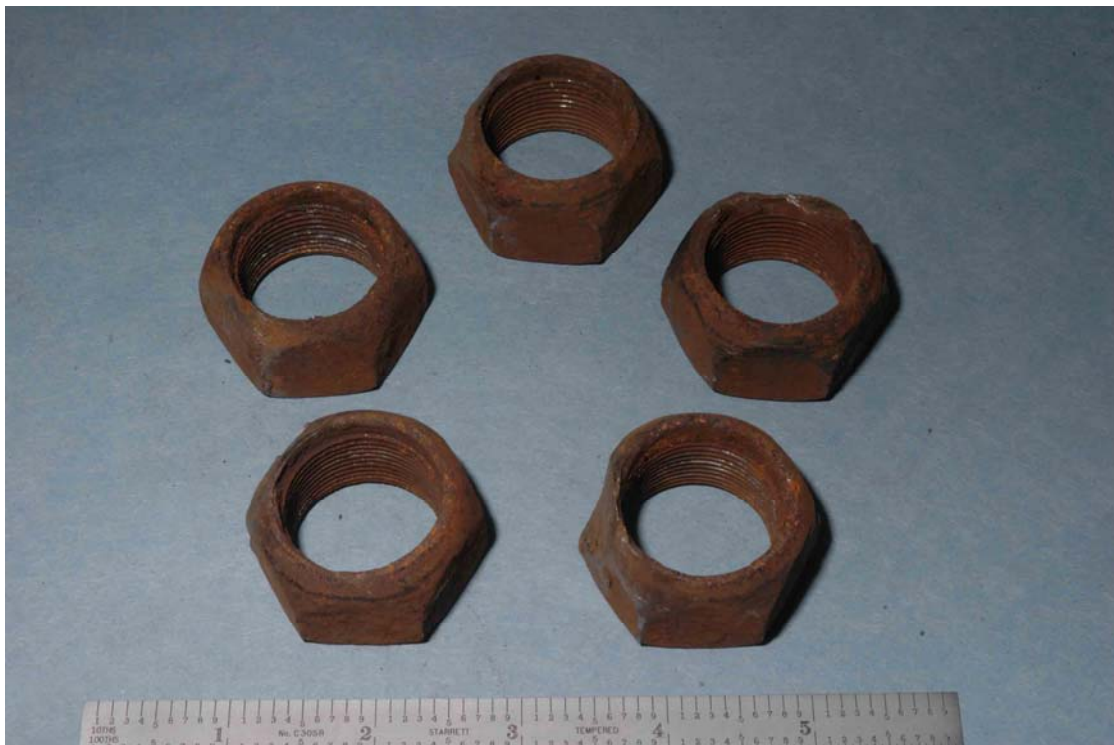
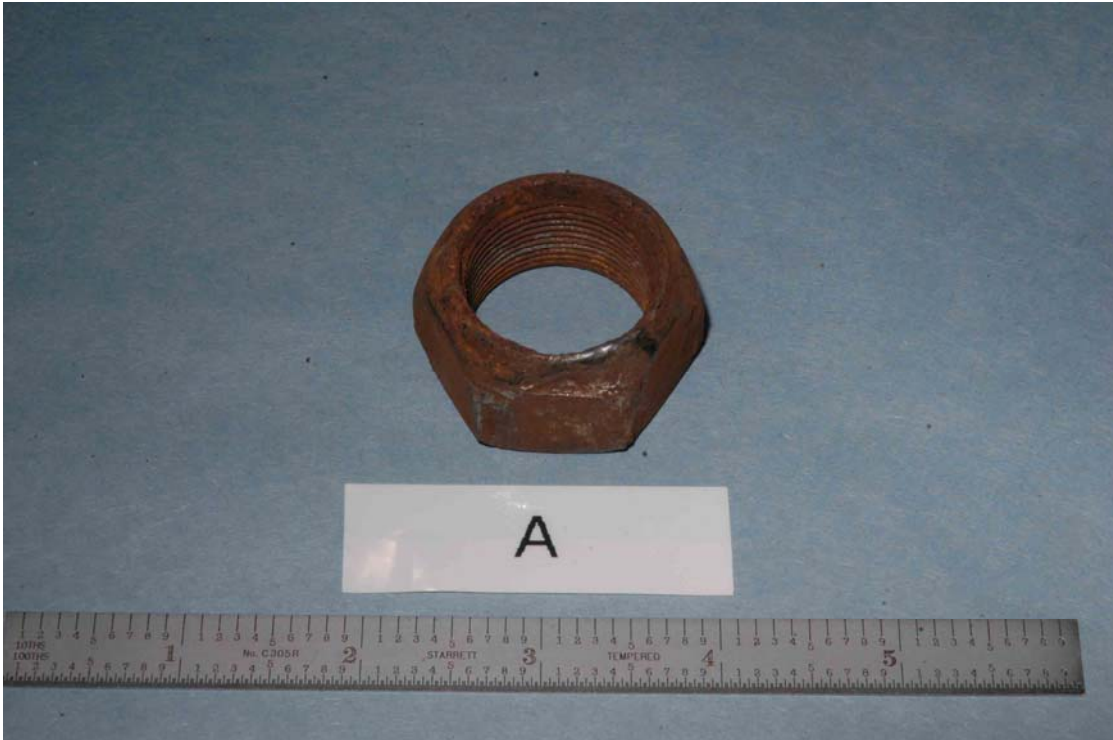
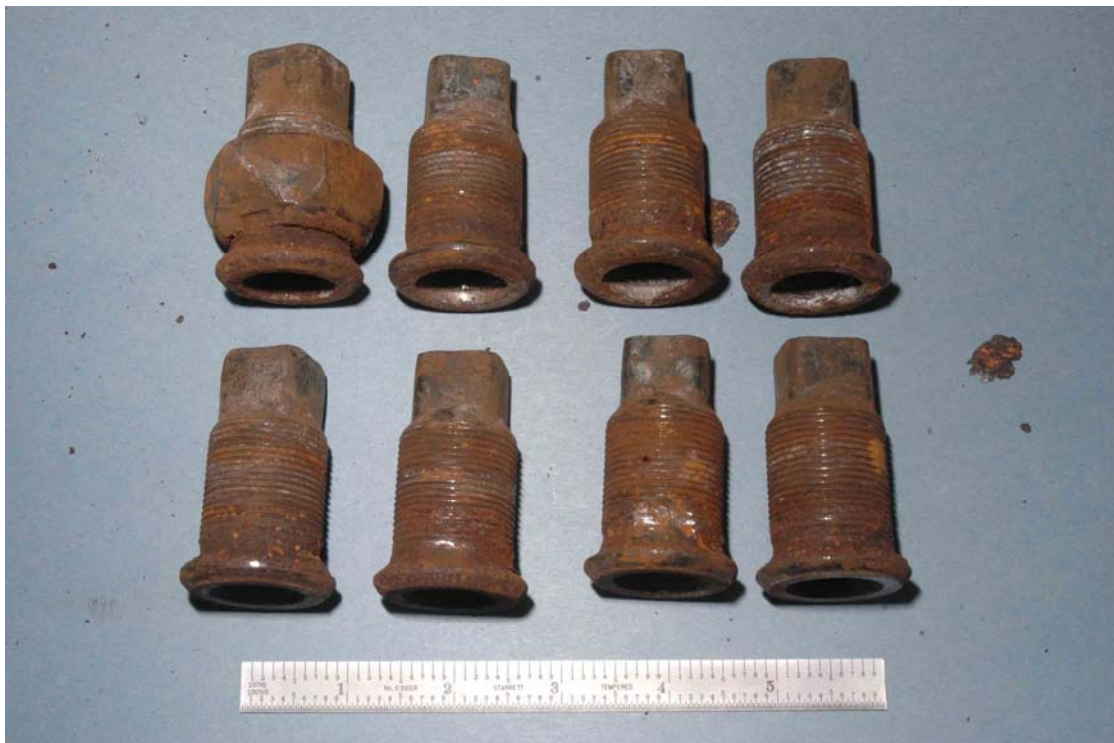
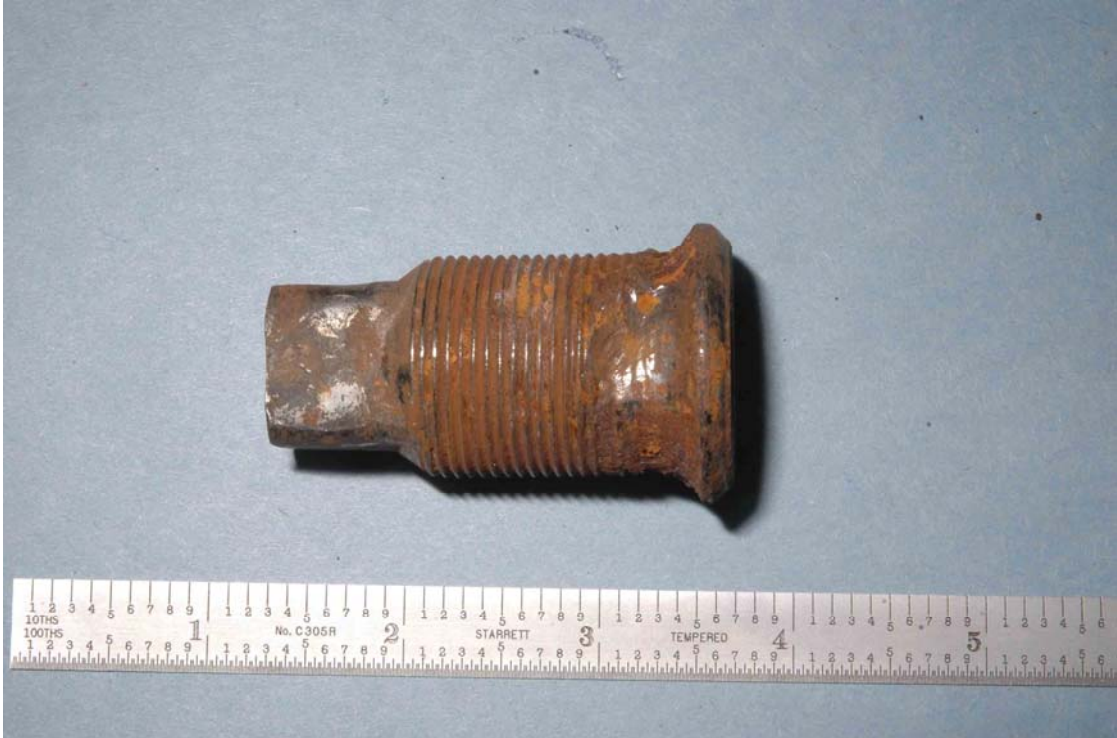
Figures 6-5 to 6-9 are photos of lug nuts and studs that were removed and recovered from the wheel. They show the extent of corrosion discernible by inspection.

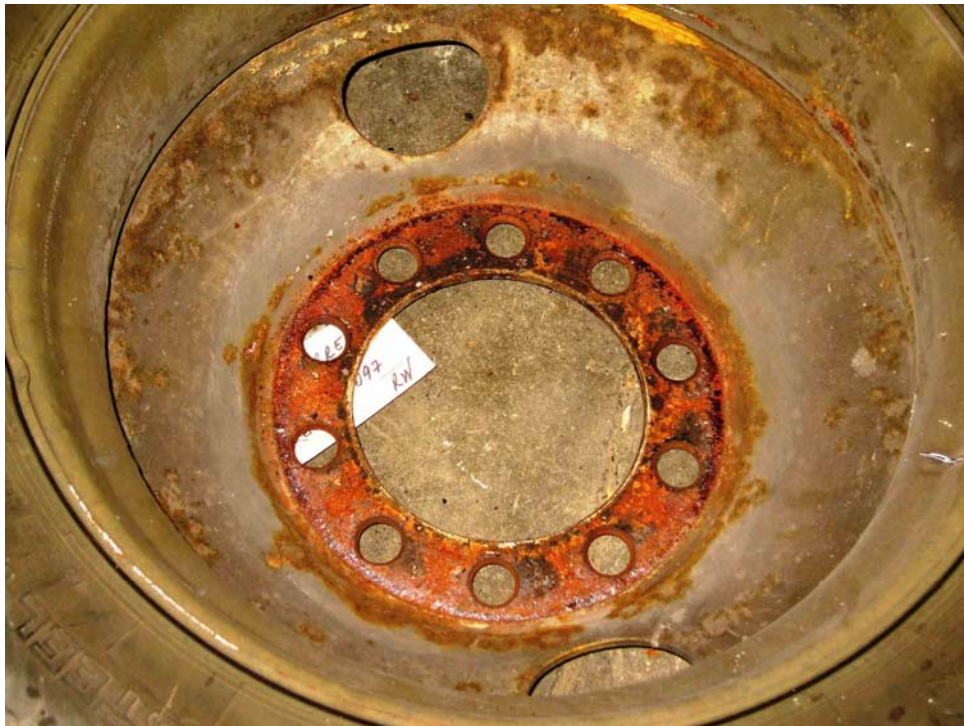
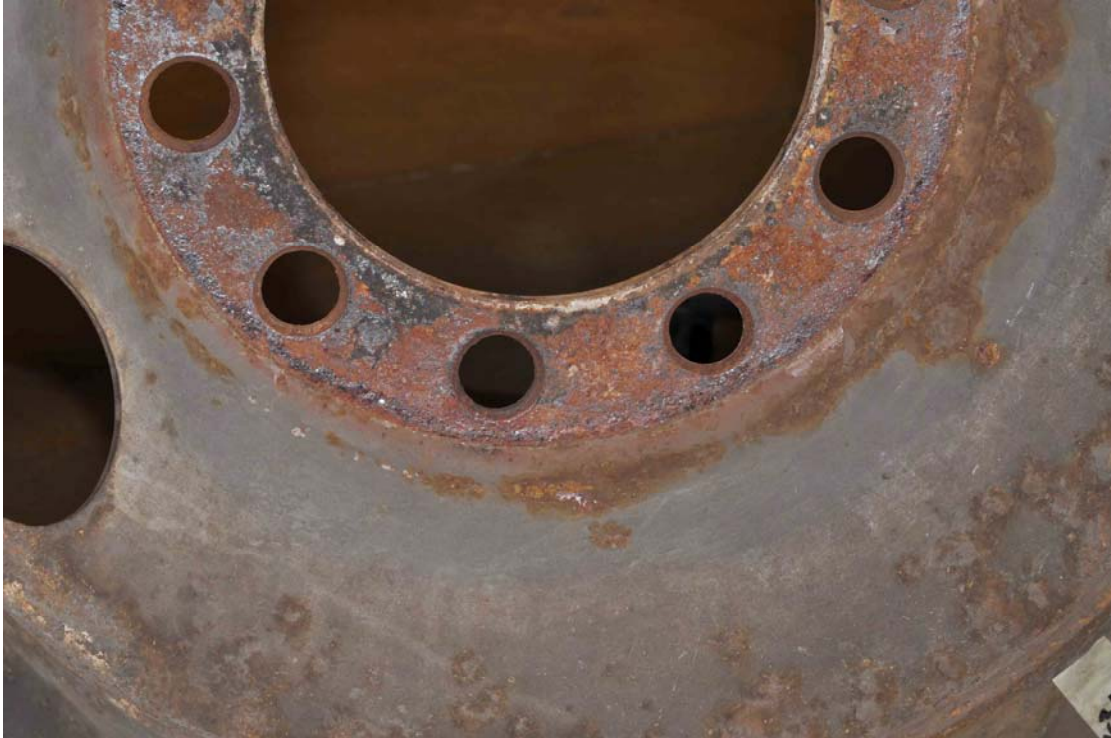
Figures 6-10 to 6-11 show the inner wheel ("exemplar" wheel) and the apparent scale and corrosion on the mating surface.

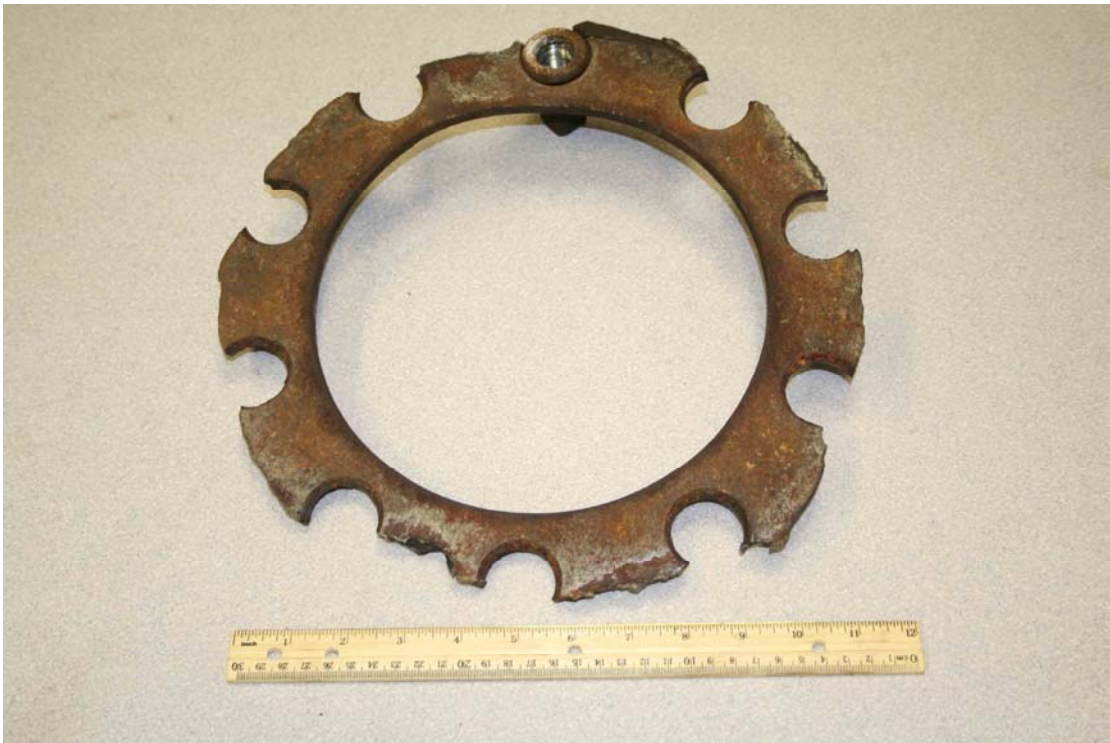
Figure 6-12. Wheel IP IV 1 LowRes.jpg

Figures 6-12 to 6-15 show various views of the detached wheel and spider taken in the laboratory, for orientation. Figure 6-12 shows the condition of the mating surface on the detached wheel, with heavy corrosion and scale.

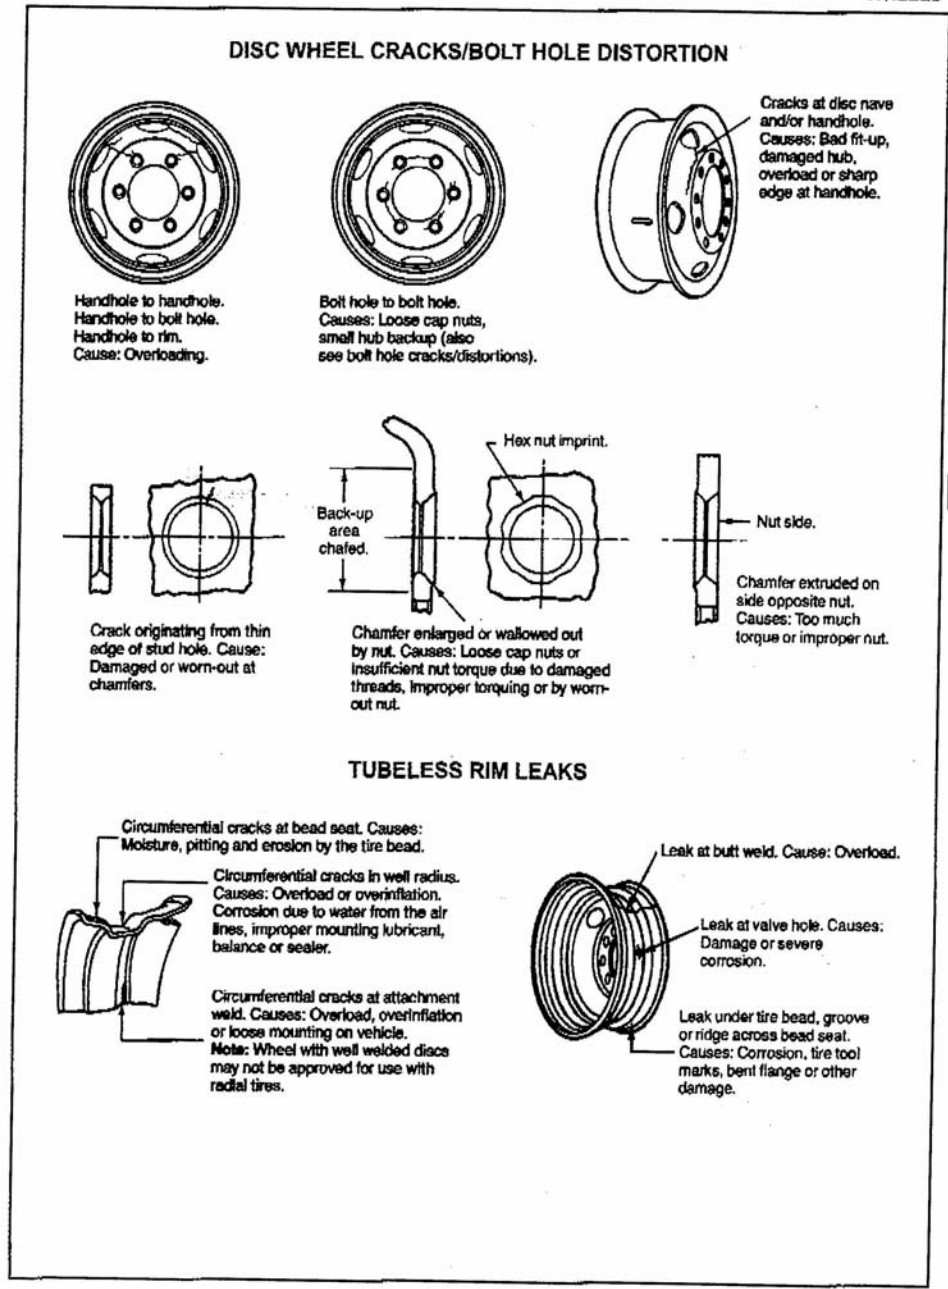
Figure 7-1. Baareman fax pages_Page_1.jpg

The principal cause of cracks around bolt holes is known to be loose lug nuts. See Figures 6-21 and Figure 7-1. Other related causes include improper installation procedures, problems with mounting surfaces (including corrosion), and problems with studs and nuts (including corrosion). One lug nut and stud assembly remain on the spider. That assembly can be rotated by hand, indicating very low tightening torque.

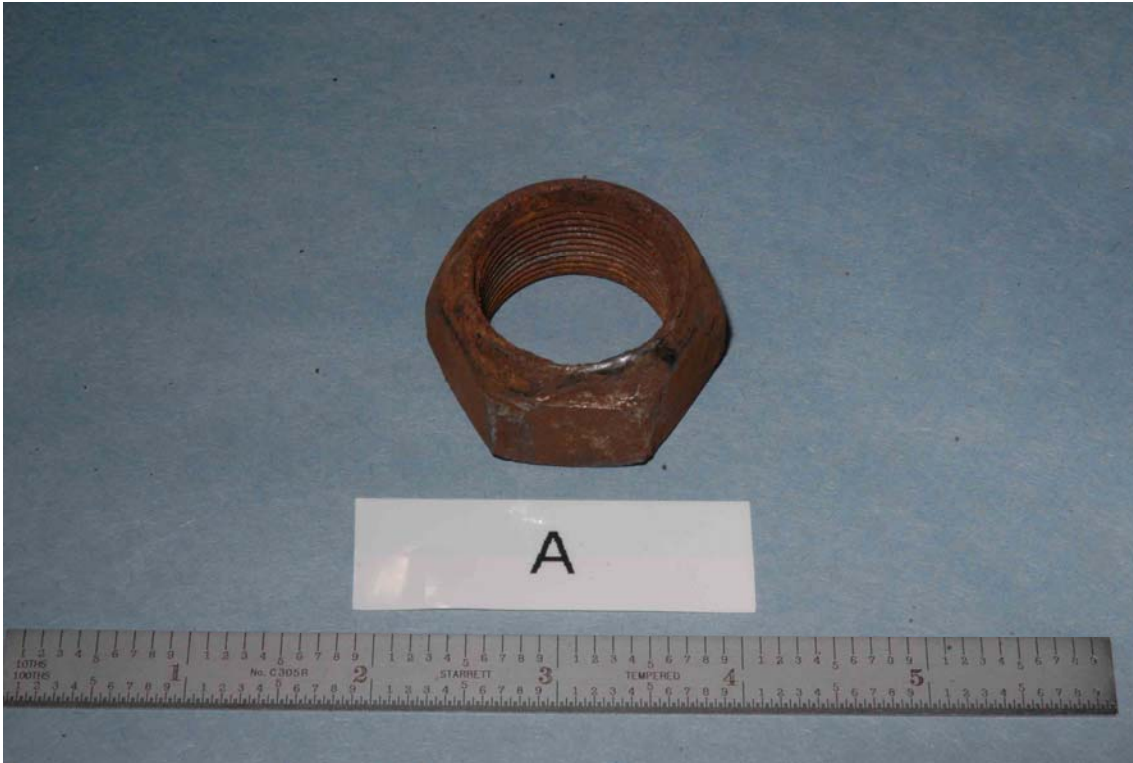
Figure 7-2. DSC_0050 LowRes.jpg

Visual inspection of the lug nuts shows corrosion but little or no gross mechanical damage on some of them (A, H) - see Figure 7-2, moderate deformation possibly caused by the wheel wobbling on others (B, D, E, F, H) - Figure 7-3, and severe damage with a significant part of the mating surface to the wheel missing (C, G, I) - Figure 7-4. The three lug nuts with the most severe damage, C, G, and I, correspond to the three softer ones with lower carbon content among the 9 lug nuts tested. (The 10th lug nut, J, remains attached to the spider. It was not analyzed.)

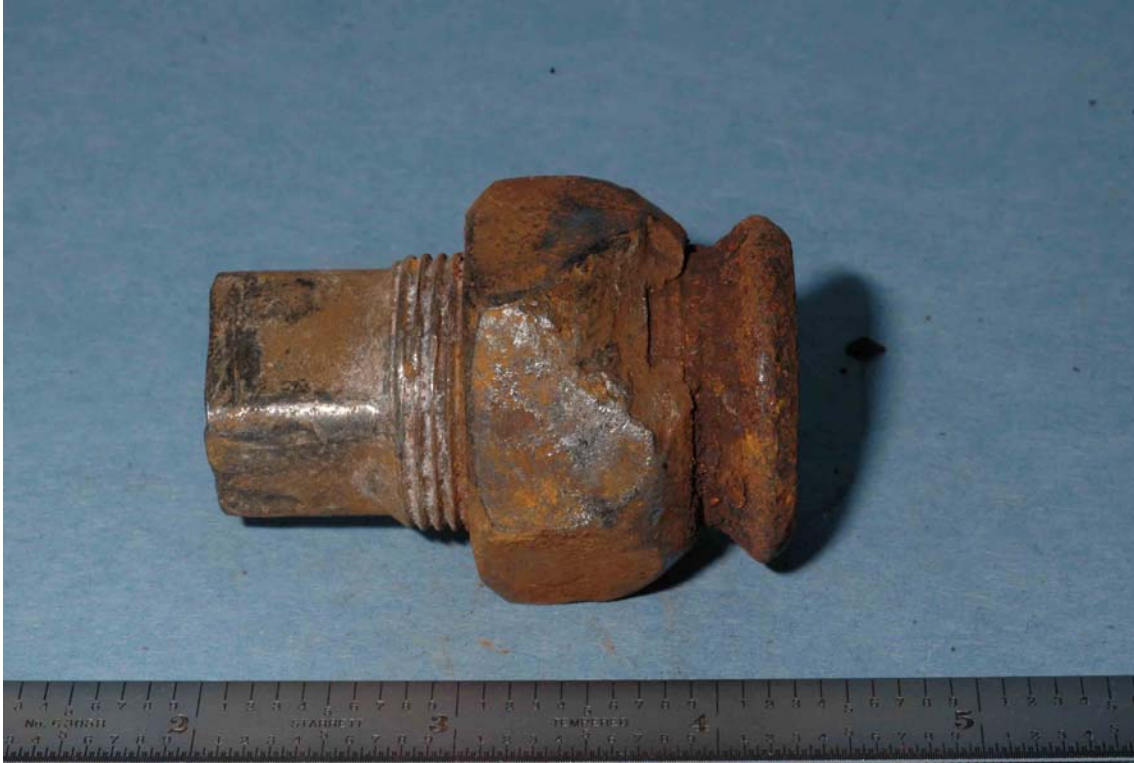
Figure 7-10. DSC_0023 LowRes.jpg

The original data appears in Tables 7-1 and 7-2. Photographs of lug nuts A-I appear as Figures 7-2 to 7-10. Figure 7-10 shows a side view of a lug and stud assembly that has not been separated.

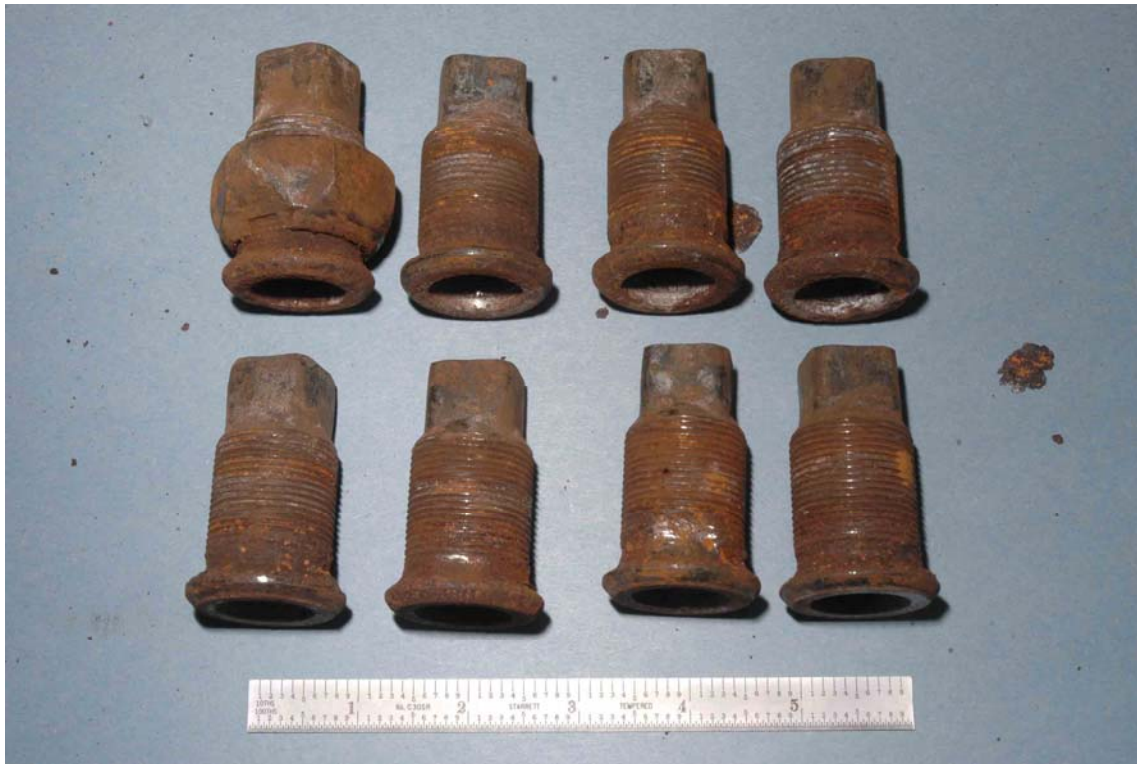
Figure 7-11. DSC_0068 LowRes.jpg

The studs, Figure 7-11, show no significant evidence of stretching. The hole depth measurements, as shown below, are all within ± 0.004 ", i.e. within 0.3% of the average length:

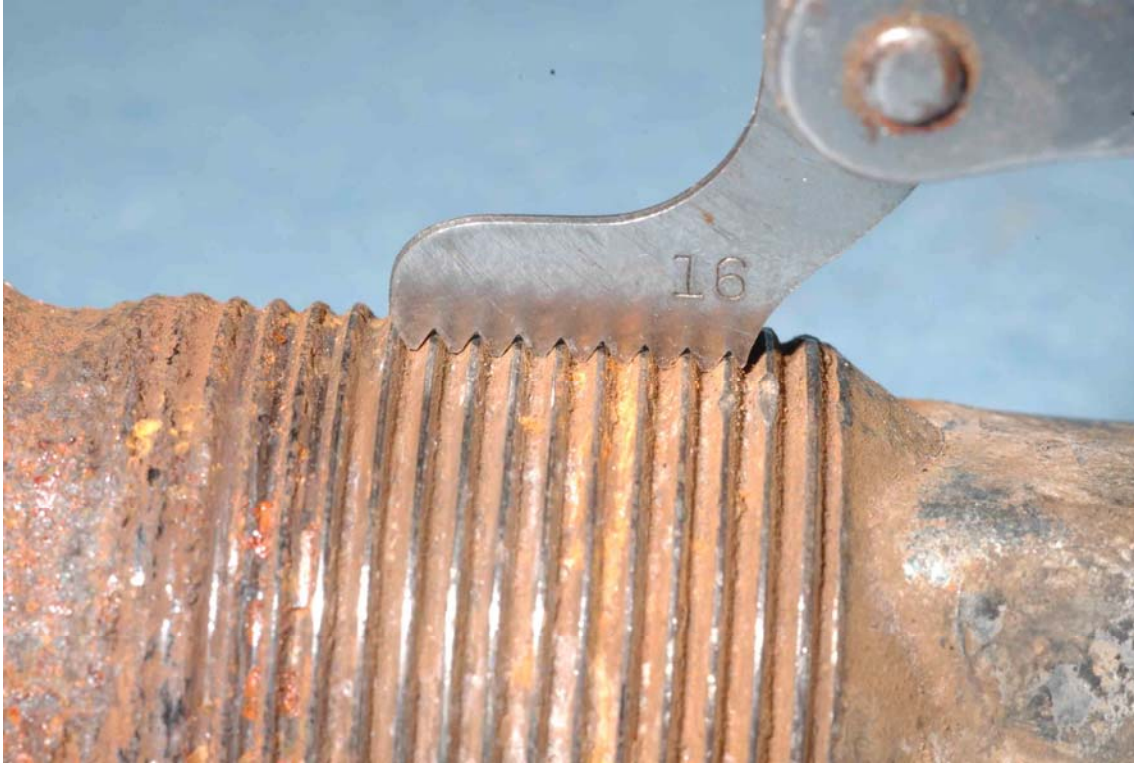
Figure 7-12. DSC_0051 LowRes.jpg

A 16/inch thread gage engaged with the threads shows no significant disregistry, as would be expected for a significantly stretched stud, Figure 7-12.

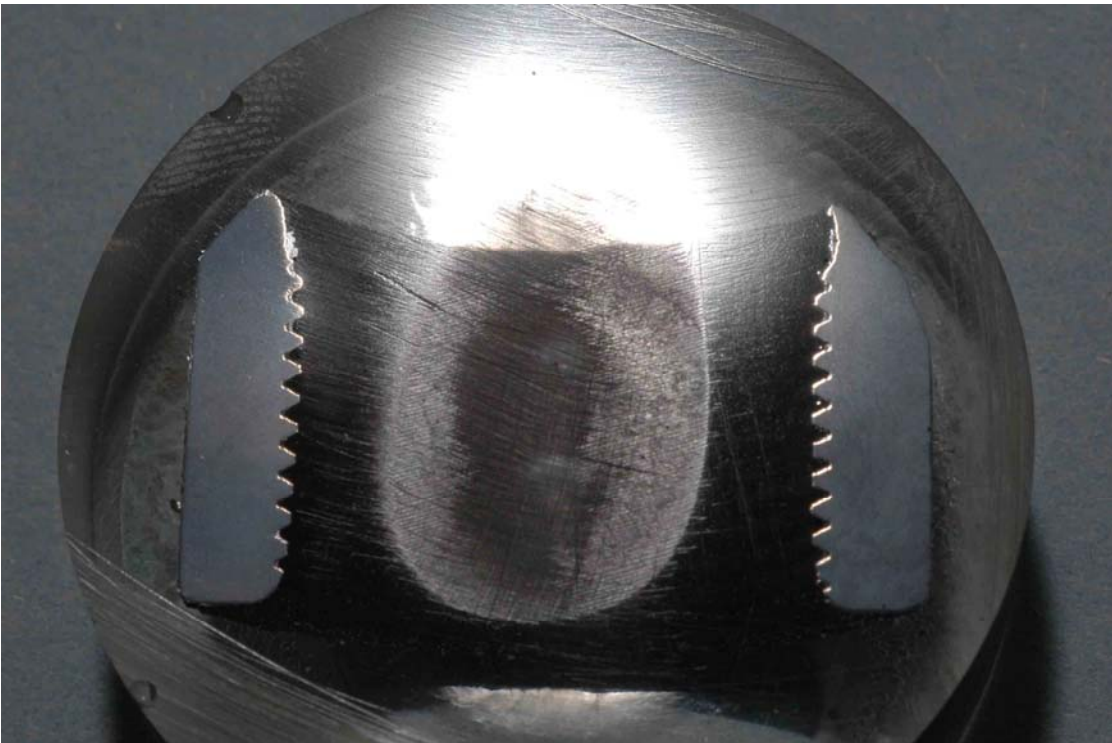
Figure 7-13. DSC_0001 LowRes.jpg

In addition to the gross deformation, corrosion, and erosion of some of the lug nuts, there is deformation of the mating surface of the lug nuts to the wheels, shown in detail in Figure 7-13. Comparison of Figure 7-13 with Figure 7-14 reveals the flattening of the mating surfaces from their normal aspect having a geometry of sections of a sphere. Such flattening and distortion of lug mating surfaces mandates removal and replacement of lug nuts, Figure 7-15.
