# Farnsworth House Flood Risk and Conceptual Mitigation Evaluation 14520 River Road Plano, Illinois

Prepared for:  
NATIONAL TRUST FOR HISTORIC PRESERVATION  
1785 Massachusetts Avenue NW  
Washington, DC 20036

May 15, 2013

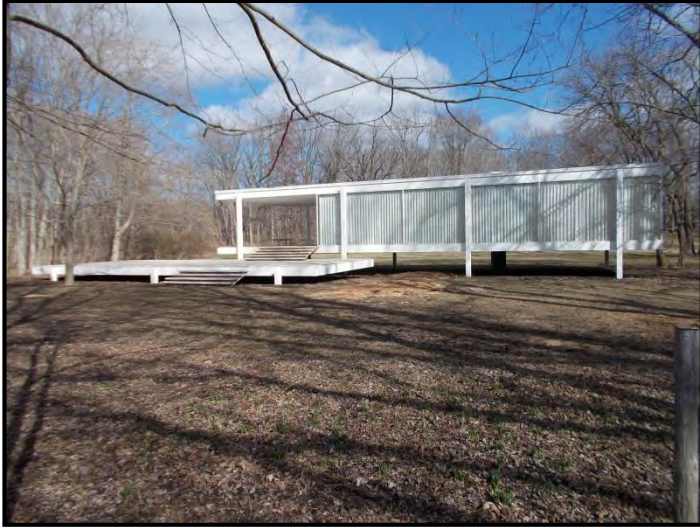
Photo 1. Farnsworth House facing north. Photo taken from top of Fox River bank.

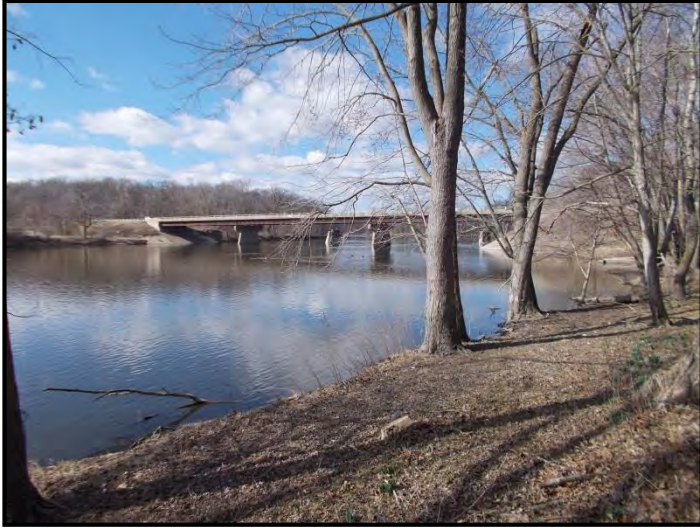
Photo 5. Fox River Drive Bridge facing west and Fox River overbanks in front of Farnsworth House.

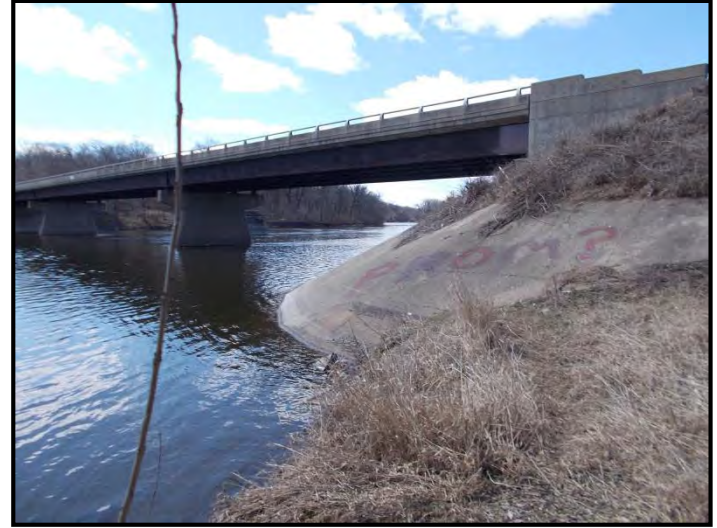
Photo 6. Fox River Drive Bridge right abutment.

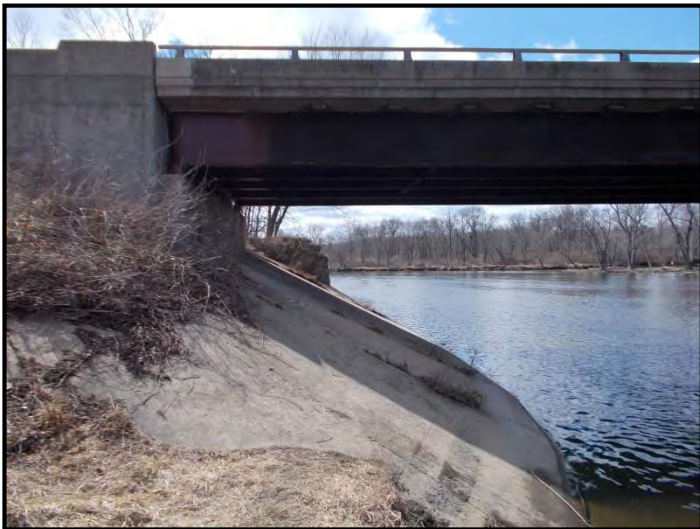
Photo 7. Fox River Drive Bridge left abutment.

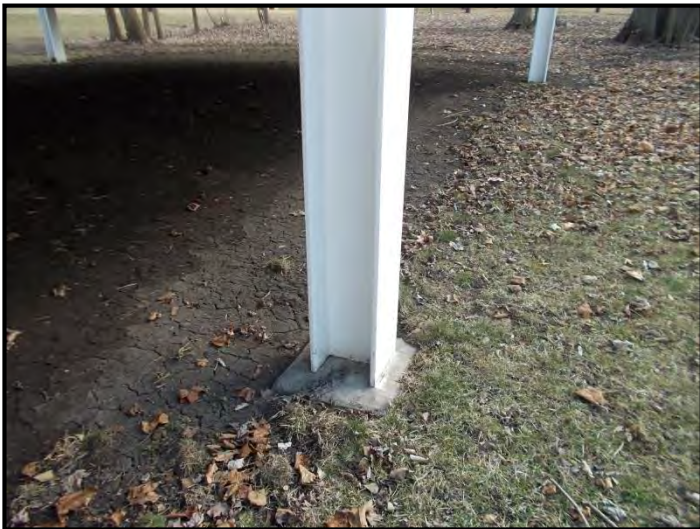
Photo 11. Photo of one of several steel I-beams that “suspend” Farnsworth House above ground.
