# FINAL INVESTIGATION REPORT

## CHEVRON RICHMOND REFINERY PIPE RUPTURE AND FIRE

### CHEVRON RICHMOND REFINERY #4 CRUDE UNIT RICHMOND, CALIFORNIA

REPORT NO. 2012-03-I-CA  
JANUARY 2015

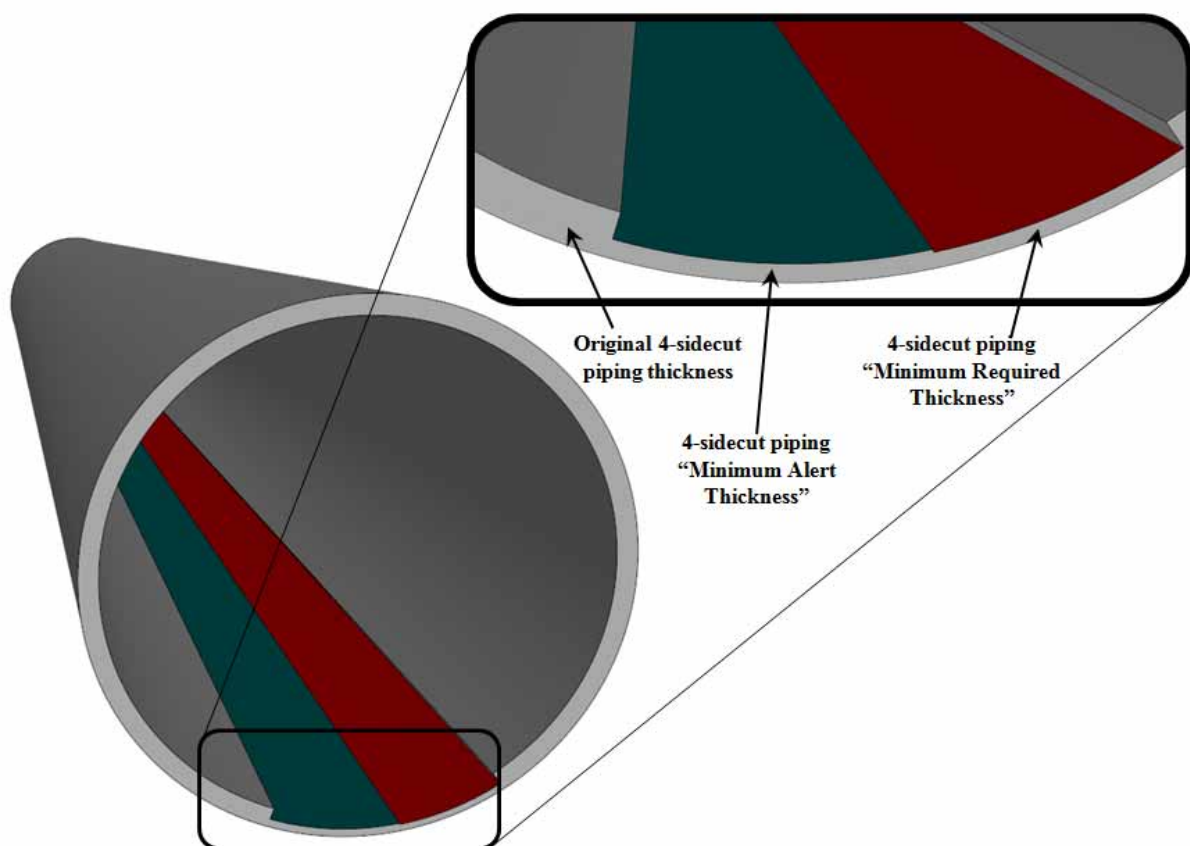
15. Sulfidation corrosion causes pipe walls to thin, which eventually leads to the need to replace the thinned piping. Chevron determines the date for replacing thinned piping by using a piping "Minimum Alert Thickness" and a piping "Minimum Required Thickness" (Figure 1).<sup>28</sup> When piping reaches its Minimum Alert Thickness, an engineering evaluation is triggered to calculate the piping's Minimum Required Thickness, or the lowest thickness that can withstand the pressure and structural stresses of the piping circuit, to determine whether the piping must be replaced immediately or if replacement can be safely delayed. This evaluation may result in the lowering of the Minimum Alert Thickness to 0.1-inch. Evaluation of the inspection thickness data obtained on the 4-sidecut piping during the 2011 turnaround indicated that the 4-sidecut piping would thin below its 0.14-inch Minimum Alert Thickness before the next turnaround scheduled for 2016. A minimum structural thickness value of 0.036-inch had been calculated for

**Figure 1. To-scale schematic of 4-sidecut piping identifying key wall thickness values. These include the original wall thickness (0.322-inch), “Minimum Alert Thickness” (0.13-inch), and “Minimum Required Thickness” (0.11-inch) using *API RP 574* default values.**

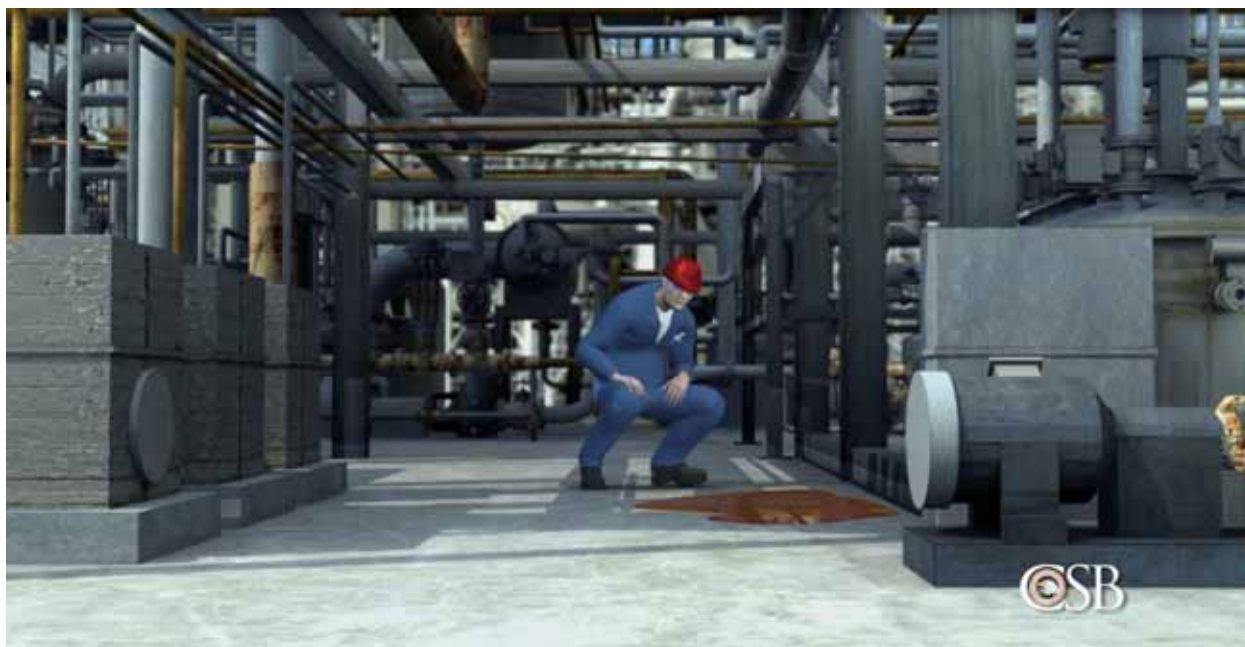
At approximately 3:50 p.m. on August 6, 2012, an outside operator performing routine checks of piping and equipment found an 18-inch puddle of what appeared to be a diesel-like material on the refinery concrete pad (Figure 6). Identifying that the leak was occurring from overhead, the operator observed intermittent drips as they accumulated on the underside of an insulated pipe 14 feet above ground level. The leaking pipe was identified to be a portion of the 4-sidecut piping that originated on the Crude Column. Visually analyzing the piping, the operator determined that the line could not be isolated from the process.

**Figure 6. CSB animation depicting operator identifying the leaking 4-sidecut pipe.**

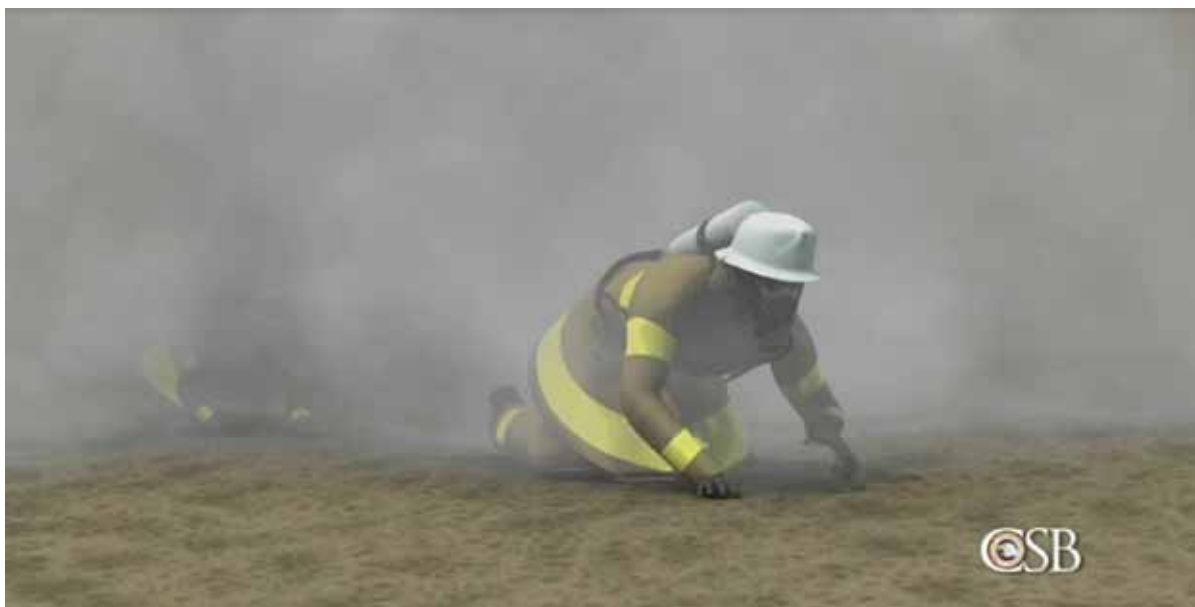
Each person engulfed in the cloud began working their way out of the vapor cloud. Several of the firefighters operating the two hoses dropped to their hands and knees to follow their hose lines to safety, feeling their way out of the cloud (Figure 12).

**Figure 12.** CSB animation of firefighters who dropped to their hands and knees to escape the vapor cloud.

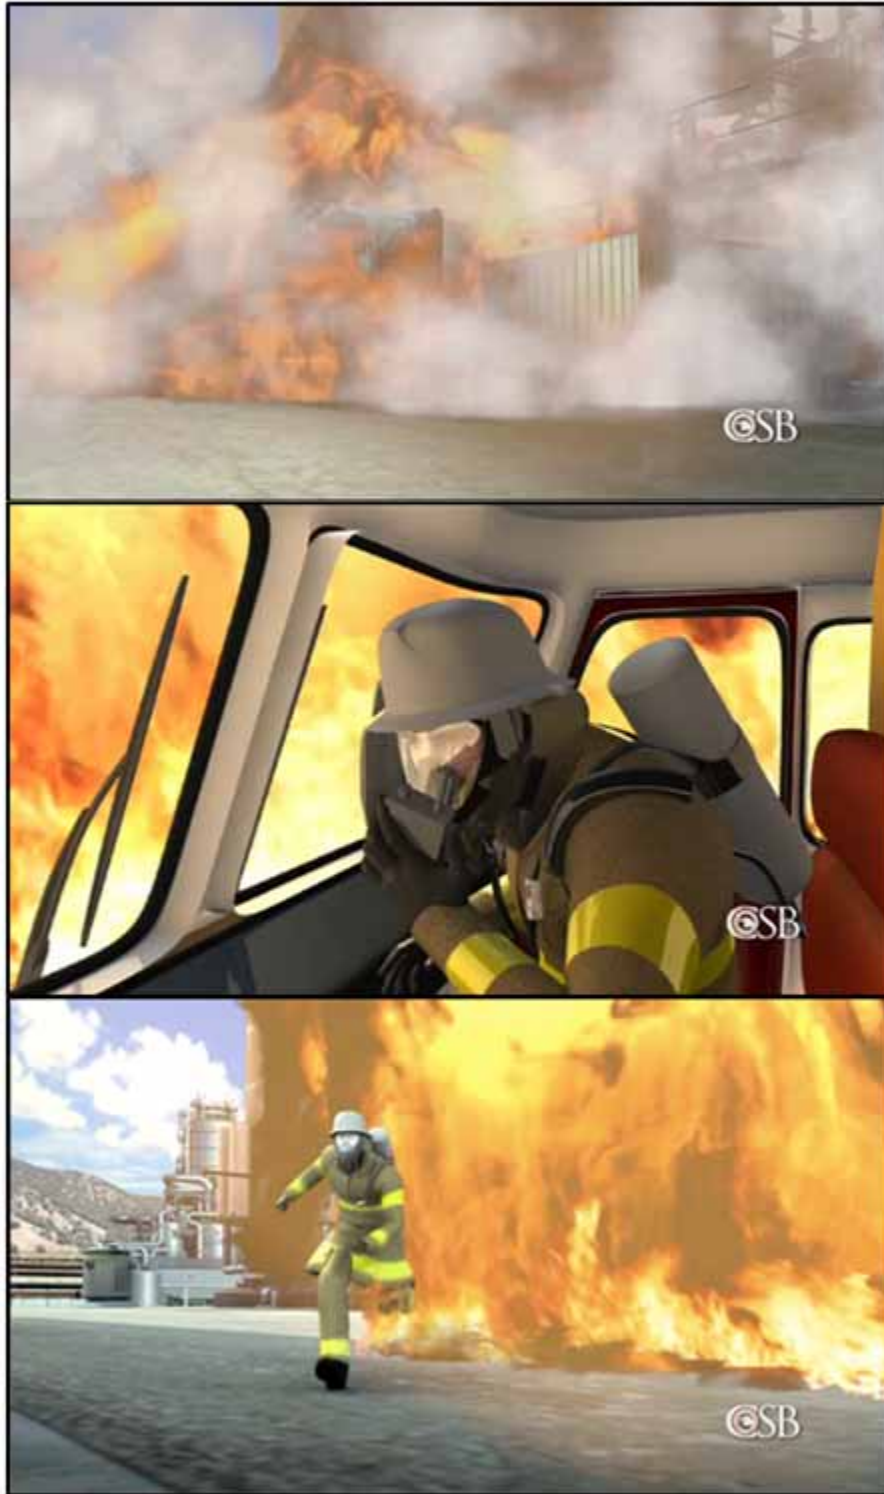
At approximately 6:30 p.m., two minutes after the large vapor cloud formed, the light gas oil ignited.<sup>53</sup> Eighteen employees safely escaped from the cloud just before ignition. One employee, a firefighter, was inside a fire engine that was engulfed in the fireball when the light gas oil ignited (Figure 13 and Figure

14). He told CSB interviewers, "... All I could see [was] heavy hydrocarbon-type boiling fire in every window of that truck. I can't even begin to describe how hot it was. It was very intense." He called "MAYDAY" over his radio but received no response. He informed the CSB, "I figured that everybody else was dead." Because he was wearing full body firefighting protective equipment, he was able to escape through the flames surrounding the fire truck and make his way to safety without physical injury.

Figure 13. CSB animation of firefighter who was inside the fire engine when the light gas oil ignited.

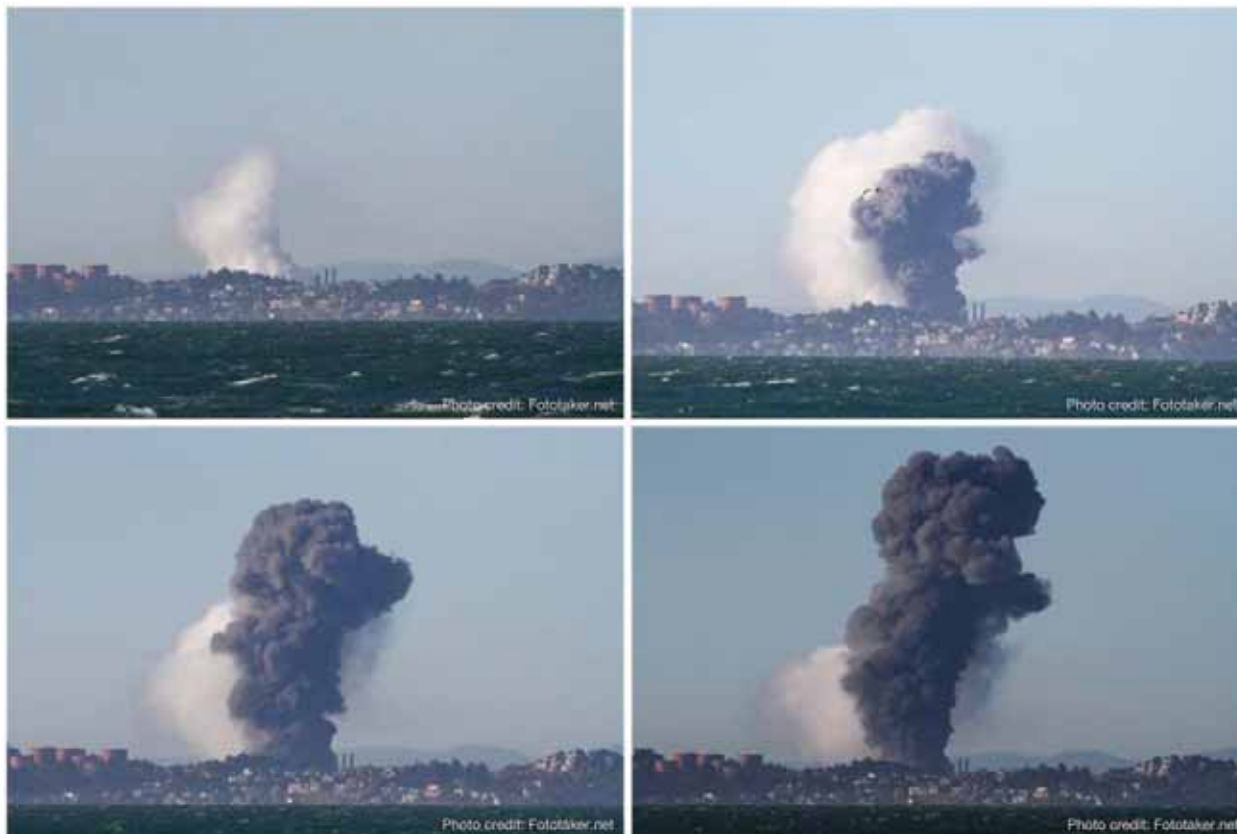
The leak resulted in a large plume of vapor which traveled across the surrounding area. The ignition and subsequent burning of the hydrocarbon process fluid created a large black cloud of smoke, which also swept across the surrounding area (Figure 15). This situation resulted in a Community Warning System (CWS) Level 3 alert,<sup>54</sup> and a shelter-in-place<sup>55</sup> advisory (SIP) was issued at 6:38 p.m.<sup>56</sup> for Richmond, San Pablo, and North Richmond. It was lifted later that night at 11:12 p.m. after the fire was fully under control. In the weeks following the incident, nearby medical facilities received over 15,000 members of the public seeking treatment for ailments including breathing problems, chest pain, shortness of breath,

**Figure 15. Initial vapor cloud formation (white cloud) and subsequent ignition (black smoke) as seen from a pier in San Francisco, California.<sup>57</sup>**

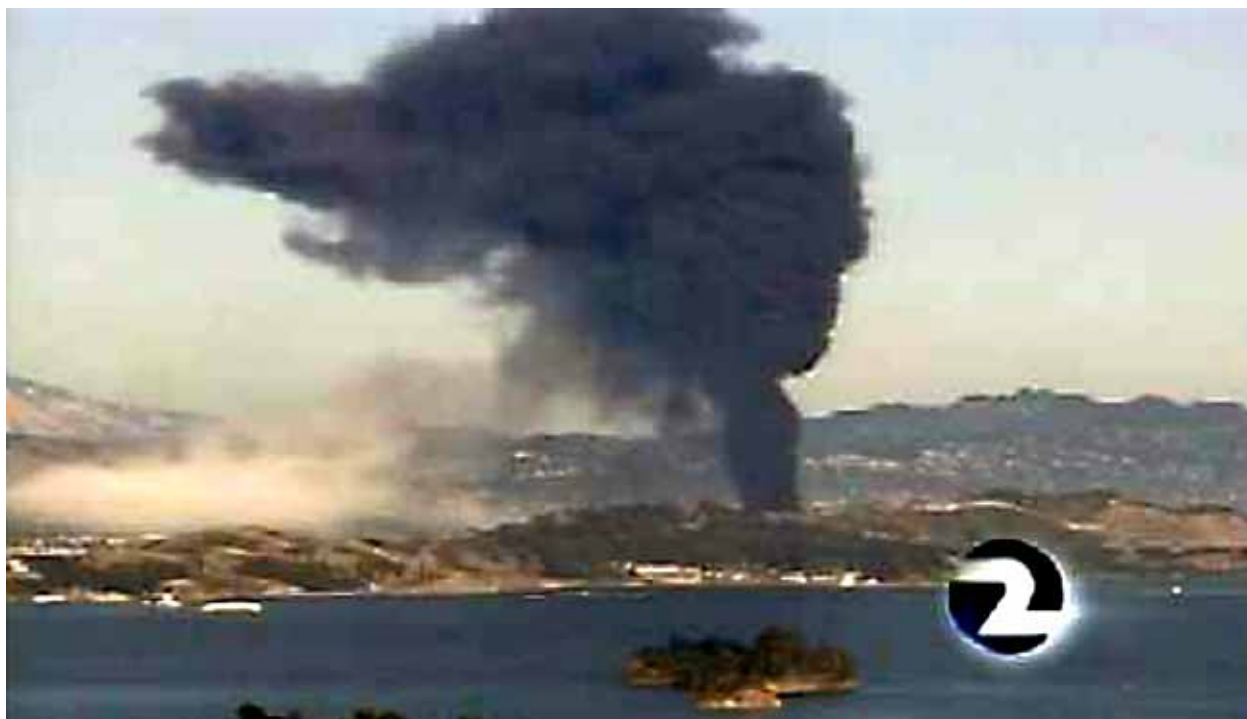
Figure 16. Vapor cloud and ignition seen from Marin County.<sup>58</sup>

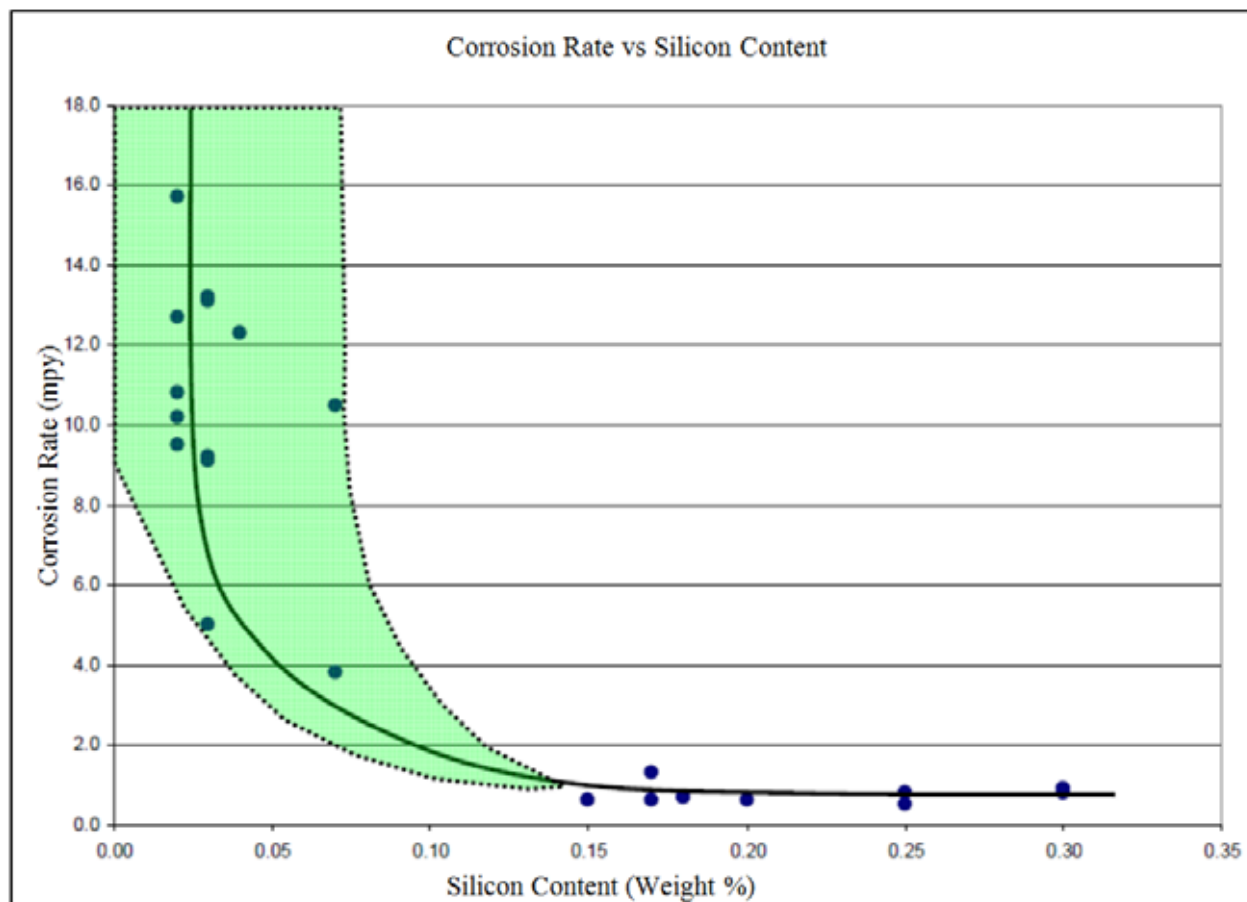
Sulfidation corrodes carbon steel at a much faster rate in comparison with its effect on other materials of construction, such as steels with a higher chromium content. This issue is discussed in depth in the CSB's Interim Investigation Report of the August 6, 2012, Chevron incident.<sup>65</sup> In addition to its naturally faster rate of sulfidation corrosion when compared with higher chromium steels, carbon steel can also experience significant variation in corrosion rates due to variances in silicon content, a component used in the steel manufacturing process. Carbon steel piping containing silicon content less than 0.10 weight percent can corrode at accelerated rates,<sup>66</sup> up to 16 times faster than carbon steel piping containing higher percentages of silicon. Figure 17 shows how carbon steel corrosion rates can greatly vary depending on silicon content.

**Figure 17. Graph of sulfidation corrosion rates with respect to silicon content in carbon steel. This graph shows how corrosion rates increase in carbon steel containing decreasing percentages of silicon. This information can be found in Annex C of *API RP 939-C*.<sup>67</sup>**

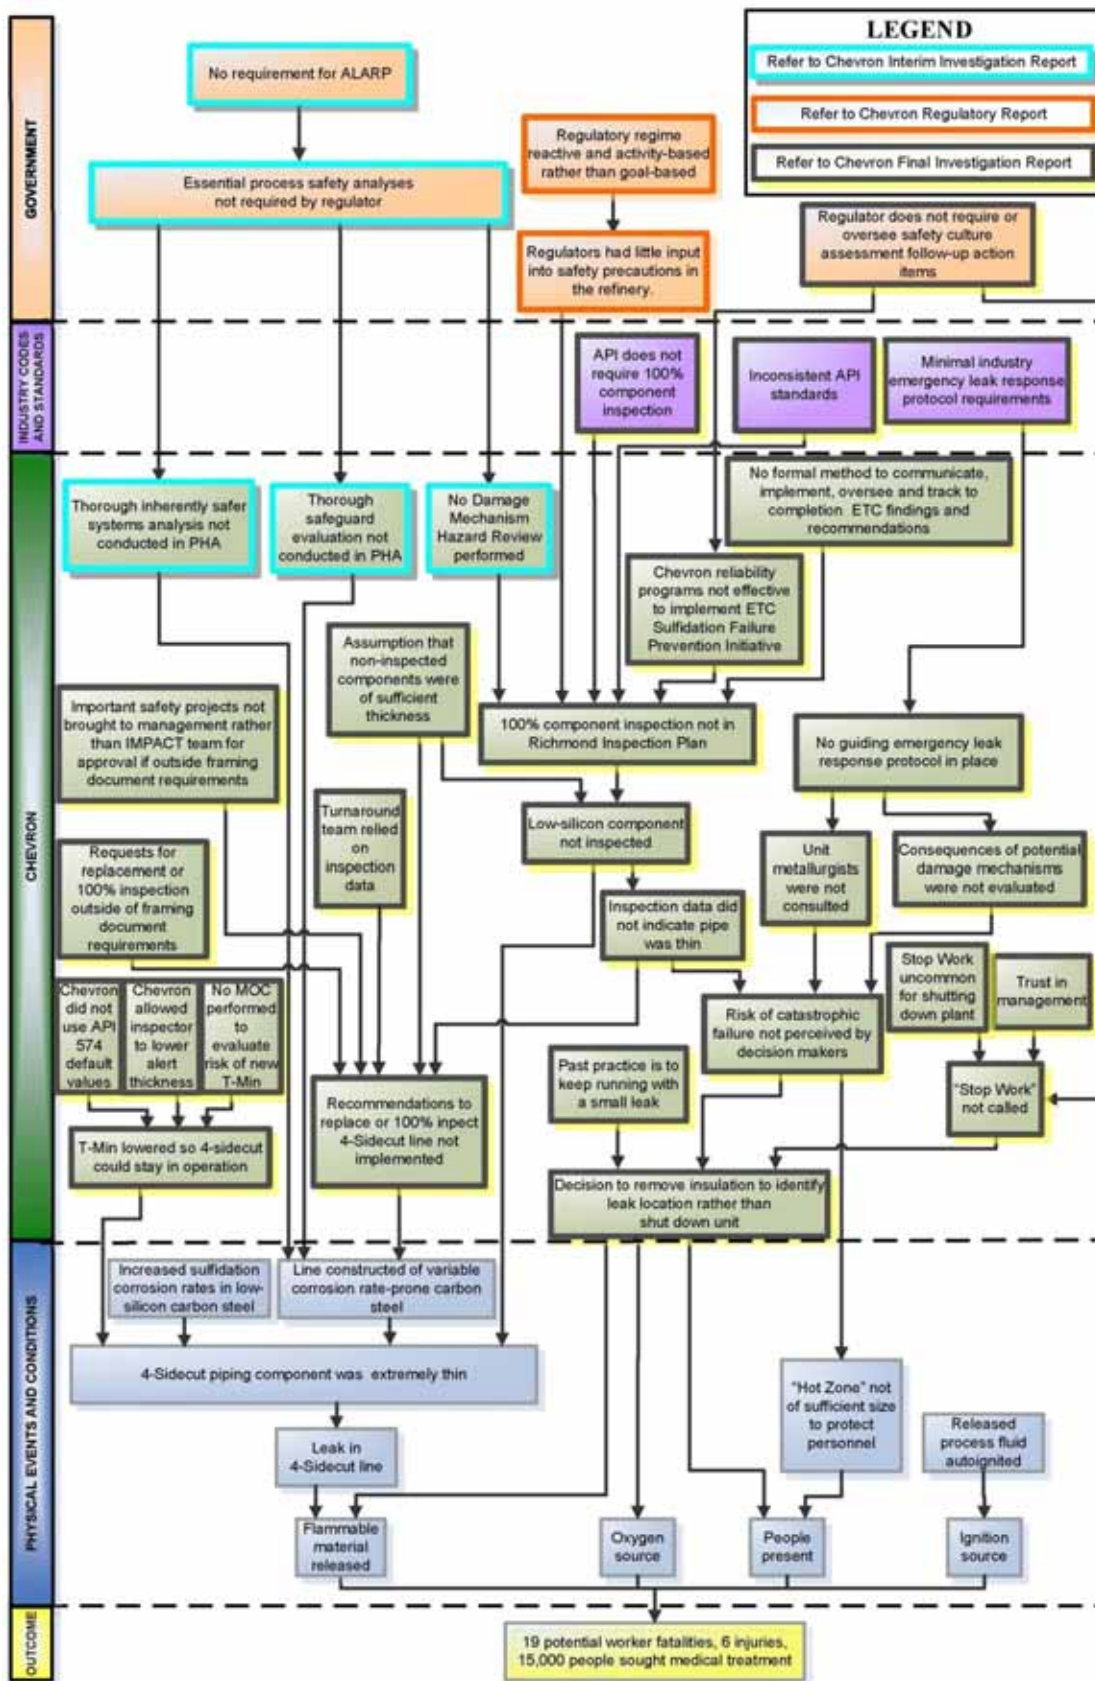
The CSB investigation team developed an accident map (AcciMap)<sup>114</sup> for the Chevron investigation (Figure 24). The AcciMap is a multilayered causal diagram that depicts immediate causes<sup>115</sup> as well as higher level contributing causes at the corporate, governmental, and regulatory levels. This diagram includes five levels:

Figure 24. Acci-Map of August 6, 2012, Chevron Refinery Fire.

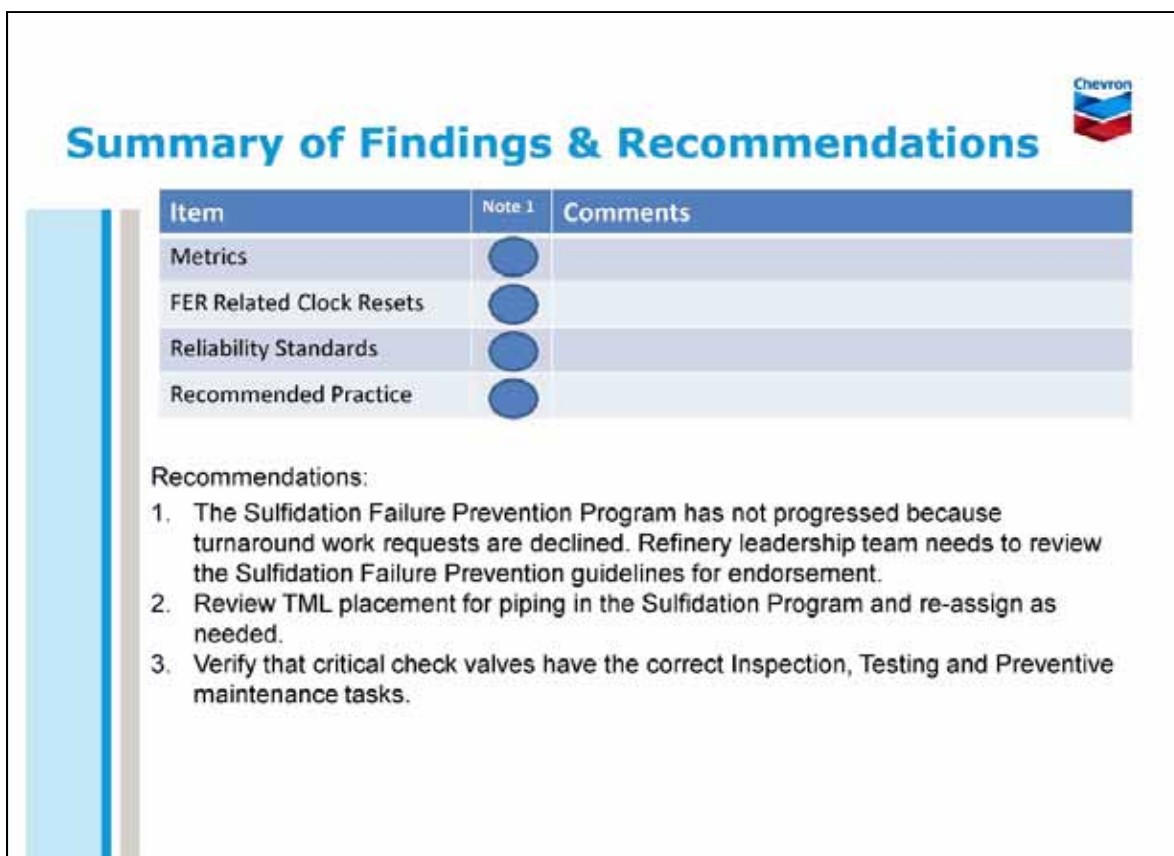
In March 2012, five months prior to the incident, the FER BIN Leader visited the Chevron Richmond refinery and identified that inspection of all carbon steel components susceptible to sulfidation corrosion was not being performed as recommended by the ETC Sulfidation Failure Prevention Initiative (Figure 35). In addition to identifying that CML placement for piping may need to be reassigned, this review found that the IMPACT team was denying critical inspection recommendations during the turnaround planning process. The FER BIN Leader identified that Richmond refinery leadership needed to review and implement the 2009 Chevron ETC Sulfidation Failure Prevention Initiative report and recommendations.

**Figure 35. Presentation slide showing corporate reliability leader’s findings that the Richmond Refinery was not complying with the ETC Sulfidation Failure Prevention Initiative.**

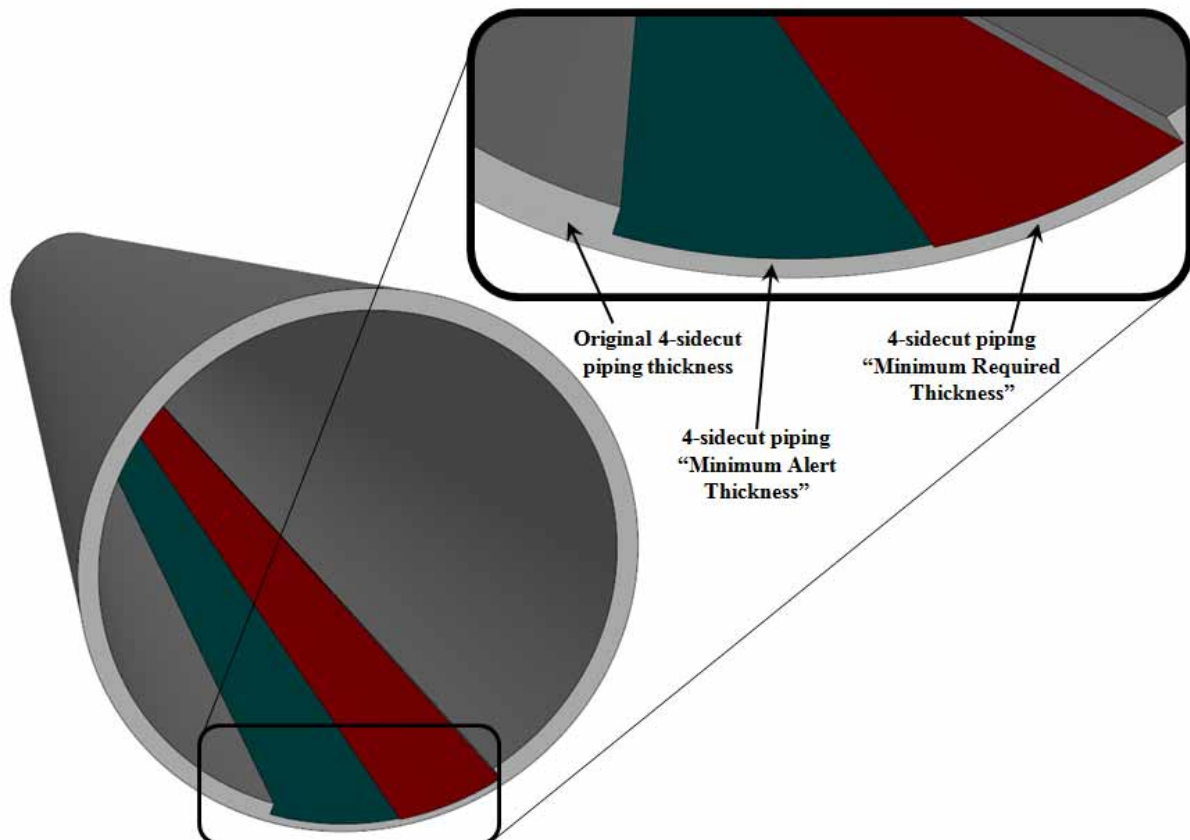
A visual depiction of the 4-sidecut original wall thickness, its Minimum Alert Thickness, and its Minimum Required Thickness appears in Figure 36.

**Figure 36. To-scale schematic of 4-sidecut piping original wall thickness (0.322-inch), Minimum Alert Thickness (0.13-inch), and Minimal Required Thickness (0.11-inch) using *API RP 574* default values.**
