# Service Bulletin

OCTOBER

1960

NO. 358

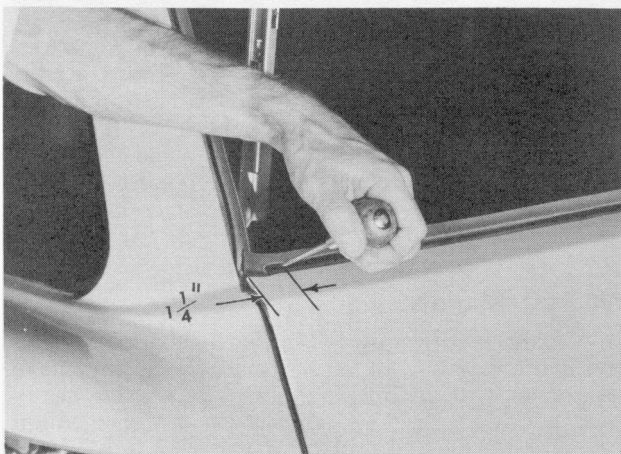
FIG. 7

A small screw and washer is now used to retain each end of the lower gate-to-upper gate rubber weatherstrip. The screws and washers are installed after the rubber is cemented to the gate.

The retaining screws and washers can be installed in the following manner:

1. If the rubber weatherstrip is loose, cement it firmly to the gate being certain the end sections of the rubber are properly located and cemented to the channel and to the end surfaces of the gate.
2. Punch or drill a 7/64" hole thru the rubber weatherstrip and thru the outer panel of the tail gate channel at the lower intersection of the vertical and horizontal section of the outer panel 1-1/4" from the outer end of the gate. (See Fig. 7).
3. Install the small screw, Part No. 2049 x **11G1**- (No. 6-18 x **34** truss head) and flat washer, Part No. CI03337 (5/32 x **38**) in the punched hole and tighten the screw securely. (See Fig. 8).
4. Repeat steps 2 and 3 at the opposite end of the gate.

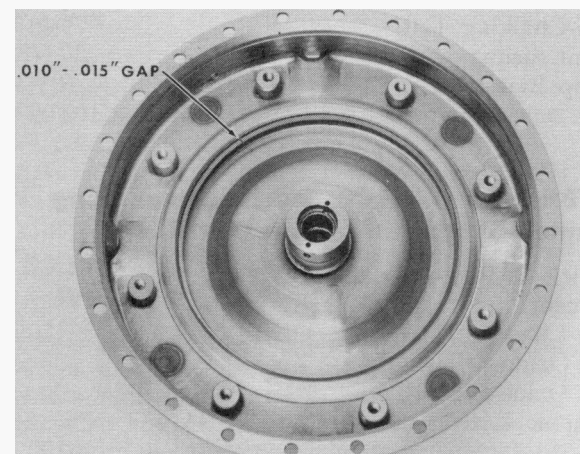
FIG. 9

An improper engagement or slow release of the direct drive clutch may be encountered following the reconditioning of the converter that includes installation of new inner and outer direct drive piston rings. It may also occur in a new service replacement assembly.

This malfunction may be caused by piston rings that are butting because of insufficient ring gap. It is recommended that all piston rings be checked for gap before installation. Each of the four outer rings should be checked for gap in the bore of the clutch housing. (See Fig. 9). File the ends as necessary to provide a gap of  $.010''$  -  $.015''$ . Clean off all burrs or roughness caused by filing. Upon installation, make sure ring gaps are spaced so that no two gaps are in line.
