**Bureau of Mines Report of Investigations/1975**

**Report of Investigations 8022**

# **Geologic Investigations of Underground Coal Mining Problems**

**By C. M. McCulloch, P. W. Jeran, and C. D. Sullivan  
Pittsburgh Mining and Safety Research Center, Pittsburgh, Pa.**

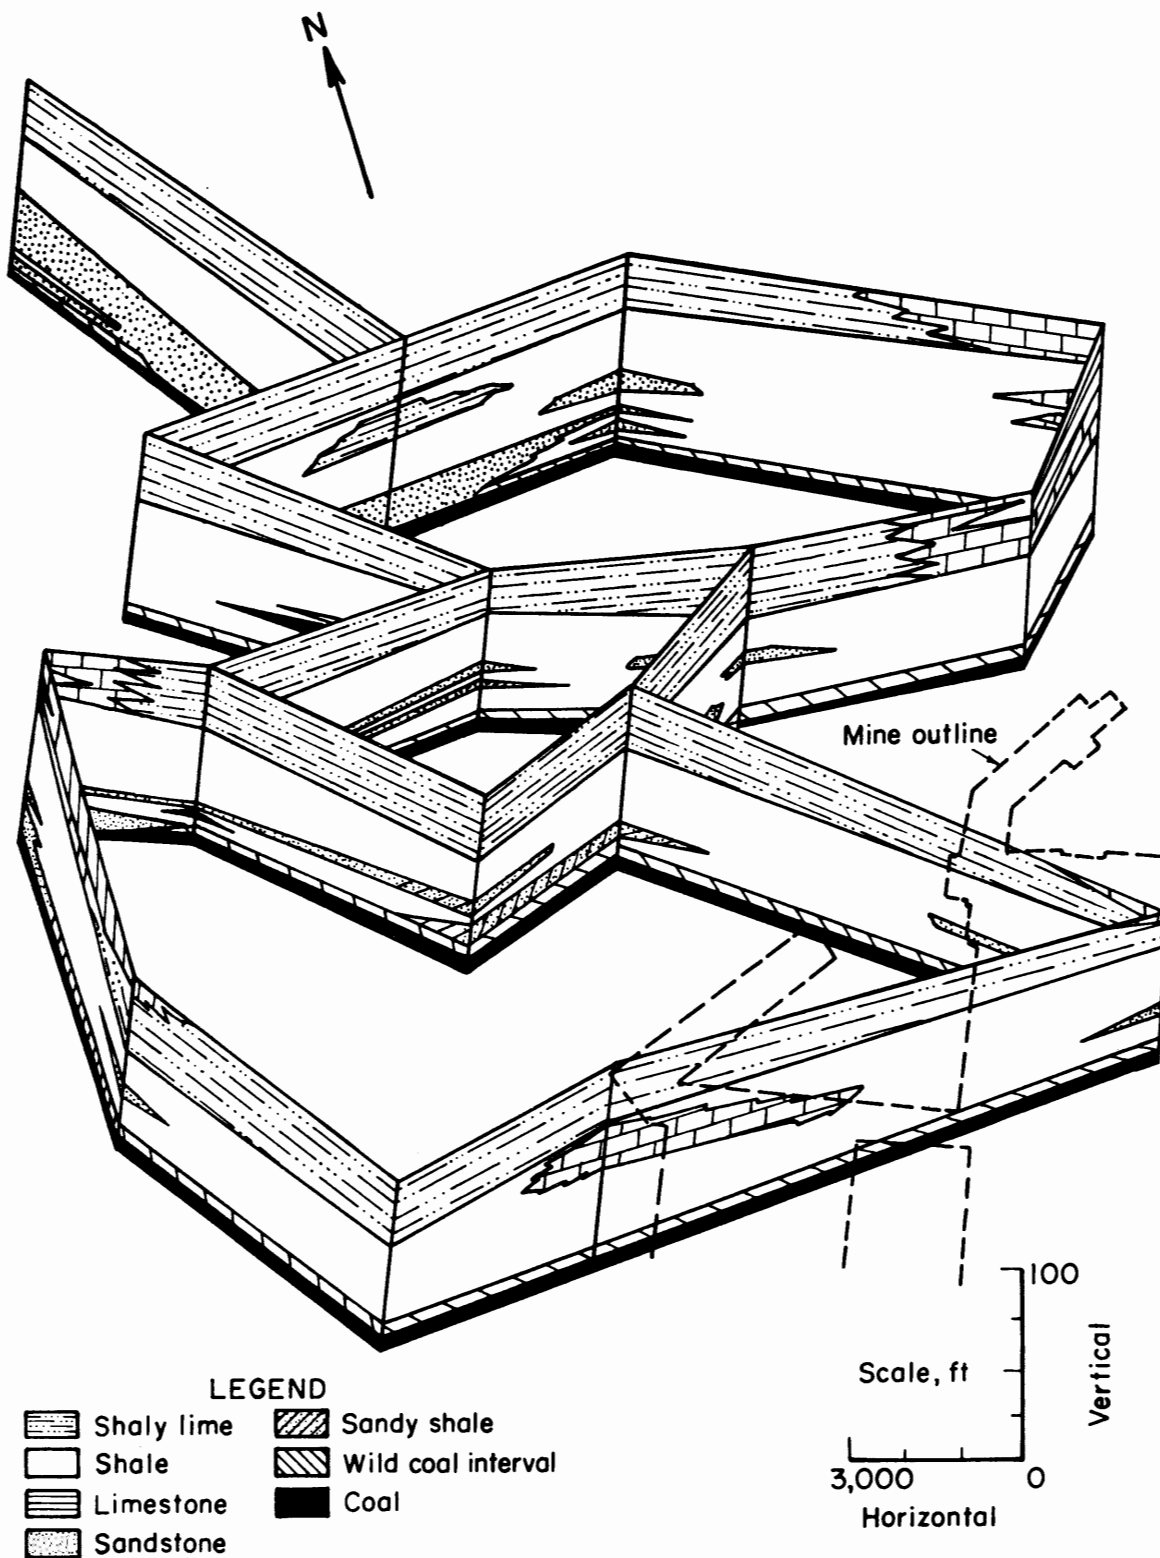
FIGURE 1. - Fence diagram of strata above the Pittsburgh coalbed, Marianna No. 58 mine.

A panel (see glossary) or fence diagram (fig. 1) and a structure map (fig. 2) of the property were prepared. A topographic map was overlaid on the mine map to correlate the

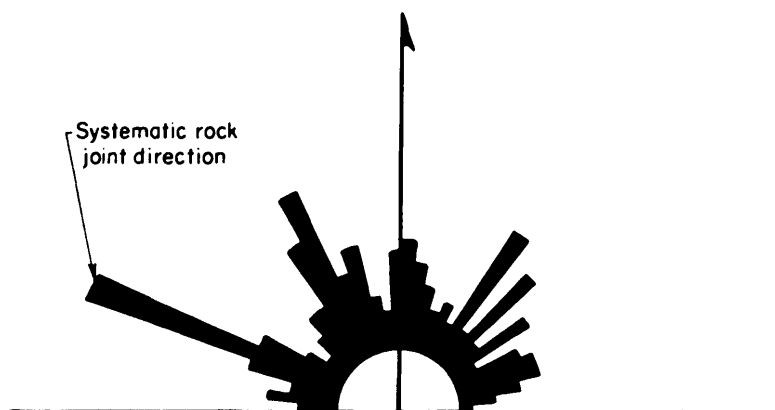
FIGURE 6. - Surface joint data above the Marianna No. 58 mine.

Joints were measured on the surface (fig. 6) to evaluate correlations between the principal fracture directions underground and those on the surface. Correlation was excellent.

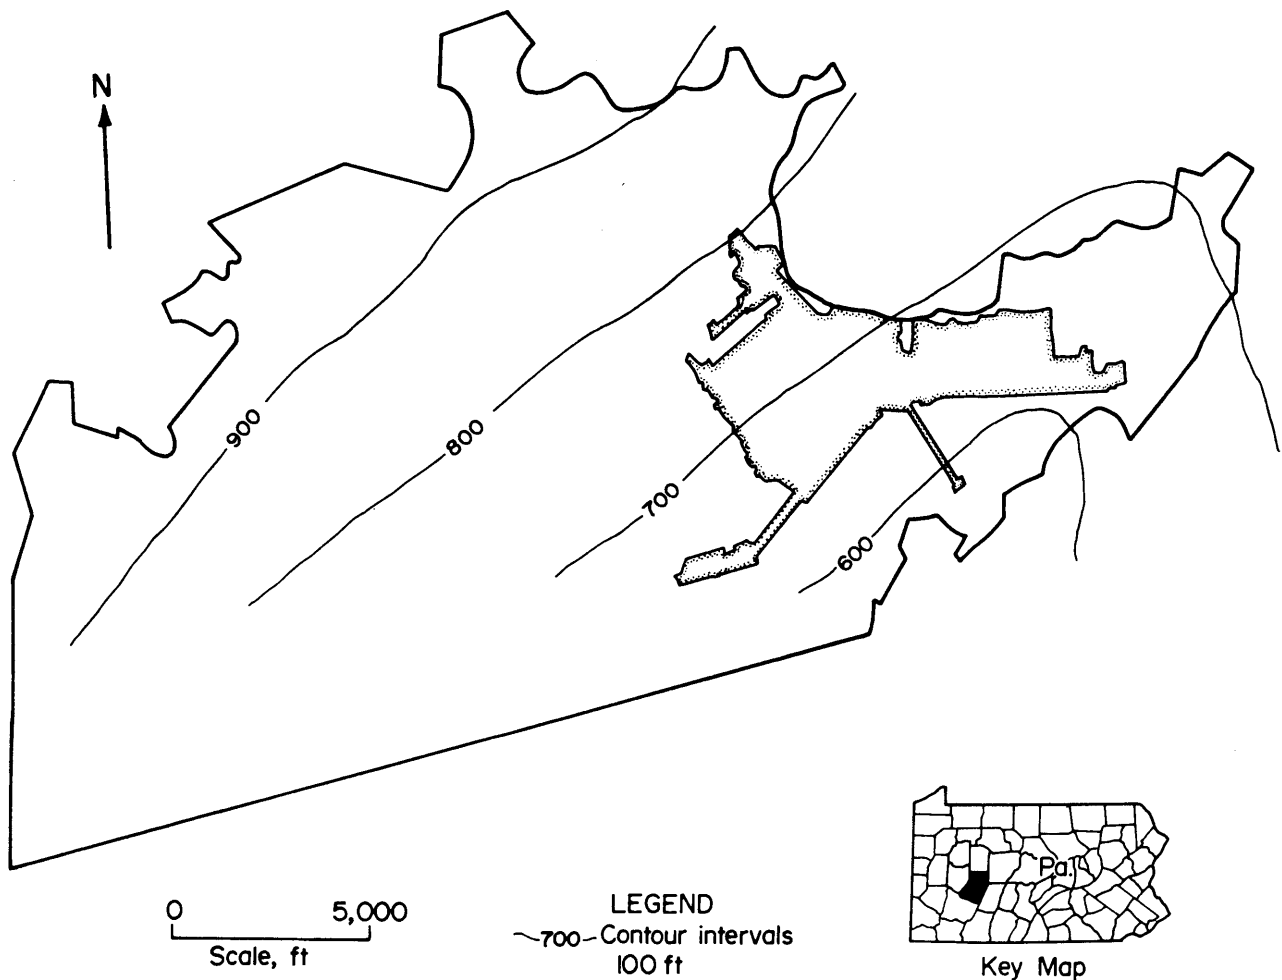
FIGURE 9. - Structure map drawn on the base of the Upper Freeport coalbed, Lucerne No. 6 mine.

A structure map (fig. 9) of the base of the Upper Freeport seam, drawn from corehole data, shows a synclinal structure with axis bearing approximately  $N30^{\circ}E$  and passing through the easternmost section of the mine. The largest part of the mine workings and reserves lies in the western limb of the syncline. The data points were too widely spaced to determine more than the gross structure of this area.

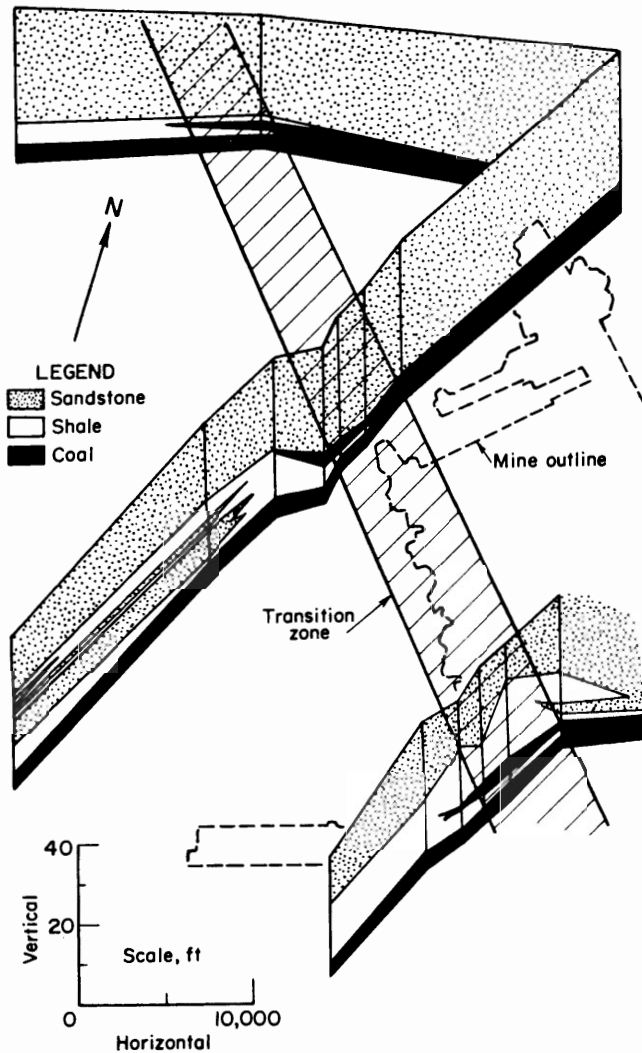
FIGURE 10. - Fence diagram of strata above the Upper Freeport coalbed, Lucerne No. 6 mine.

zone is  $N30^{\circ}W$ . This is illustrated by the fence diagram (fig. 10) constructed from the core log descriptions of the first 40 feet of rock above the coal. Within this interval, sandstone is present throughout almost the entire area. This sandstone is separated from the coal locally by shales and sandy shales. Its large lateral extension makes it a probable water and gas reservoir. Thick sandstone directly overlying coal often exhibits deformations due to compaction which appears locally to be thrust faults, but this was not the case here. The core logs were examined for records of broken rock, but they yielded no pattern indicative of possible fault zones.

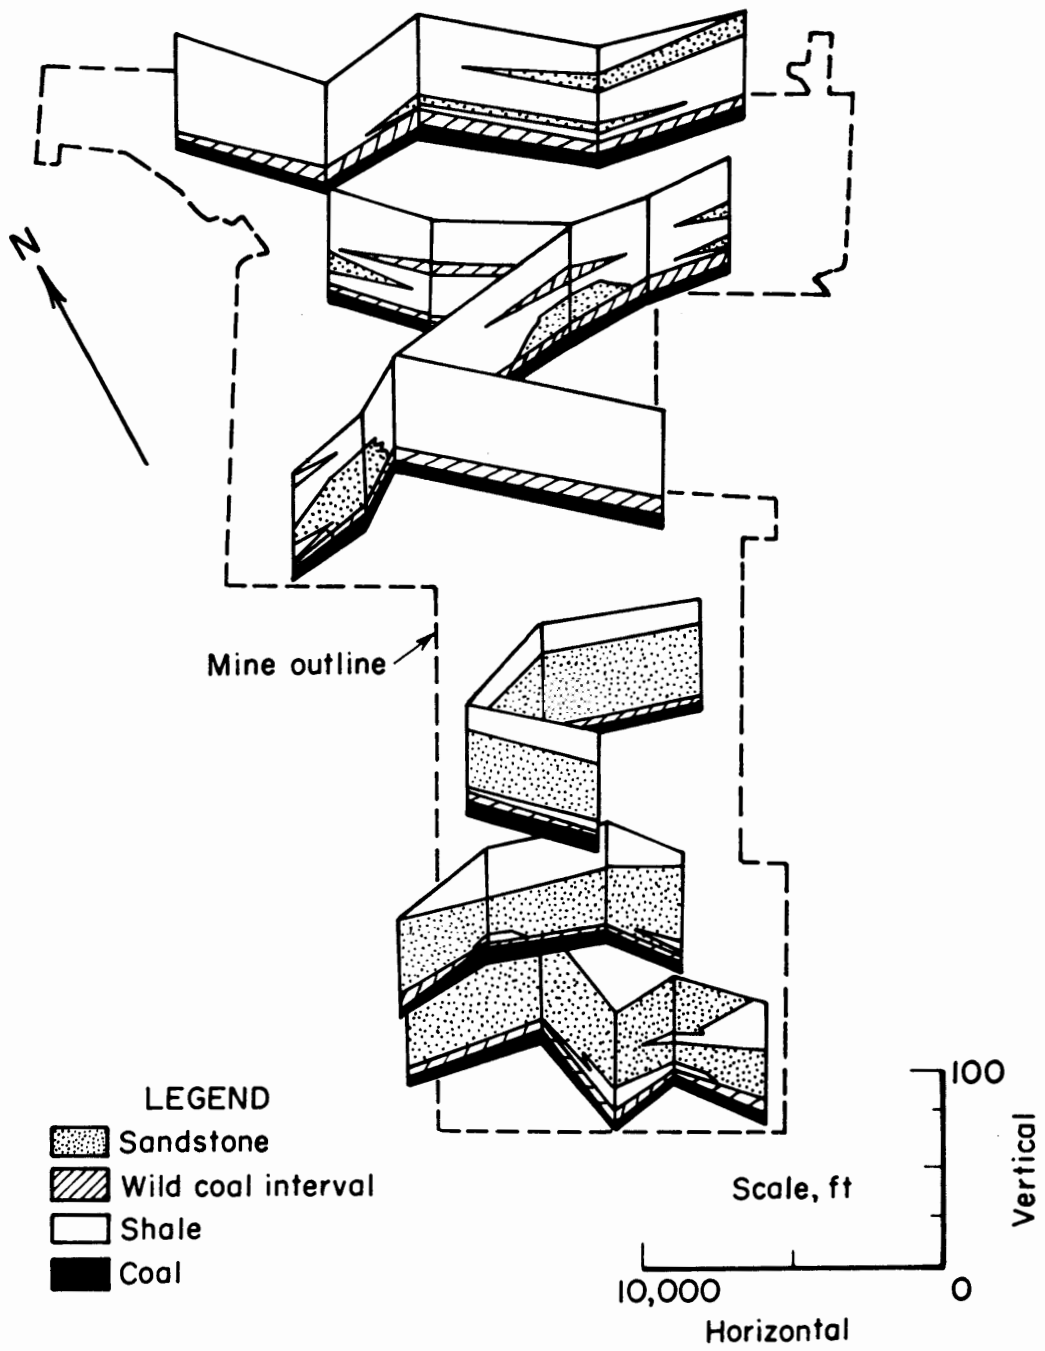
FIGURE 12. - Fence diagram of strata above the Pittsburgh coalbed, Somerset No. 60 mine.

A fence diagram of the 40 feet of strata immediately above the main bench of the Pittsburgh coalbed (fig. 12) in the 84 field directly to the west of the present mining was constructed, because of the occurrence of sand channels cutting out coal in the western part of the active mine workings. The data were taken from the company core logs. There was an abrupt change in this interval from north to south, with shale predominating in the north and sandstone in the south. The abruptness of this change is shown by drill

The geological data from core holes spaced more than 3,000 feet apart are difficult to correlate. More closely spaced drilling is necessary to delineate the northern limit of the sandstone. This zone is of particular importance in mining because it represents the northern limit of stream erosion of the strata overlying the Pittsburgh coalbed. Zones of abrupt lithology change can also coincide with areas of unstable roof, high gas emission, and related mining problems.

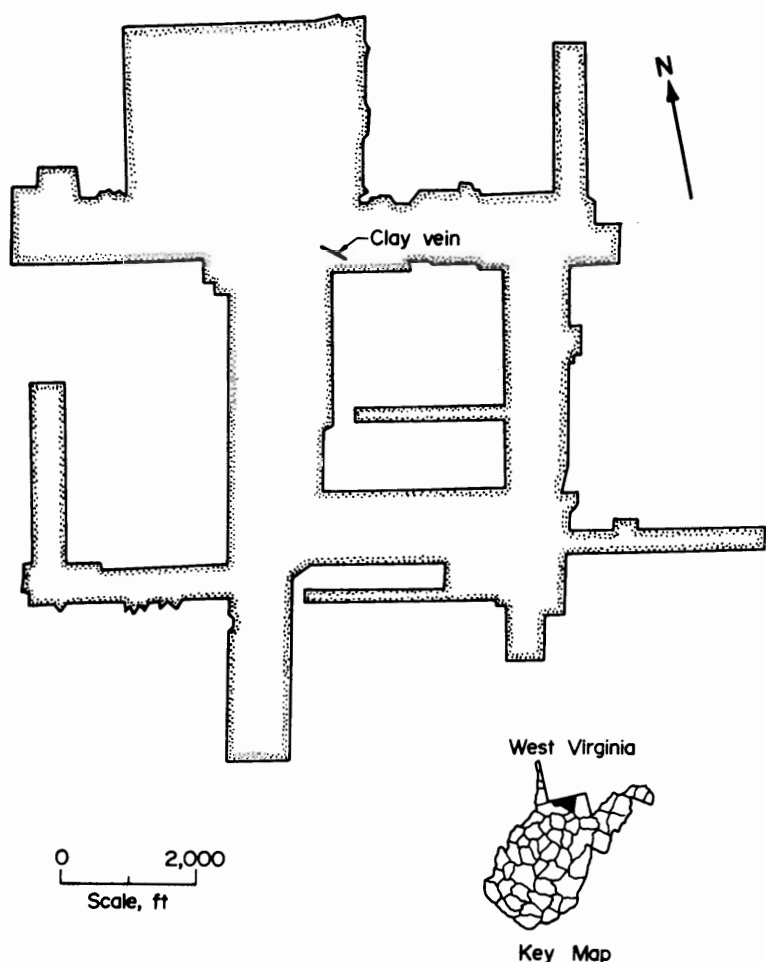
FIGURE 16. - Outline of the Federal No. 2 mine.

Analysis of the cleat data showed uniformity within the present mine development. The face cleat strikes  $N68^{\circ}W$ , the butt cleat strikes  $N22^{\circ}E$ , and the dip is essentially vertical. A series of slump fractures were observed in the East Bleeder, and one clay vein (fig. 16) approximately 150 feet long extends from the roof 2 feet into the coalbed near the mouth of the East Mains. The slump feature may be due to some local channel erosion or to differential compaction. Geologically related mining problems are methane emissions and roof instability, which go hand-in-hand in many instances. Driving north-south tends to develop high gas by intersecting face cleats. Roof control problems are probably due to bolting into the incompetent alternating coals and shales (draw slate interval).

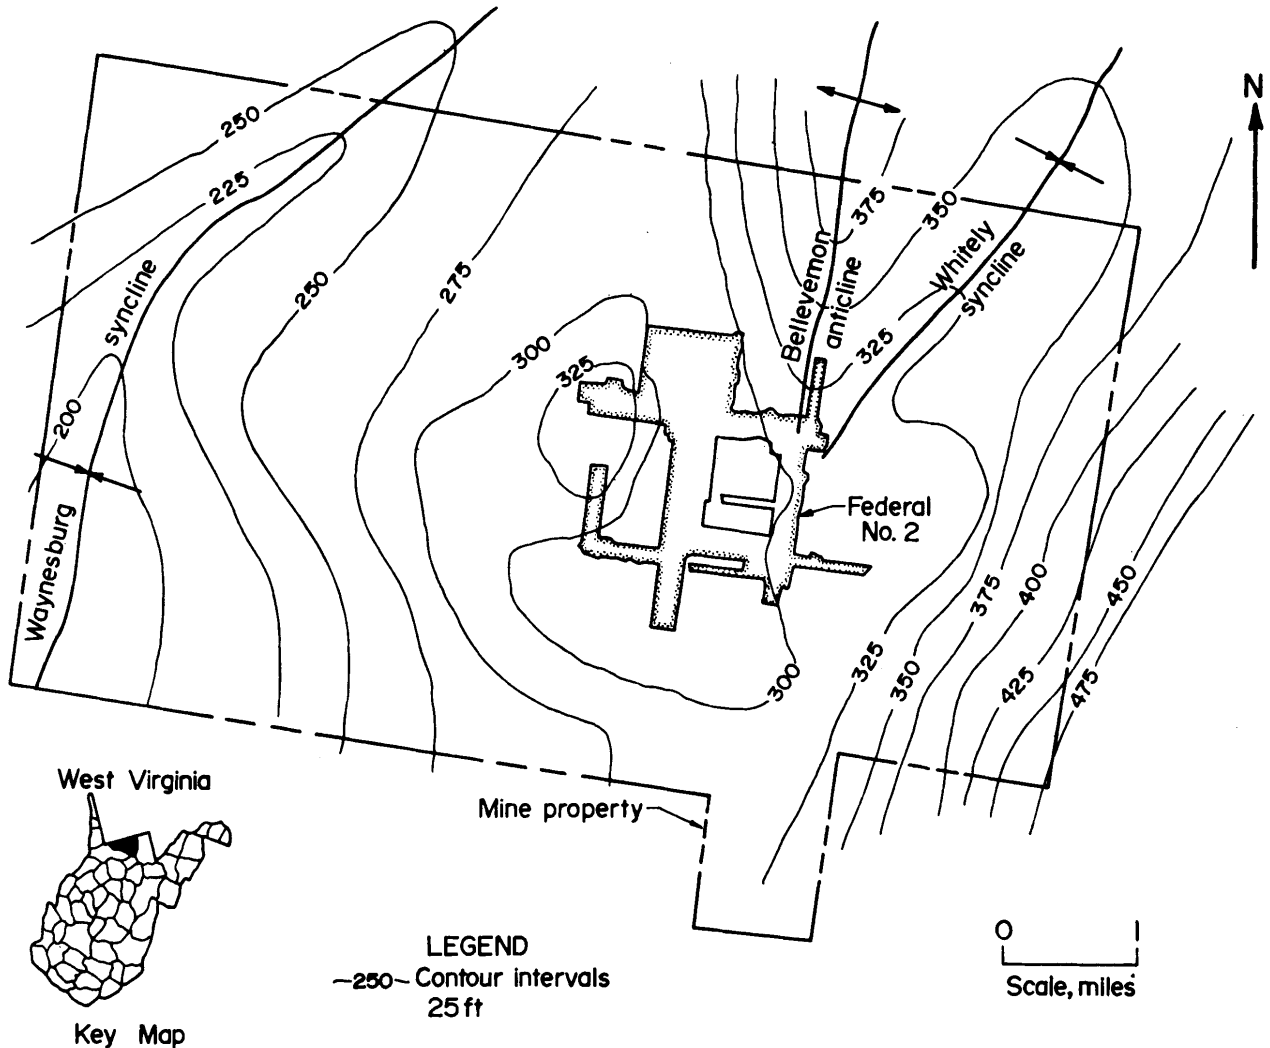
FIGURE 17. - Structure map drawn on the base of the Pittsburgh coalbed, Federal No. 2 mine.

A structure map (fig. 17) shows the axis of the Waynesburg syncline passing through the western extremity of the mine property. The Pittsburgh coalbed dips generally west-northwest towards the axis. The Belle Vernon anticline and the Whitely syncline are well developed northeast of the mine area. In the central portion of the mine property, there is a local upwarping which interrupts the gentle westerly dip.

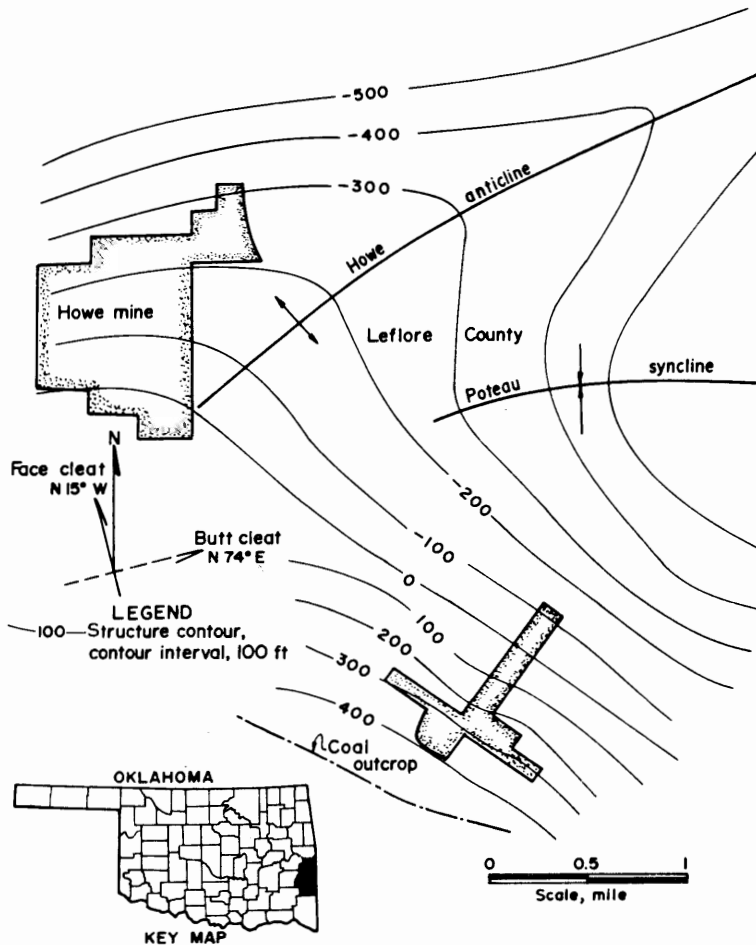
FIGURE 18. - Structure map drawn on the base of the Lower Hartshorne coalbed, Howe mine.

The mine is located 6 miles south of Poteau, La Flore County, Okla. It is on the south side of the Arkoma Basin, which is described as a synclinorium. Figure 18 shows the generalized structure of the Lower Hartshorne coalbed and the two major structures present in the area--the Howe anticline and Poteau syncline--with the cleat orientations. The Hartshorne coalbed consists of an upper bench averaging about 32 inches in thickness, below which there is a shale parting up to 24 inches thick, followed by several thin layers of usually impure coal laminated with black, carbonaceous shale.

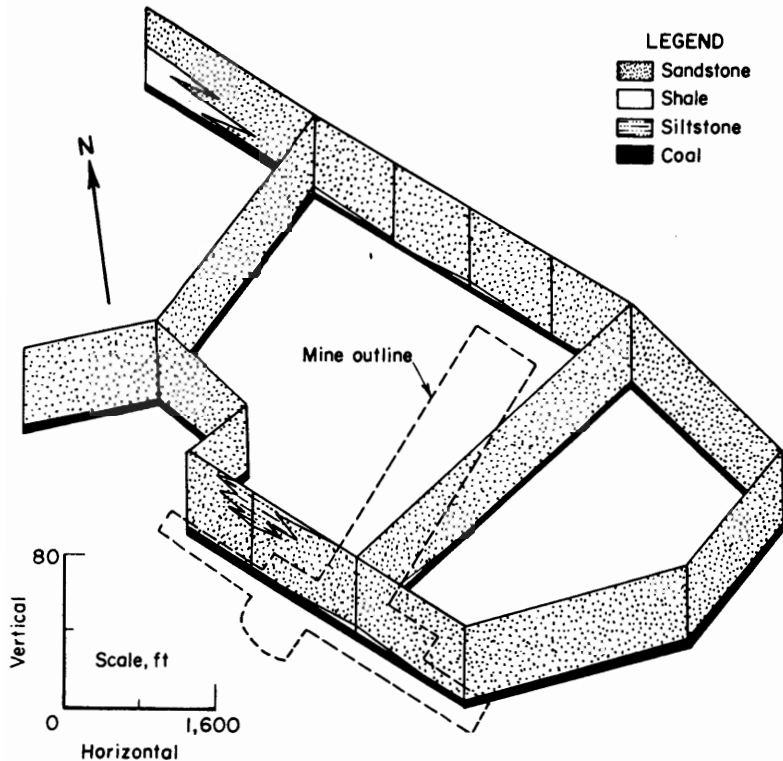
FIGURE 19. - Fence diagram of the strata above the Lower Hartshorne coalbed, Howemine.

A panel diagram (fig. 19) constructed from core logs of the test holes drilled by the company shows that the immediate roof over most of the property is sandstone. According to Bureau research, the absence of shale between the coal and sandstone greatly increases the probability of sandstone channels.

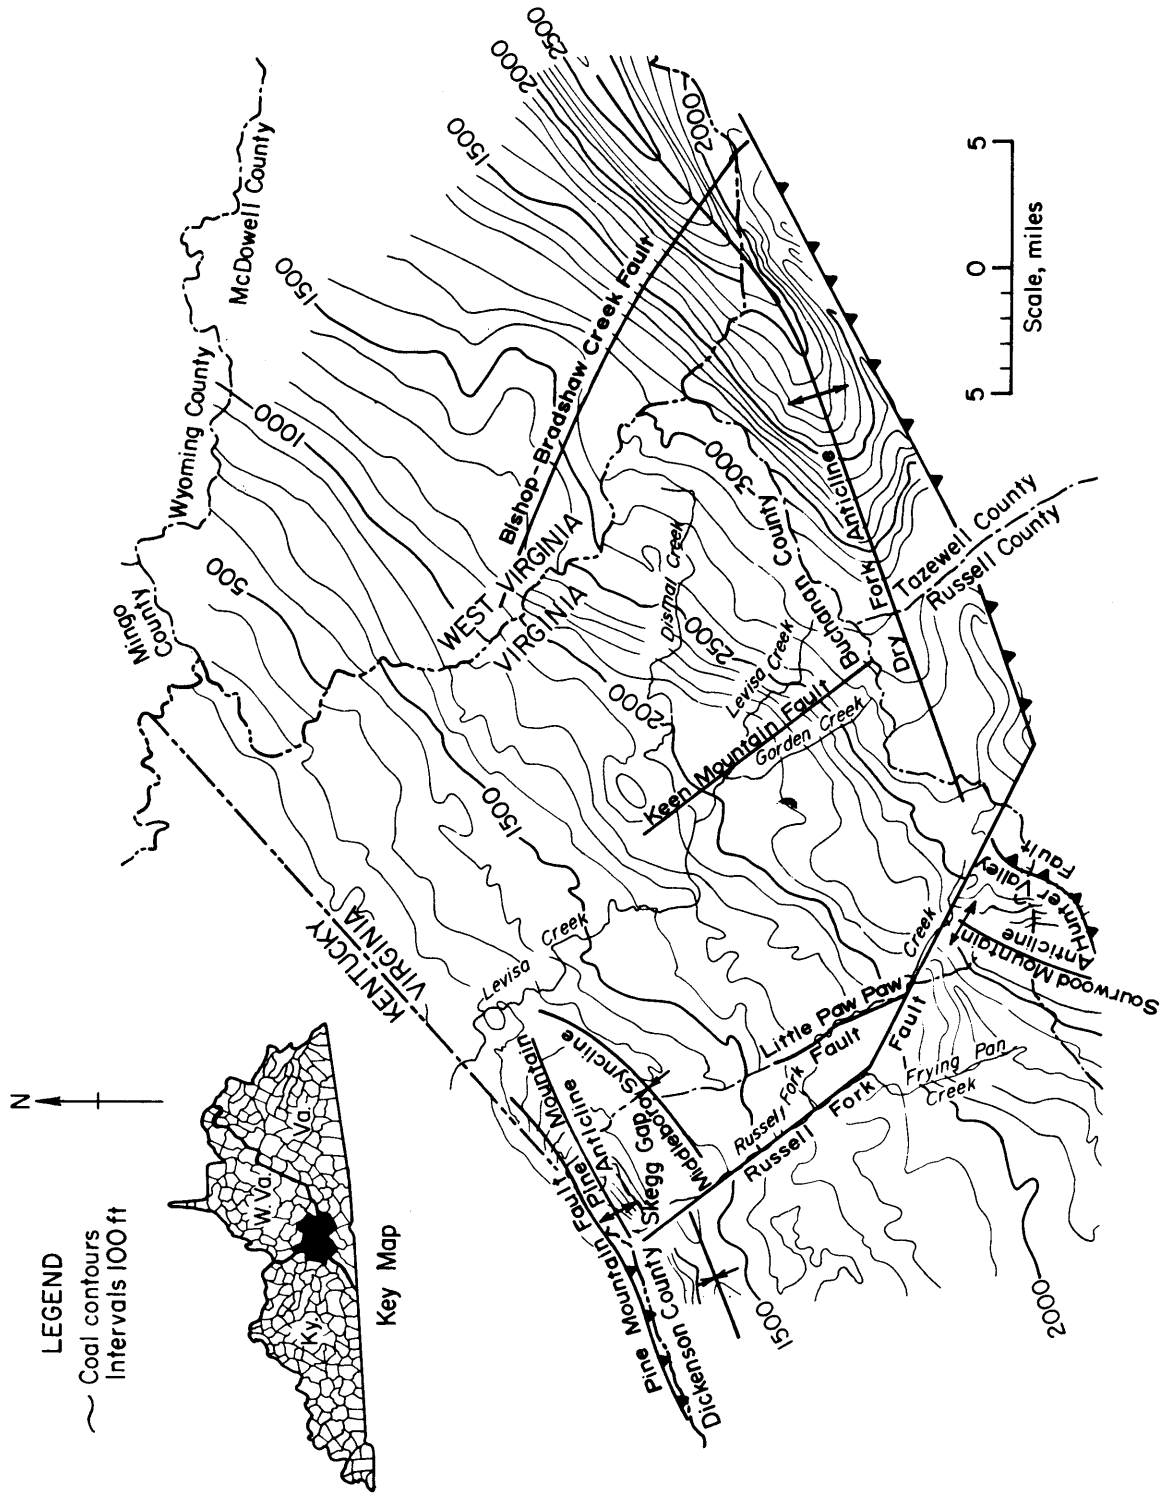
FIGURE 20. - Map of Keen Mountain fault in the Pocahontas No. 3 coalfield, Beatrice-Pocahontas mine.

A shear fault (fig. 20) of 2 to 18 feet vertical displacement, but unknown horizontal displacement, was encountered within the mine, trending northwest-southeast at 145° and 155° alignment and dipping 60° to the southwest. Slickensides on the faulted rock surfaces were parallel to bedding, indicating that the major movement was horizontal rather than vertical. Further evidence from surface exposures, together with data from mine operations in seams above the Pocahontas No. 3, permitted the delineation of a strike-slip fault at least 9 miles long. A more detailed study of the area using side-looking airborne radar (SLAR) was done by Elder (1).

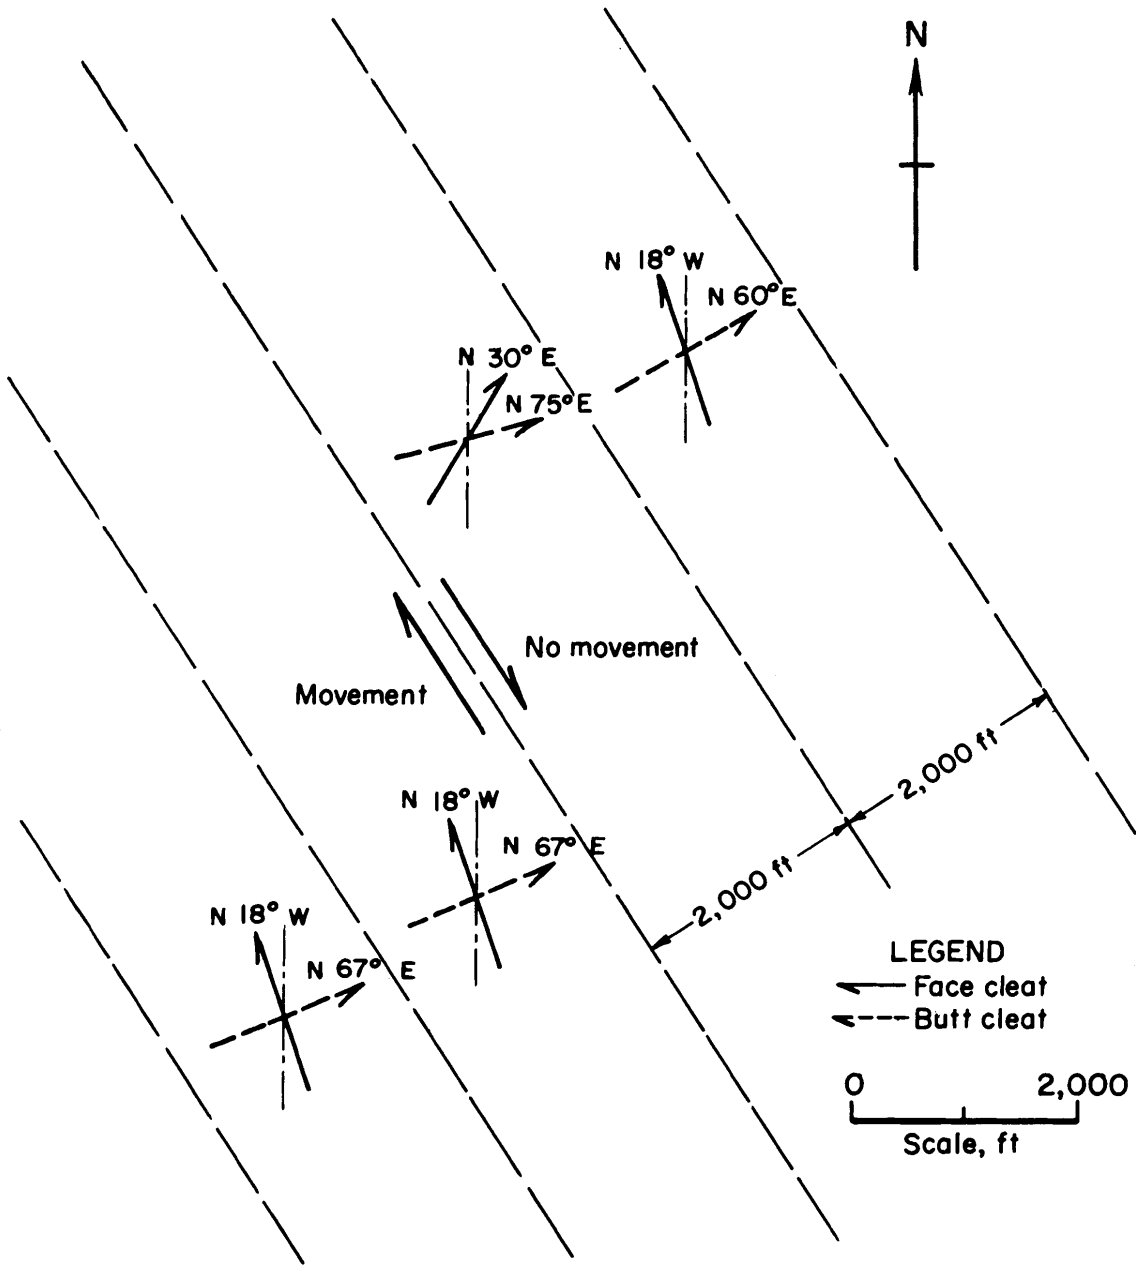
FIGURE 21. - Cleat rotation in relation to shear fault, Beatrice-Pocahontas mine.

Cleat measurements showed face cleat trending N18°W and butt cleat trending N67°E. On the northeast side of the fault, a rotation of the cleat (fig. 21) indicated that this side had acted as a buttress against which the southwest block moved.

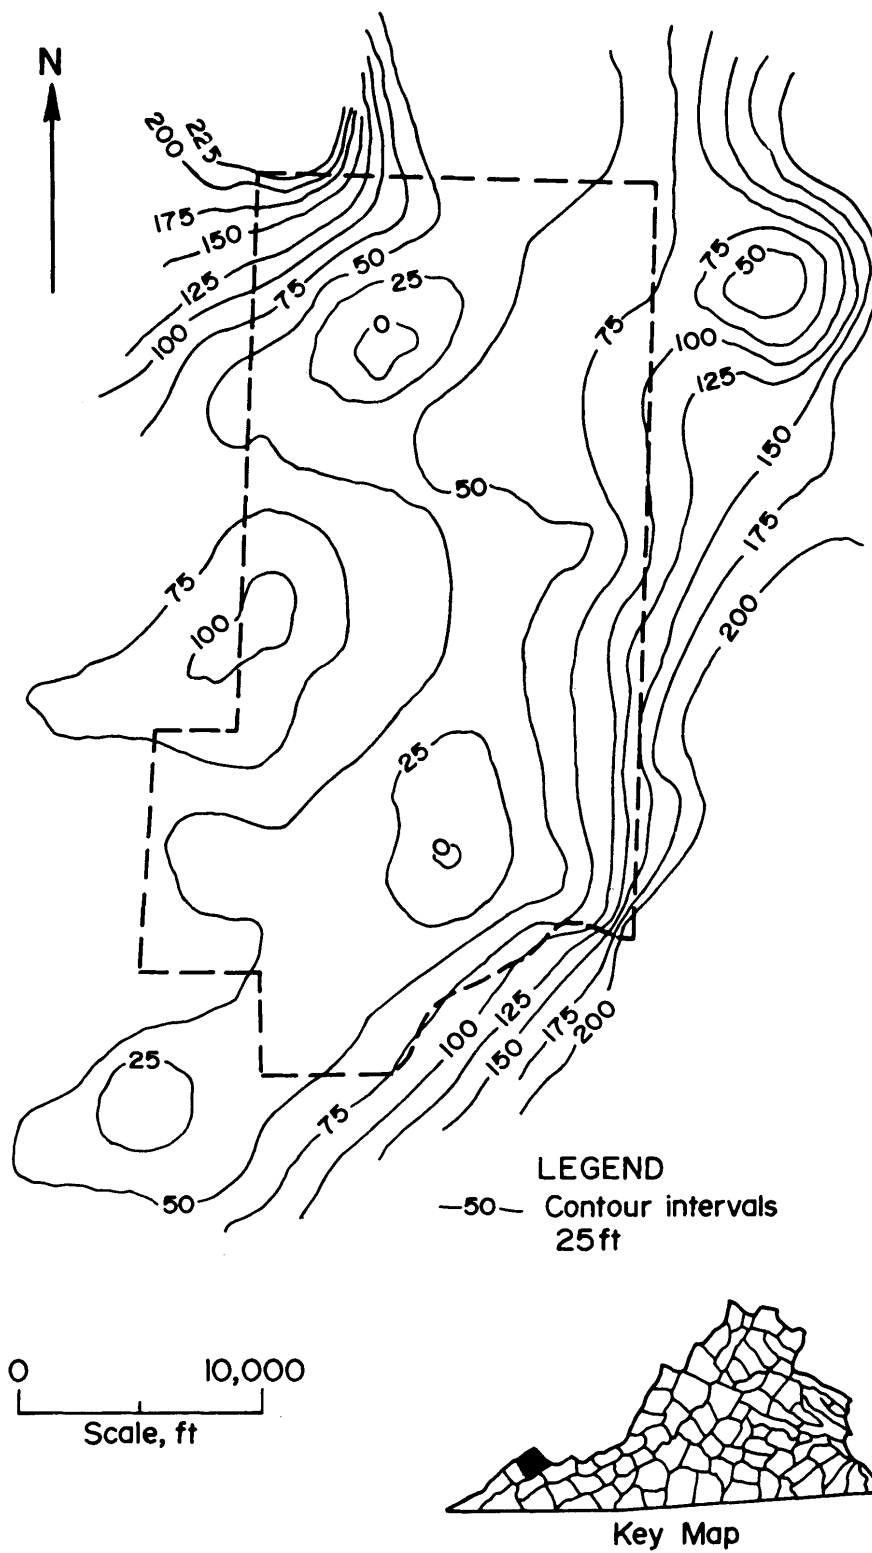
FIGURE 22. - Structure map drawn on the base of the Pocahontas No. 3 coalbed, Beatrice-Pocahontas mine.

According to a structure map (fig. 22), the mine is located on the flank of a monocline with a west-southwest dip. A fence diagram (fig. 23) showed two possible sandstone channels, one running southeast and the other northeast. The one trending southeast has already been encountered in mining and did cut out the coal. The one trending northeast has not yet been reached, but it is expected to cause much the same type of problem as the first one.

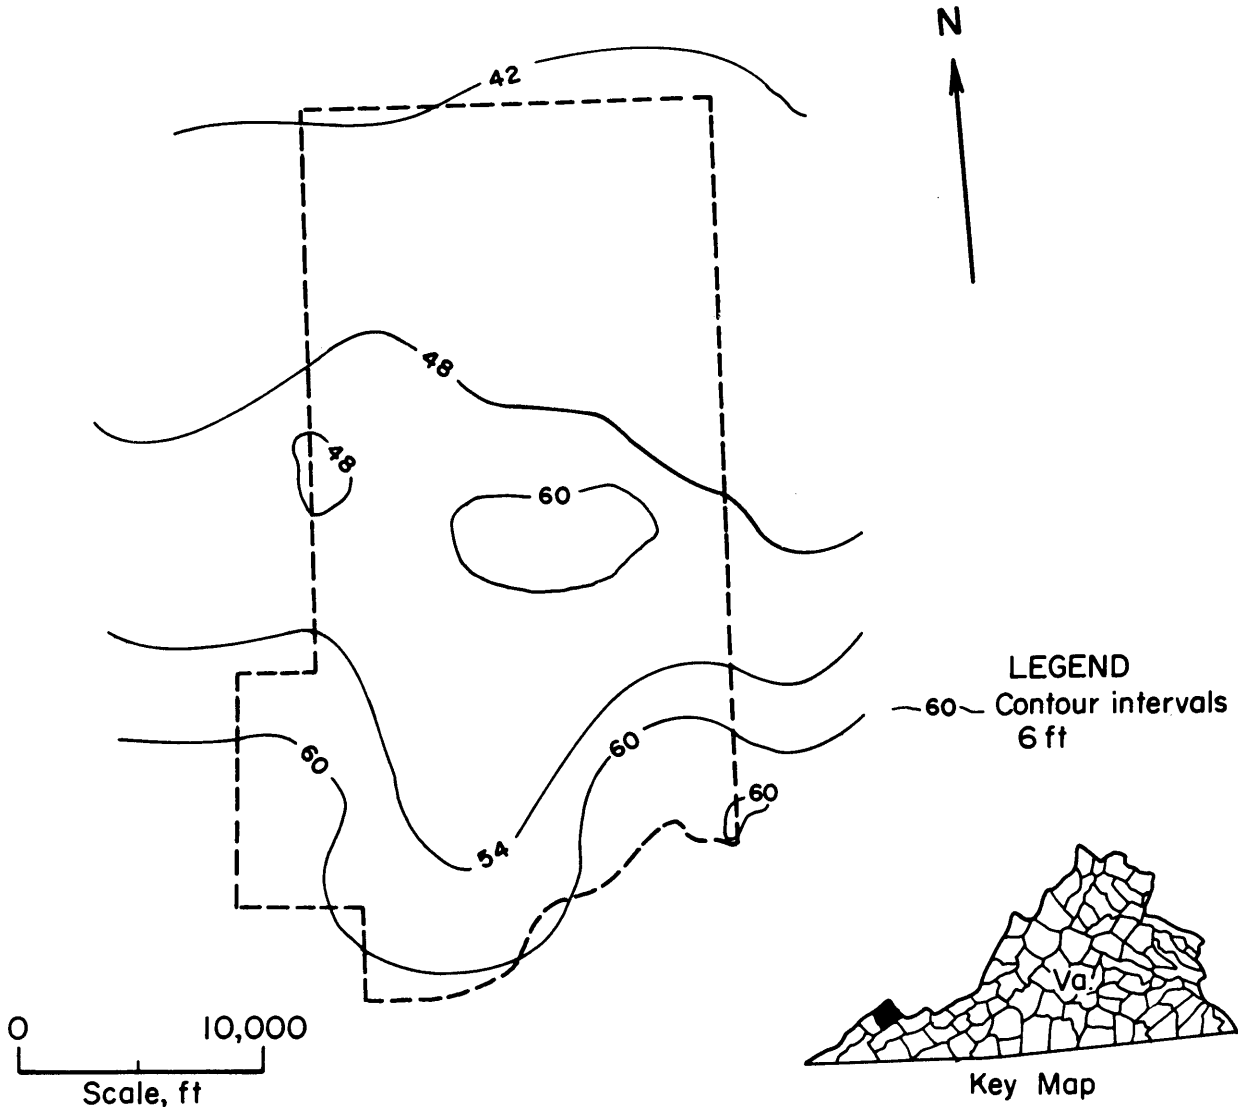
FIGURE 25. - Isopach of Pocahontas No. 3 coalbed (inches), Beatrice-Pocahontas mine.

An isopach map (fig. 25) of the coal thickness was prepared to determine if any washouts could be located. A second isopach from the coal to the sandstone above (fig. 26) was constructed to determine if the roof falls and gas content correlated with proximity to the sands and as an additional aid in locating washouts and channels.

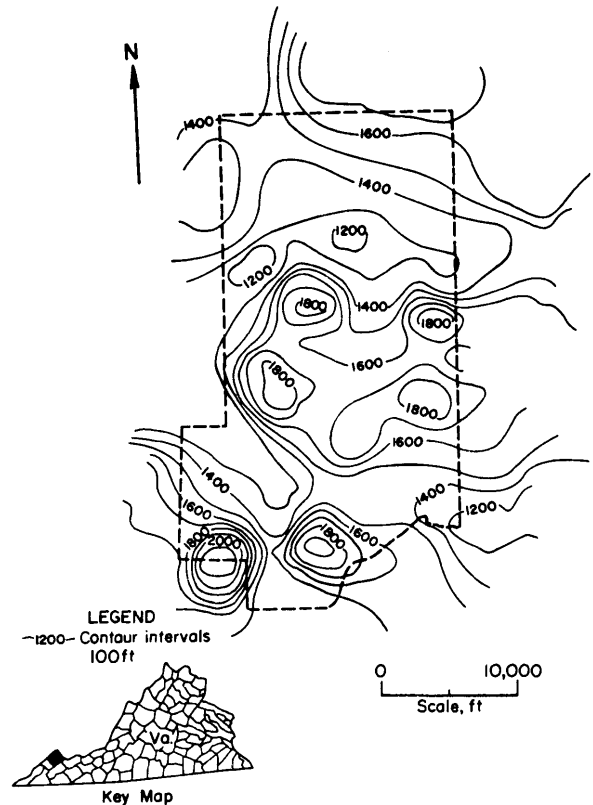
FIGURE 27. - Overburden isopach map of interval from Pocahontas No. 3 coalbed to surface, Beatrice-Pocahontas mine.

Finally an overburden isopach (fig. 27) was drawn to verify a Bureau of Mines theory that relates the amount of gas to the thickness of the overburden.
