**Geotechnical investigation for the
rehabilitation of Albert's Farm Dam
– Braamfontein West Water
Management Unit**

Reference: 504630-G3-00

Report No: 12239

26 July 2019

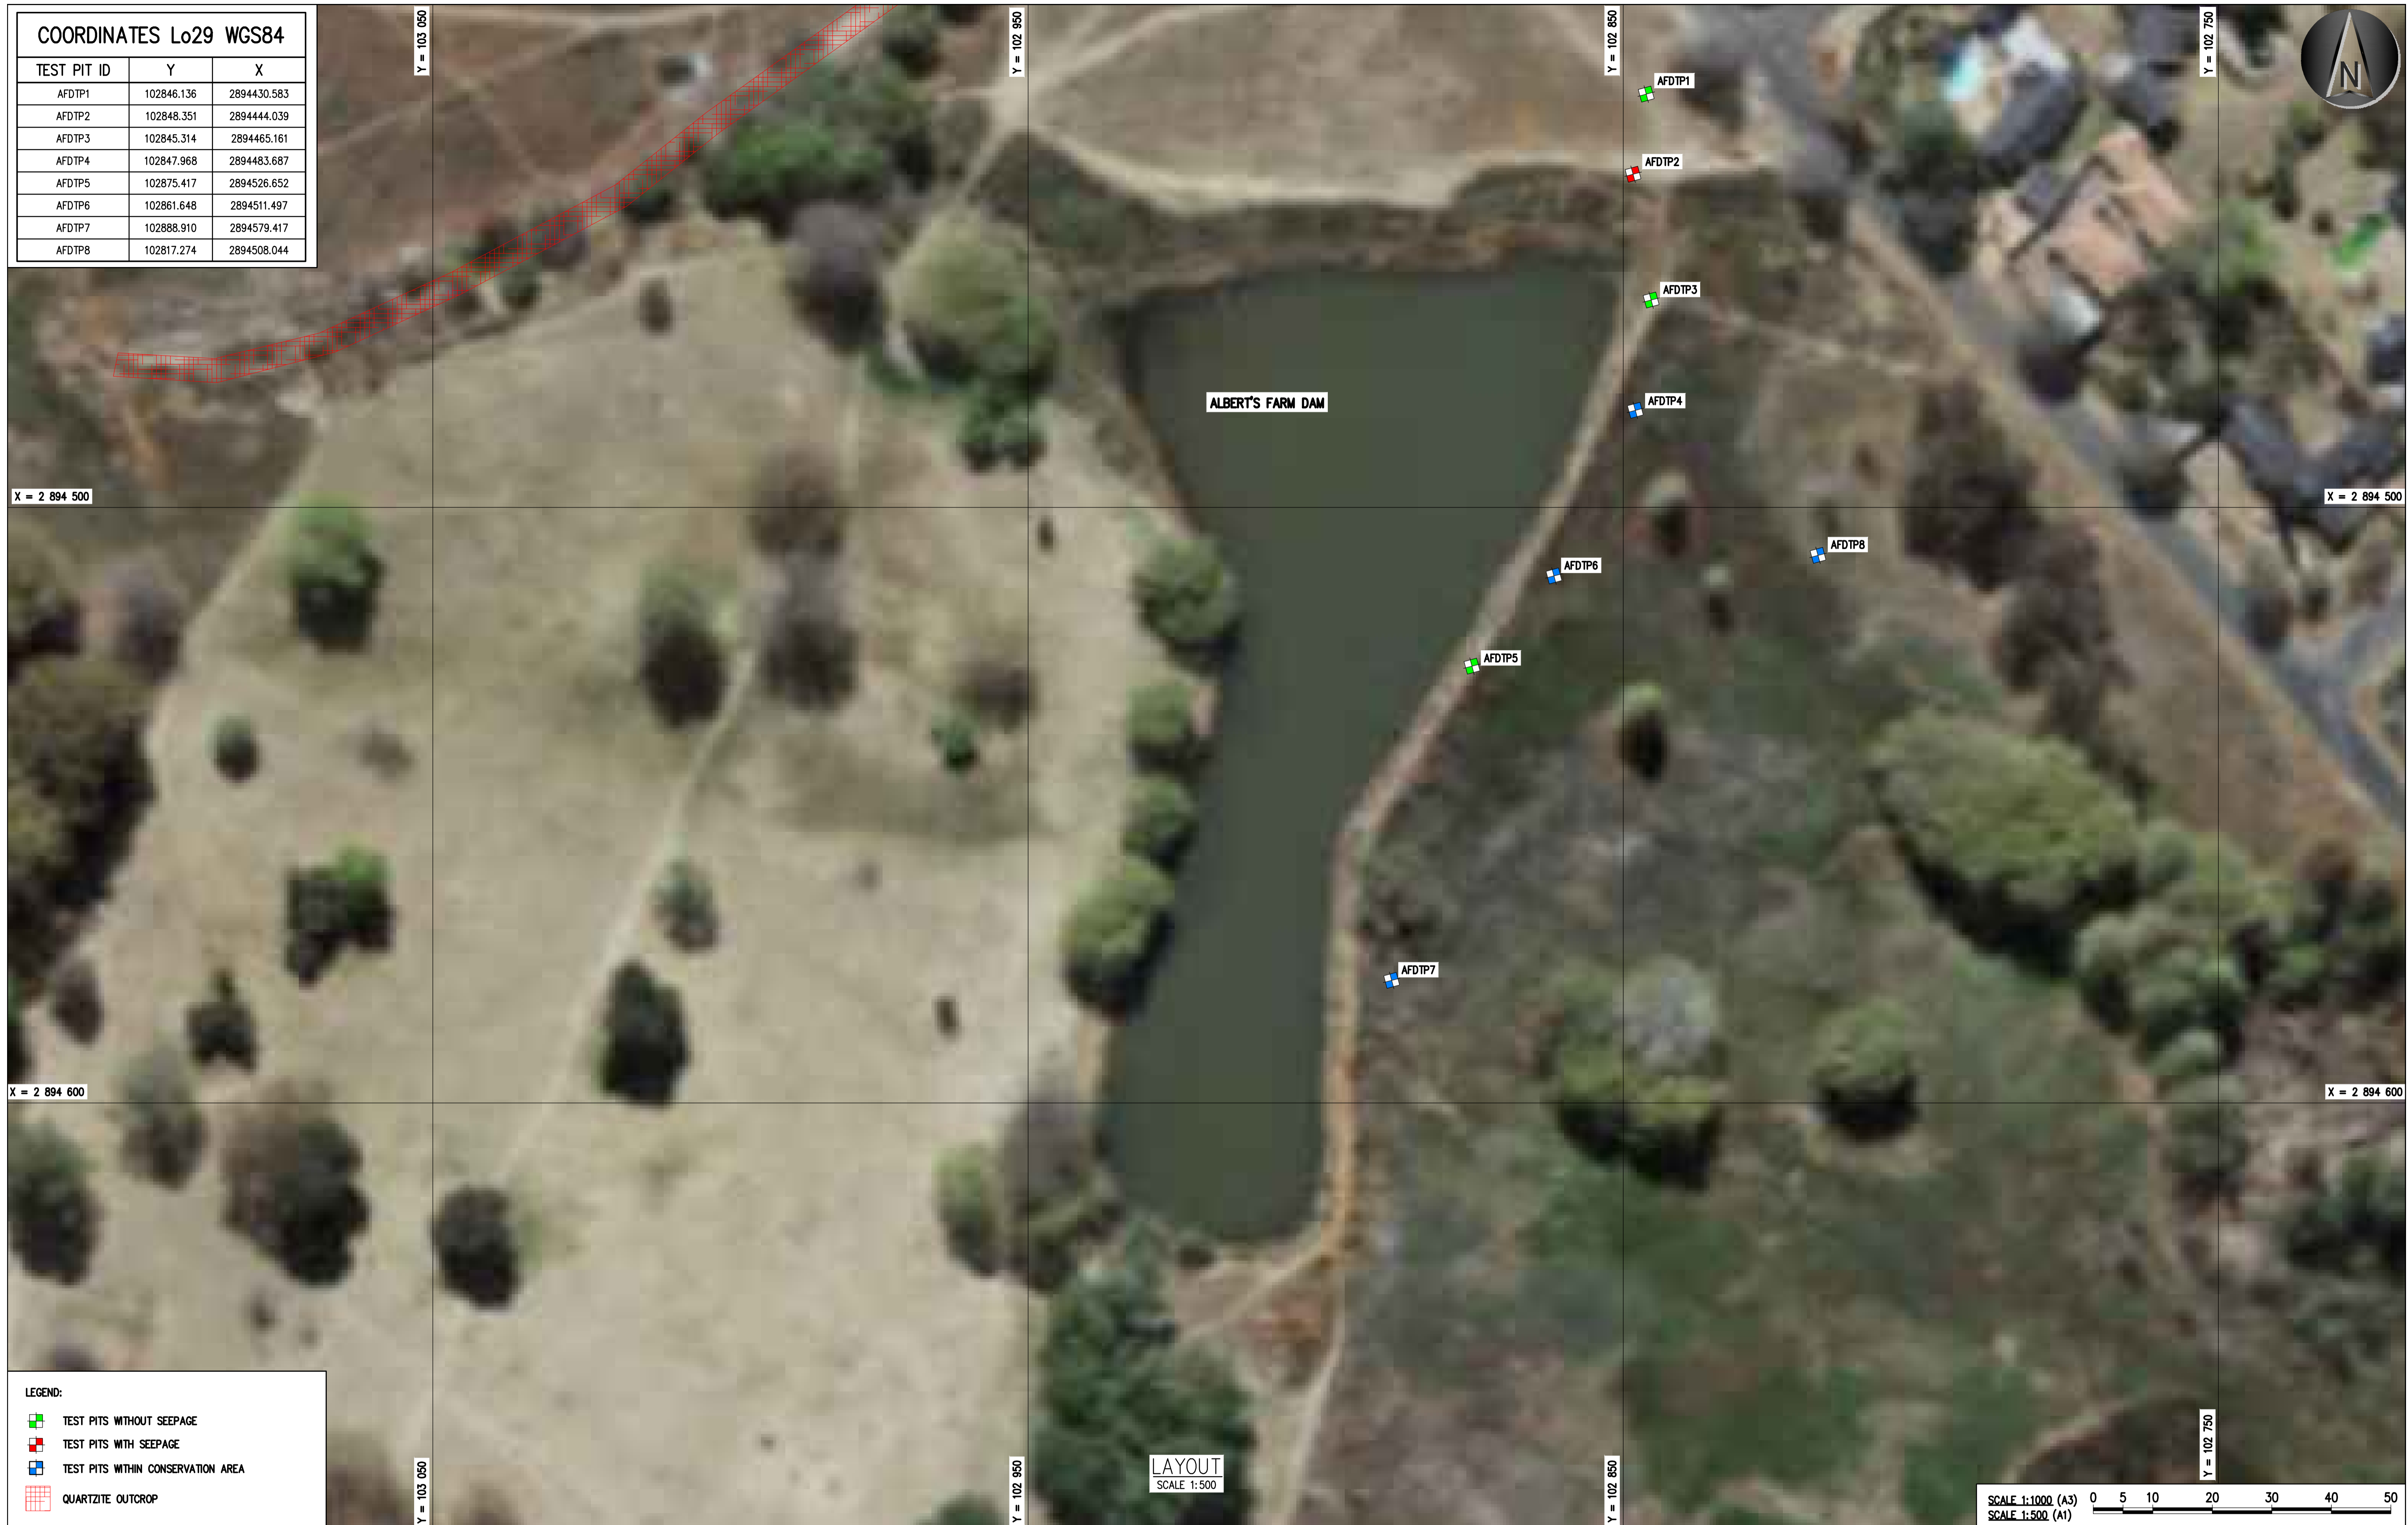
**Appendix C: Drawing (504630-0000-DRG-G3-0001 - Plan of
Albert's Farm Dam with test pit positions)**

Seepage was encountered at AFD TP2, the test pit located at the proposed spillway position. The seepage occurred at a depth of 1.2m below surface. The test pit was actually moved from the proposed position due to wet conditions being noted. Thus, the general area is defined by such conditions which possibly results from overflow.

The embankment fill material recorded an average coefficient of permeability value of 1.2 E-08 indicative of practically impervious material. No seepage occurred at test pits located on fill material. Seepage was noted on the test pit located at the proposed spillway (AFD TP2).
