# Hot-Dip Galvanized Reinforcing Steel Performance Report

Longbird Bridge • Bermuda 1953 - 2020

### EVALUATION OF GALVANISED REINFORCING STEEL IN THE LONGBIRD BRIDGE, BERMUDA

**EVALUATION OF GALVANIZED REBAR: LONGBIRD BRIDGE, BERMUDA**

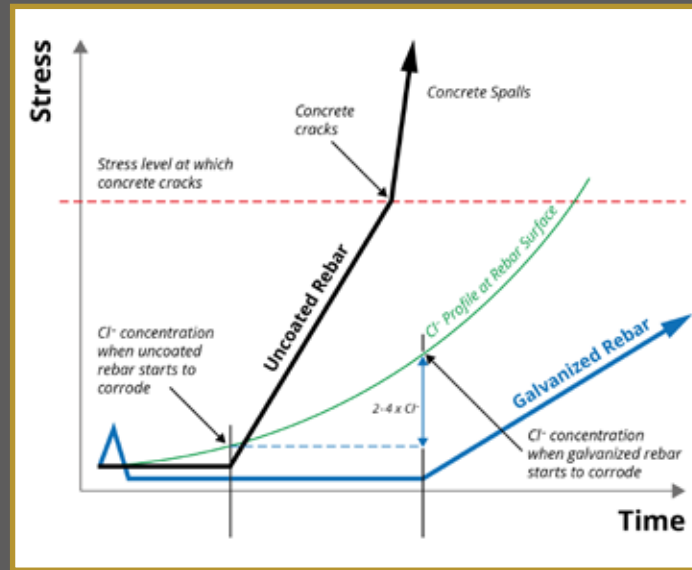
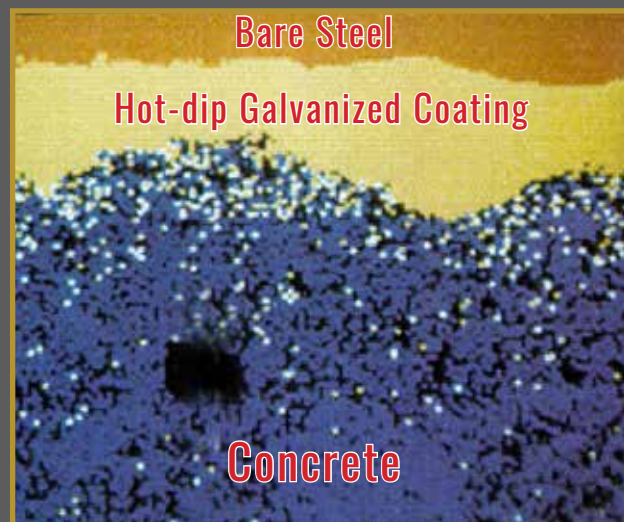
Even when the hot-dip galvanized coating begins to corrode, zinc corrosion products have the unique property of diffusing into the concrete matrix opposed to building up pressure at the surface of the rebar and causing cracking and spalling. The elemental map (left) is evidence of this migration. Bare steel is represented as orange, the hot-dip galvanized coating is yellow and the white spots in the concrete indicate zinc oxide which has migrated away from the galvanized rebar/concrete interface.
