I-40 Hernando deSoto Bridge

Fracture Investigation

Memphis, Tennessee

FINAL REPORT

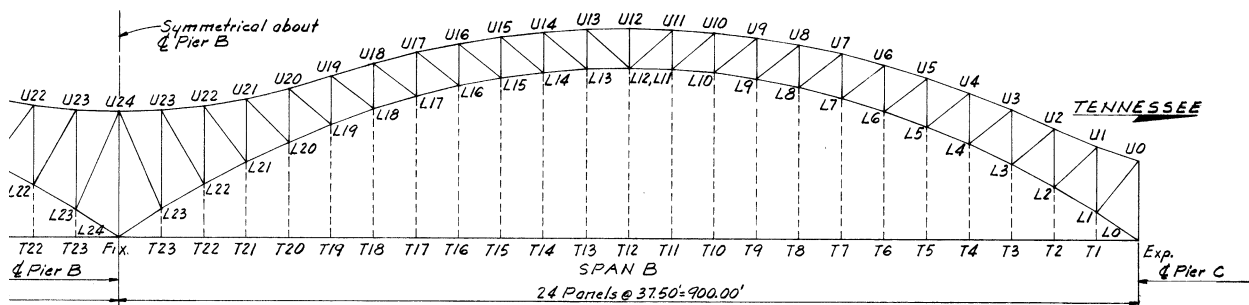
Figure 2. Arch Span B looking north with tie girder connection points labeled T1 to T23 from design drawings.

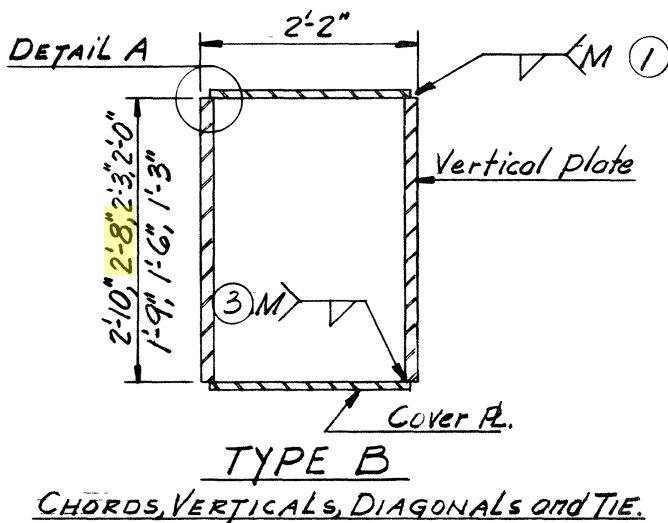
The 32-inch deep by 26-inch wide boxed-shaped tie girder in each truss is continuous and consists of 1/2-inch thick top and bottom cover plates and two, 1 3/8-inch thick vertical side plates (Figure 3). To accommodate the net-section demands at the bolted hanger/floorbeam/tie girder connections, the thickness of the vertical plates is increased to 1 15/16-inches at odd numbered connections and to 2 1/4-inches at even numbered connections where the tie girder is spliced (Figure 4). The plate thickness transitions are formed through double-bevel groove welds (Figure 5).

Figure 3. Type B bridge elements including tie girder section from design drawings (depth highlighted in yellow).

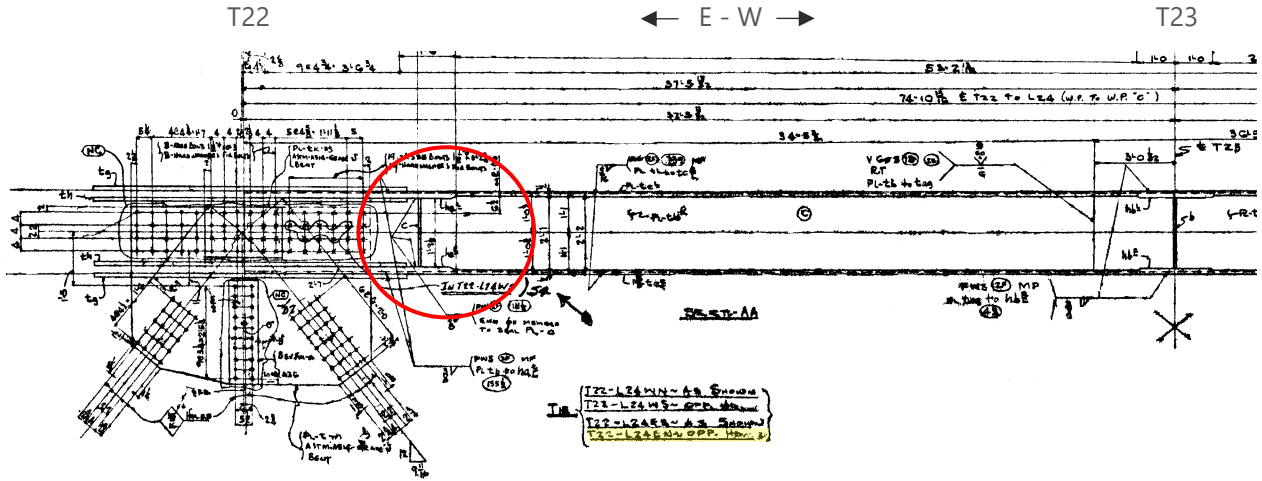
Figure 4. Shop drawing (longitudinal section view shown opposite hand) for tie at location of fracture (circled).

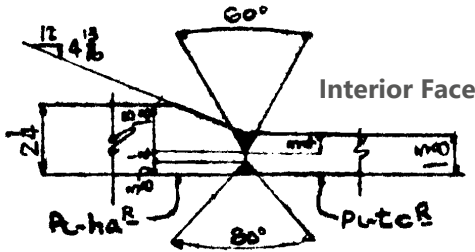
Figure 5. Side plate complete joint penetration groove weld details from shop drawings

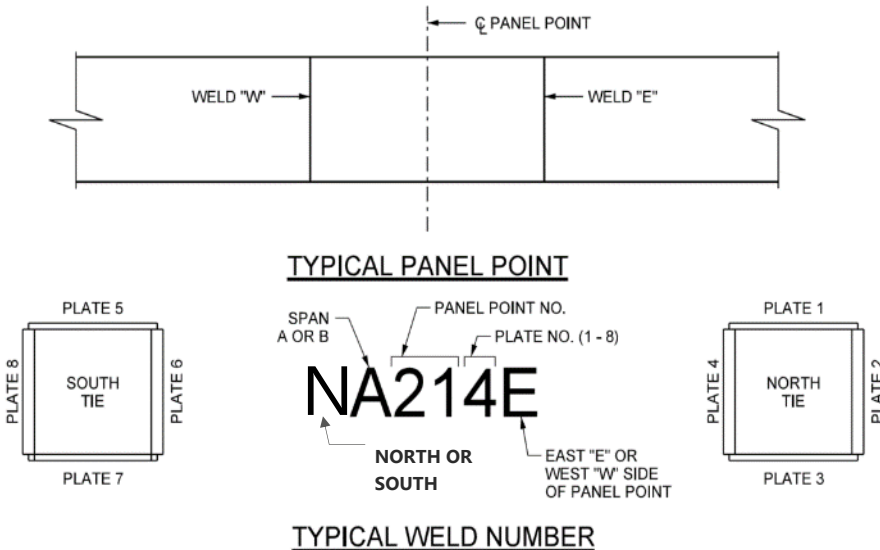
For inspection purposes, each tie girder plate was numbered 1 to 8 depending on its location within the upstream (north) or downstream (south) tie. The weld locations were identified by span and by their locations east or west of the hanger. Refer to Figure 6 which provides the plate numbering identification system.

Figure 6. Identification of tie plates and welds (figure provided by HNTB).

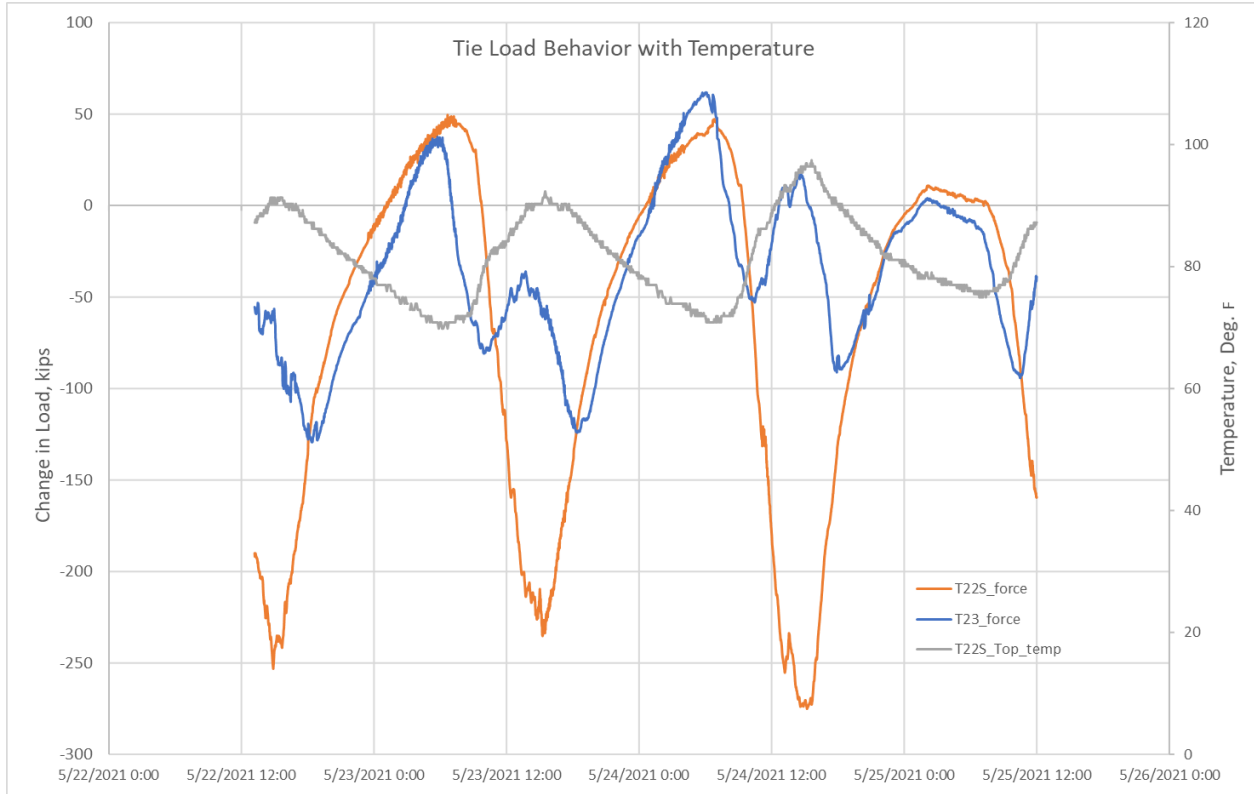
For this structure, the total design dead load in each tie girder was 4,575 kips. The design live load increased the tension in the ties by only 890 kips or about 16 percent. The thermal data shows a nearly 300 kip increase in tie girder load with a 20 deg. F drop in temperature or nearly a third of the maximum live load plus impact demand. The upstream tie girder experienced about a 160 kip increase in tie tension with the same drop in temperature. It was reported as part of a previous thermal study of the bridge¹ that the Pier A pendulum bearings overcame friction at an estimated load of 250 kips while the Pier C bearings moved at a load of 212 kips. Thus, it was postulated that the pendulum bearing slip load would serve to limit the maximum thermal force that could be realized in the tie girders. However, the data used to develop these slip limits were limited. Moreover, the data shown in Figure 12 do not indicate that slip of the bearings occurred.

Figure 12. Change in load of north (blue) and south (orange) tie girders with changes in temperature (grey).

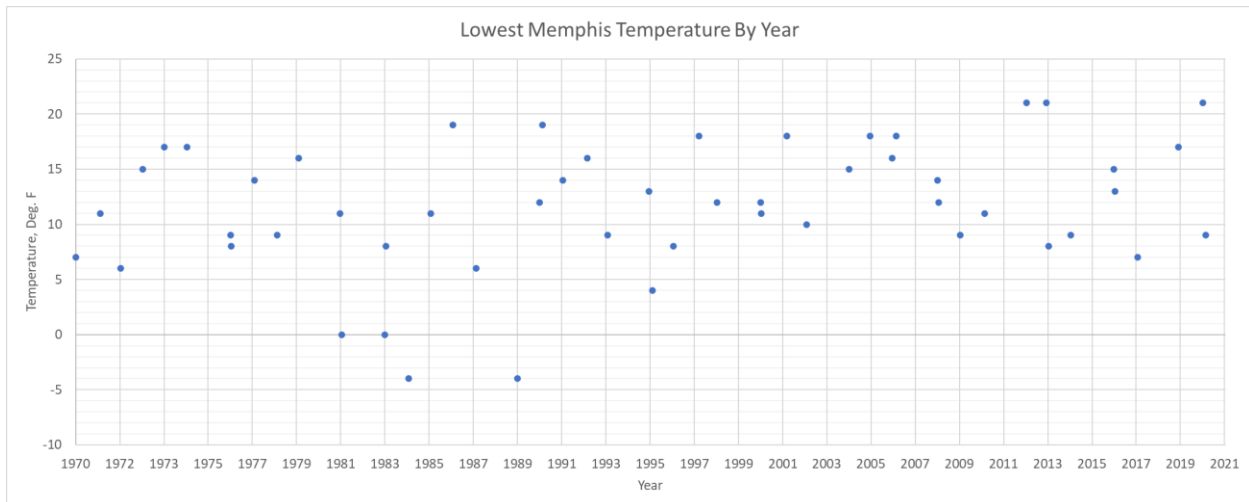
Temperature records for Memphis over the last fifty years were reviewed. Figure 13 provides a list of annual low temperature events over that time period. These data were collected at the Memphis International Airport. Since 2019, the lowest temperature has been 9 deg. F on February 15, 2021. Since the bridge was constructed there have been twenty minimum low temperatures of 10 deg. F or below with the coldest temperatures of -4 deg. F recorded in 1985 and 1989.

Figure 13. Annual lowest temperatures in Memphis.

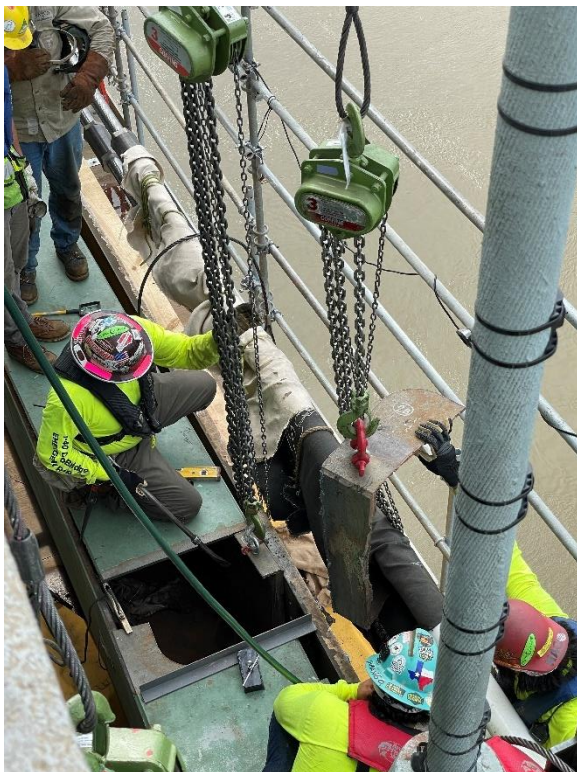
Following the installation of a jacking system to temporarily support a portion of the north tie girder load, the fractured portions of the top and bottom cover plates and outboard (north) side plate were removed from the bridge by Kiewit Infrastructure South Co. and transported to WJE's Northbrook, Illinois laboratory for examination and evaluation. A combination of plasma and oxygen-acetylene torch cutting were used to remove the pieces of plate from the bridge (Figure 14).

Figure 14. Removal of fractured pieces from tie.

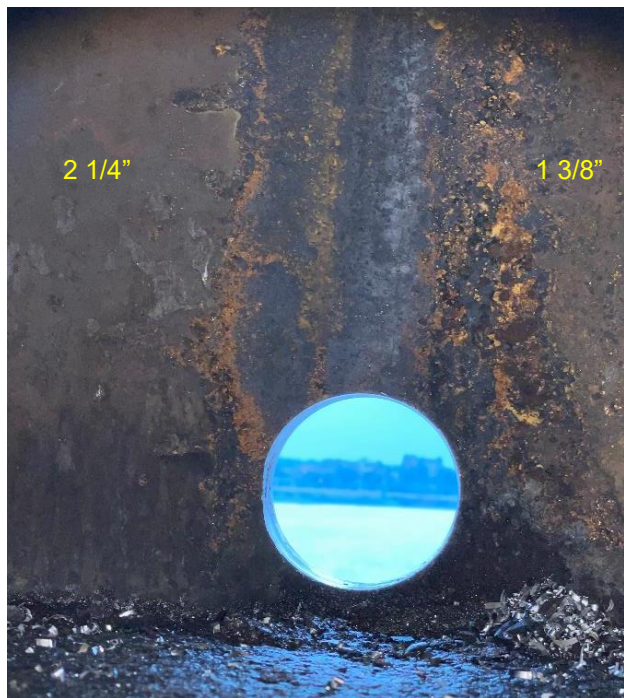
In addition to the fractured plates, ten 3-inch diameter core samples were removed by WJE at locations identified by PAUT has having possible defects. A core sample extracted from the weld at SA168W is shown in Figure 15. The ten core locations are shown in Figure 16.

Figure 15. View from inside tie showing core sample removed from groove weld.

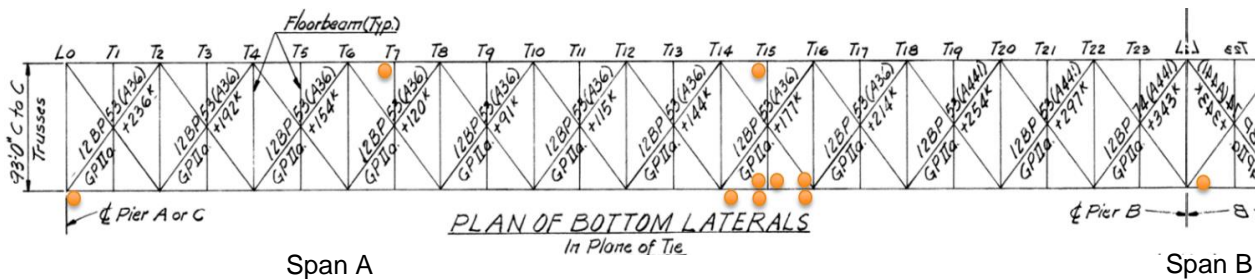
Figure 16. Locations in Span A of core samples removed from other tie girder groove welds with defect indications.

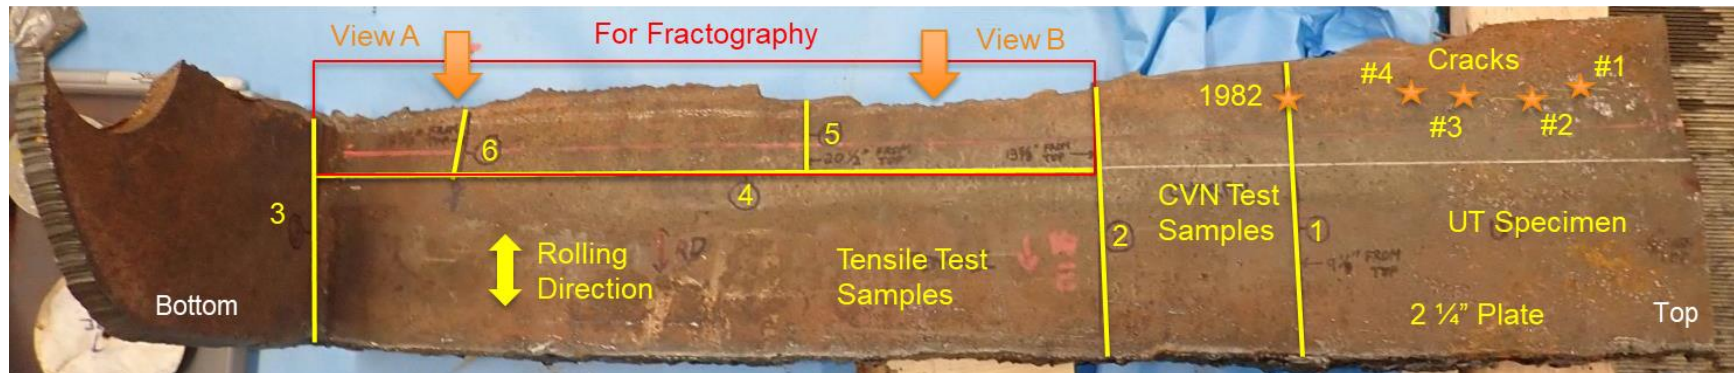
Figure 18. Overall photograph of the east fracture surface depicting the samples used for mechanical testing and metallographic analysis prior to sectioning.

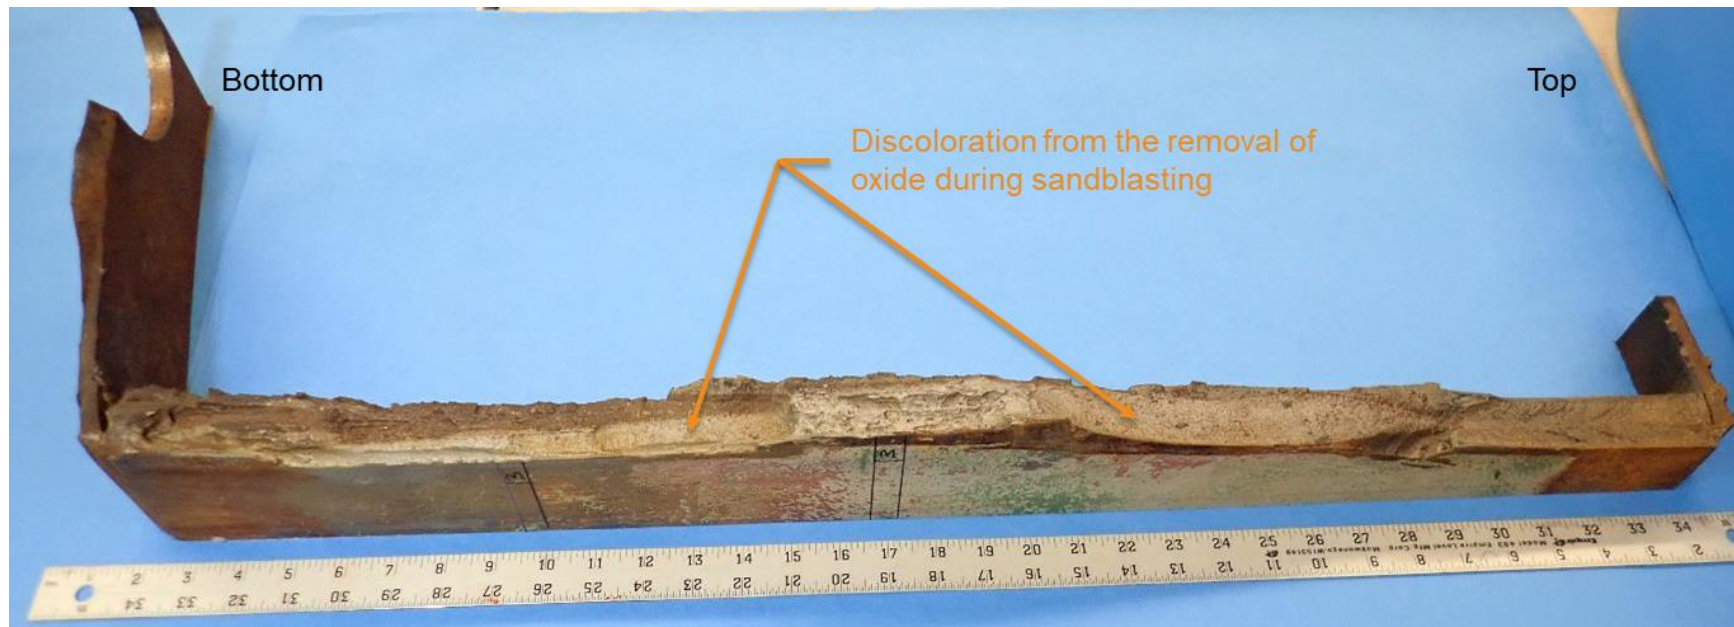
Figure 19. West fracture surface (left piece shown in Figure 17).

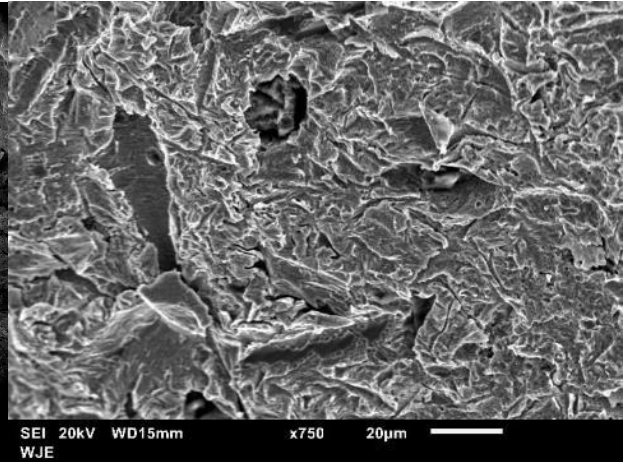
Figure 25. More highly magnified (750X) SEM image obtained from region inside box shown in Figure 24.

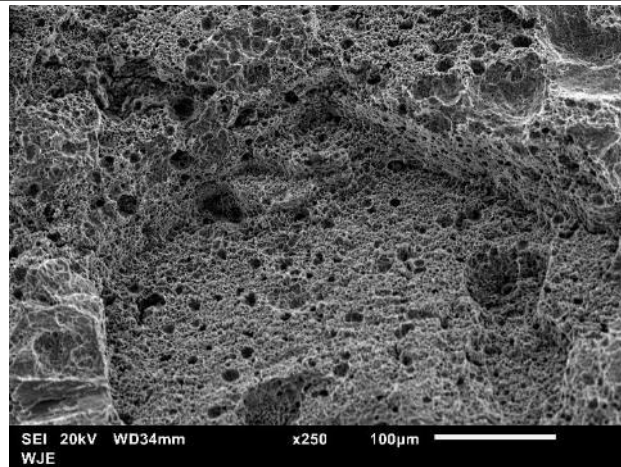
Figure 27. More highly magnified (250X) SEM image obtained from region inside box shown in Figure 26.

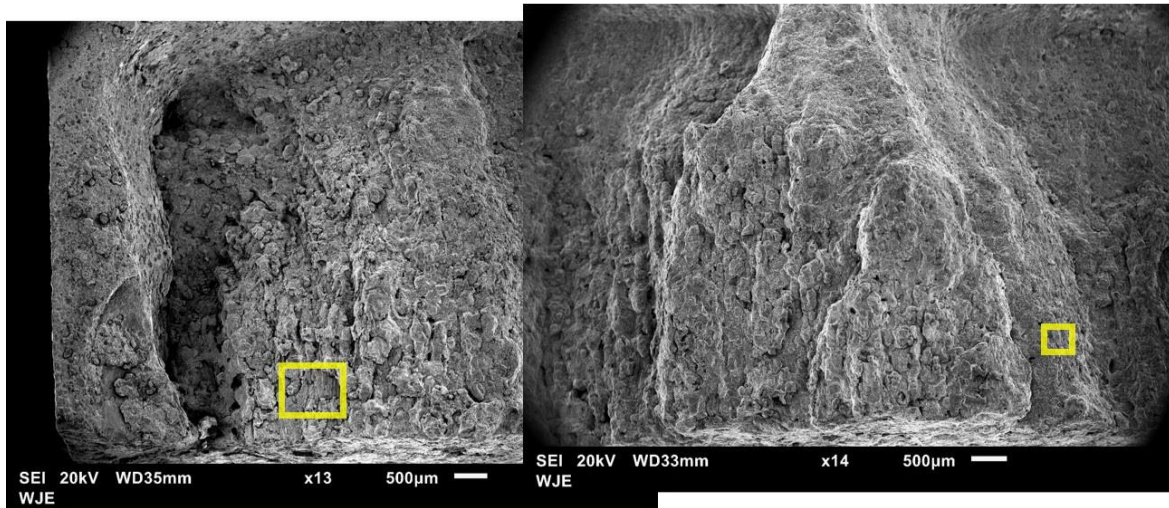
Figure 28. Low-magnification (13X and 14X) SEM images of primary preexisting crack. Internal surface of side plate is visible along bottom.

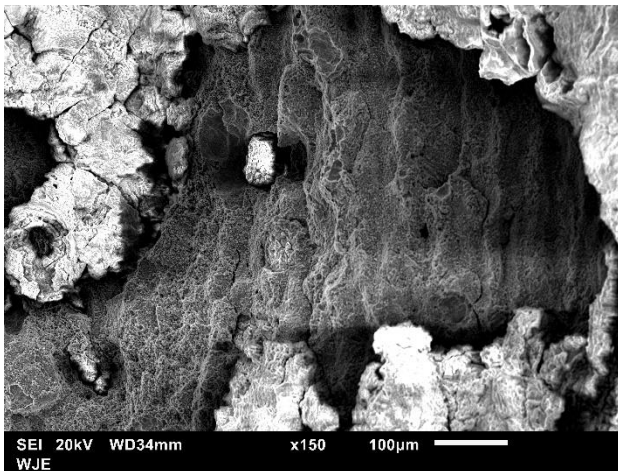
Figure 29. More highly magnified (150X) SEM image obtained left box within Figure 28

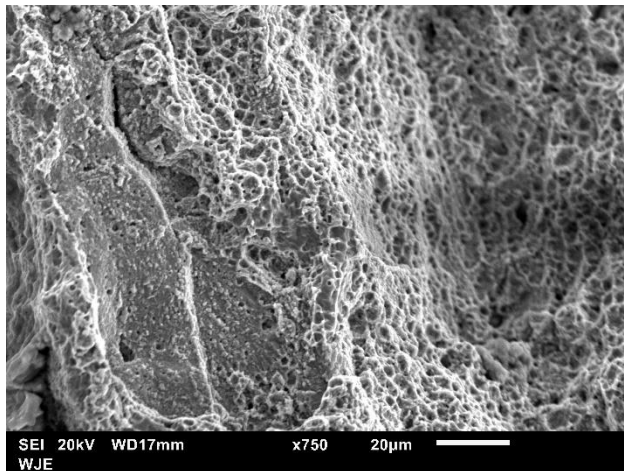
Figure 30. More highly magnified (750X) SEM image obtained from right box within Figure 28.

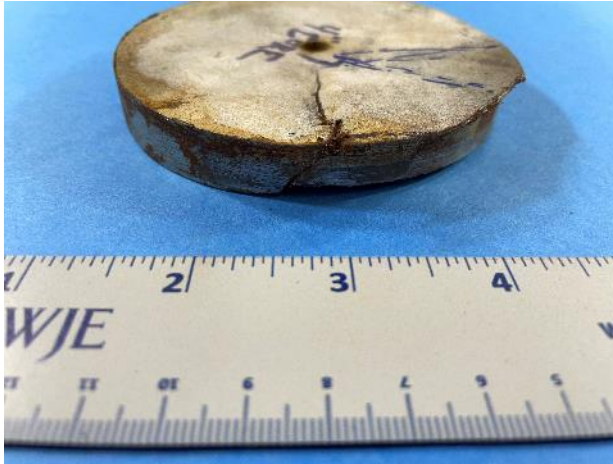
Figure 31. Core in the bottom flange plate at the arrested crack tip.

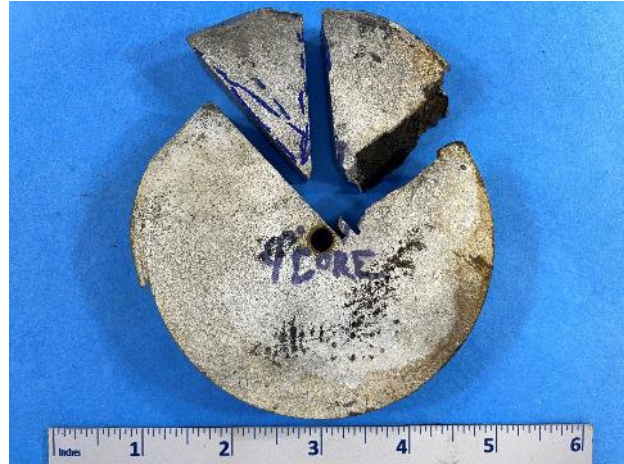
Figure 32. Sectioned core from the arrested crack tip.

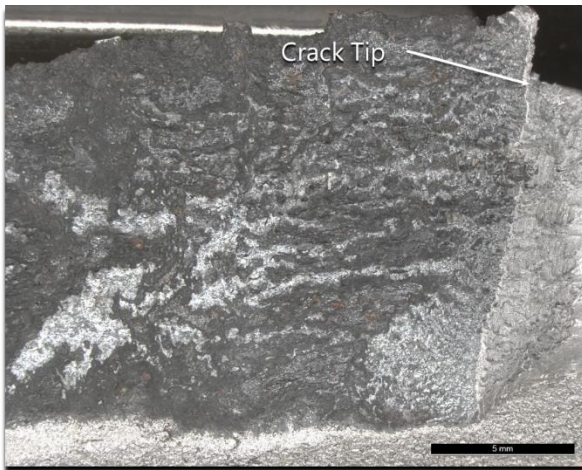
Figure 33. Arrested crack tip fracture surface.

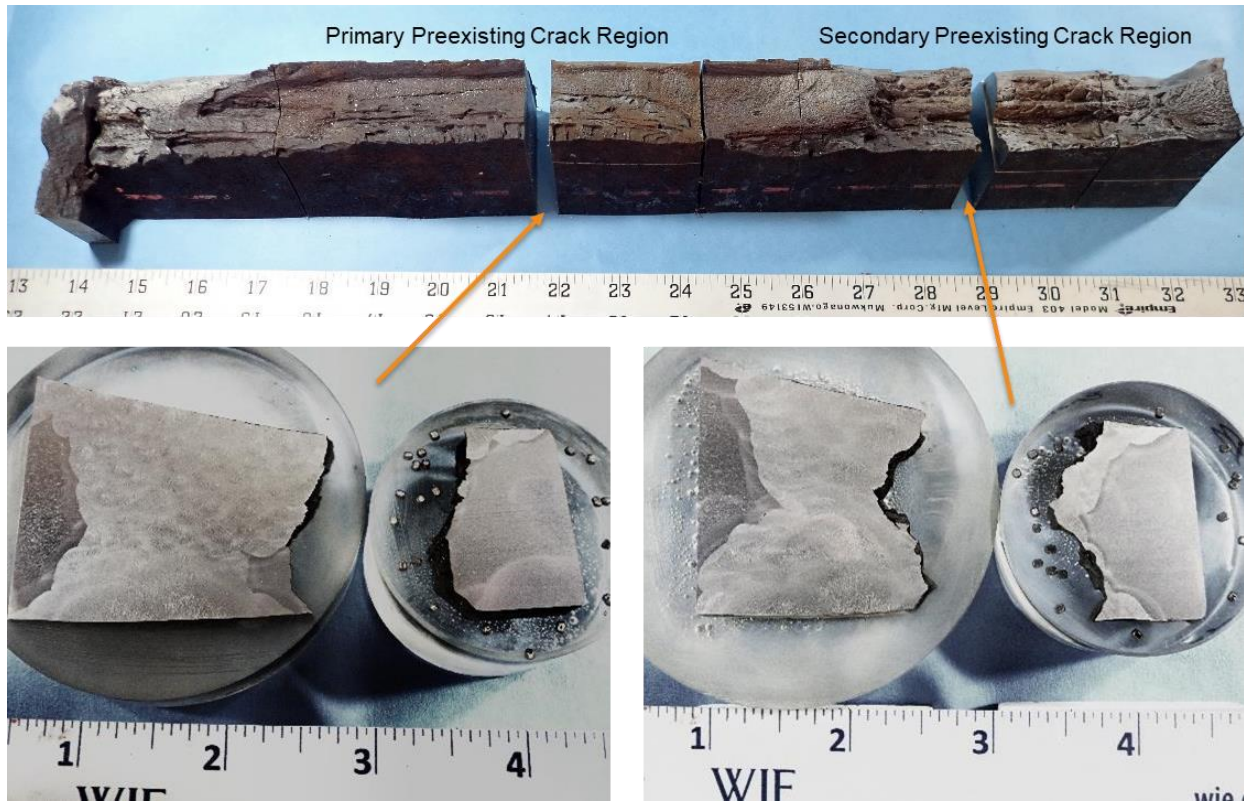
Four large-format cold mount samples were removed from the mating surfaces of the fracture at locations indicated by the orange arrows shown in Figure 35. A low magnification montage was assembled as Figure 36 to examine the full cross-section of the primary preexisting crack. The 2 1/4-inch plate is on the left side of the weld and the 1 3/8-inch plate is on the right. The crack was observed to pass through the weld metal, heat affected zones (HAZ), and base metal. Figure 37 displays a montage of the two mating surface samples prepared at the secondary (upper) preexisting crack region of the weld. In this section, most of the crack growth progressed through weld metal.

Figure 35. Overall primary and secondary preexisting crack regions along the fracture surface and associated mating fracture surface prepared for metallographic examination.

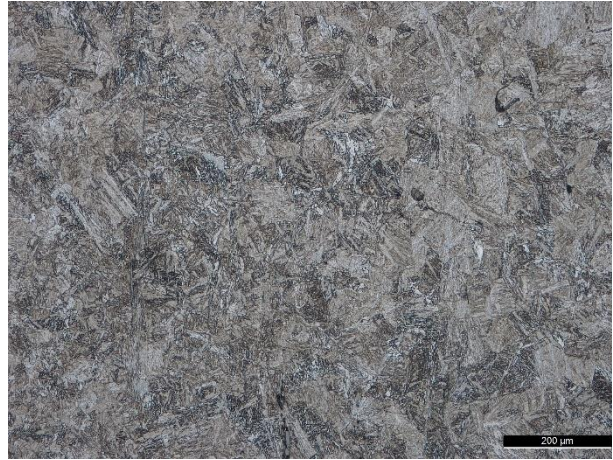
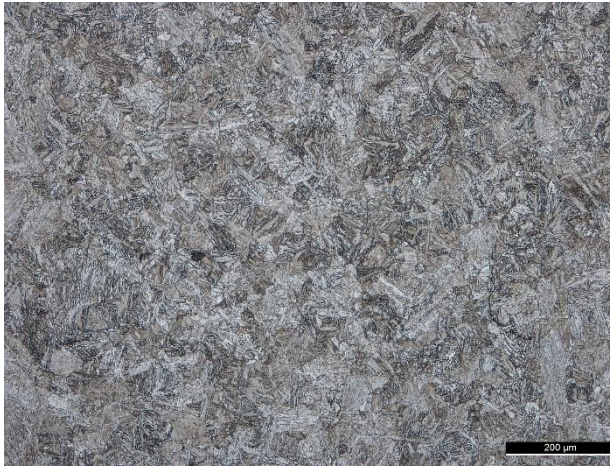
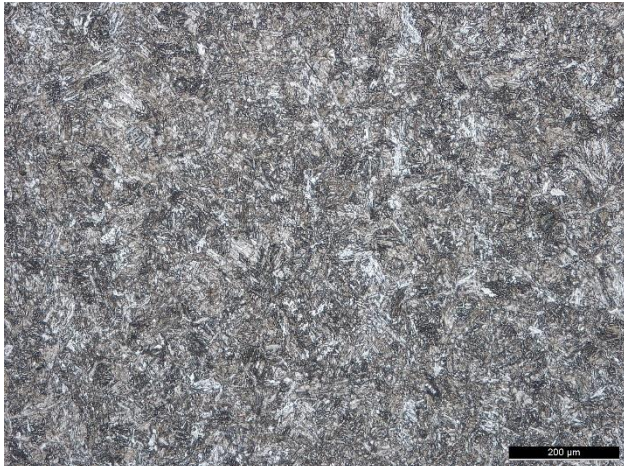
Coarse grains were observed in the base metal of the 2 1/4-inch plate adjacent to the weld fracture. ASTM-A517-69a requires a grain size of 5 or finer for this material. Figure 38a highlights an area in the 2 1/4-inch base metal viewed at a magnification of 100X with a grain size comparator overlayed. The austenite grains are coarser than an ASTM grain size of 1. Using the core samples removed from other welds in the bridge as comparators, samples of the 2 1/4-inch plate were examined and found to have average grain sizes much finer and meeting the ASTM specifications. Micrographs of three core samples are shown in Figure 38b-d.

b. Core Sample SA008E.

c. Core Sample SA148E.

d. Core Sample SB246E.

Figure 38. Comparison of grain sizes for 2 1/4-inch plate – 100X magnification.

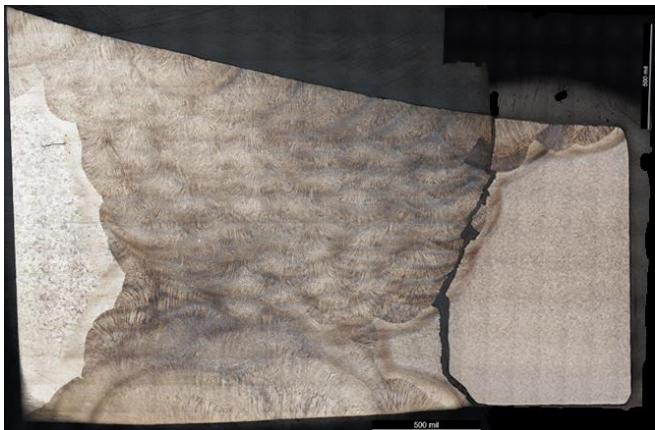
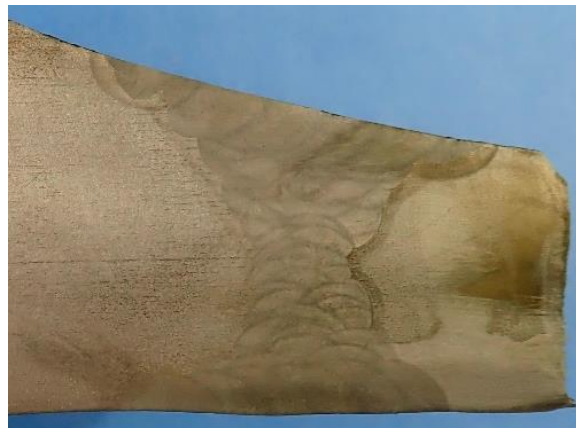
When the two montages of the weld profiles cut from the preexisting crack regions (Figure 36 and Figure 37) were viewed in comparison to the weld region near the top of the fractured side plate or with welds contained in the core samples, the weld profiles from the preexisting crack regions were significantly wider. Figure 39 and Figure 40 show these comparisons. Moreover, the placement of the weld beads differed in that welds shown in Figure 39b and Figure 40a and b indicated the inside bevel weld had been placed first with the two plates laid flat, as shown in the photo, followed by the second bevel weld after the plates were flipped over. In comparison, the welds in the preexisting crack regions showed the inside weld beads having been placed after the outside weld, and the weld bead stacking arrangement appeared to have been misaligned with the root of the weld. This suggested that the two preexisting crack regions were likely weld repairs.

a. Primary Preexisting Crack weld profile.

b. Weld profile near top of fractured side plate.

Figure 39. Comparative weld profiles in fractured side plate.

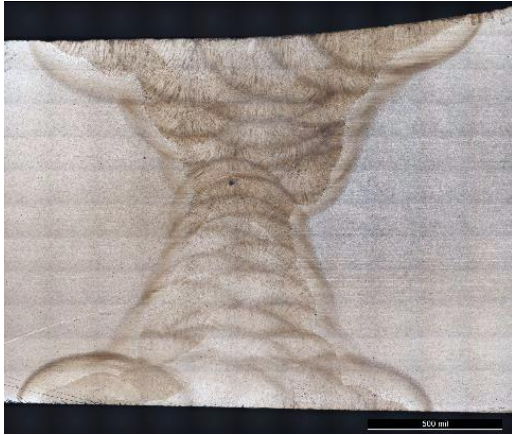
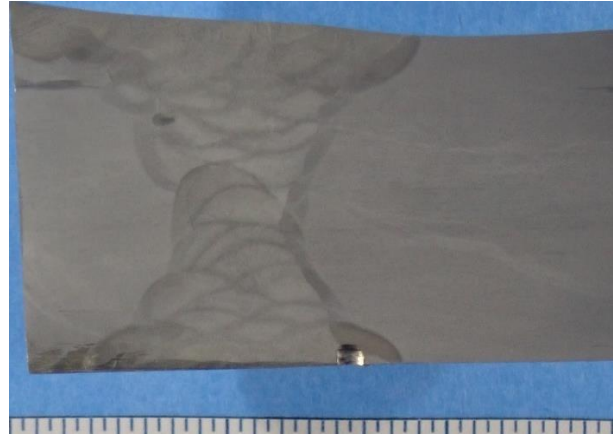
a. Core Sample SA008E weld profile.

b. Core Sample NA154W weld profile.

Figure 40. Comparative weld profiles from representative core samples.

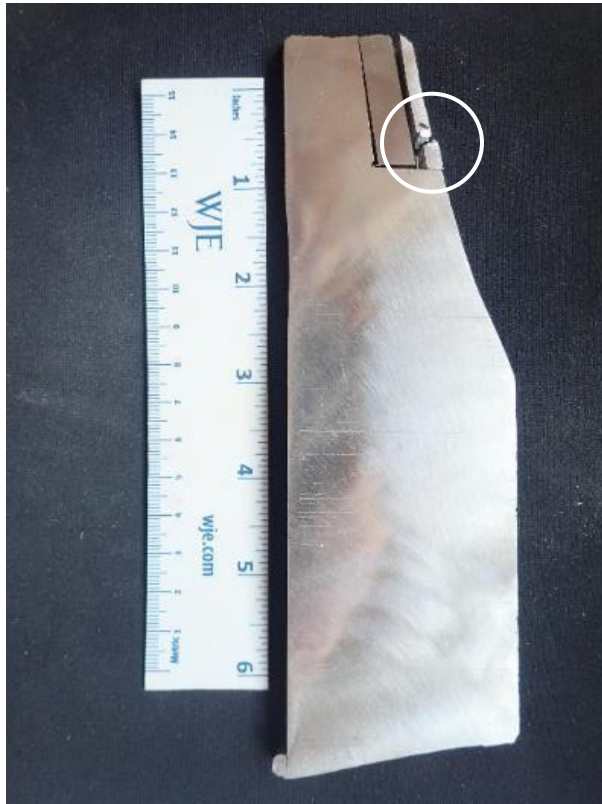
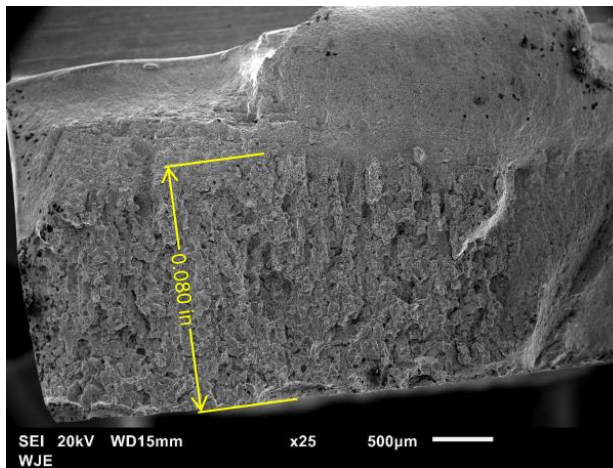
A previously identified flaw in the vicinity of the fracture is shown in Figure 41a. Optical and SEM fractography were performed to evaluate its characteristics. The crack was opened to view the fracture surface (Figure 41b). Surface oxides were present on the fracture surface, which exhibited a typical thumbnail shape. This fracture was further examined in the SEM at magnifications of 25X (Figure 41c) and 250X (Figure 41d). Figure 41d indicates that the fracture mode of the crack was intergranular.

a. Sample cut from fracture piece.

c. SEM micrograph of crack at 25X magnification.
Figure 41. 1982 previously identified crack near fracture.

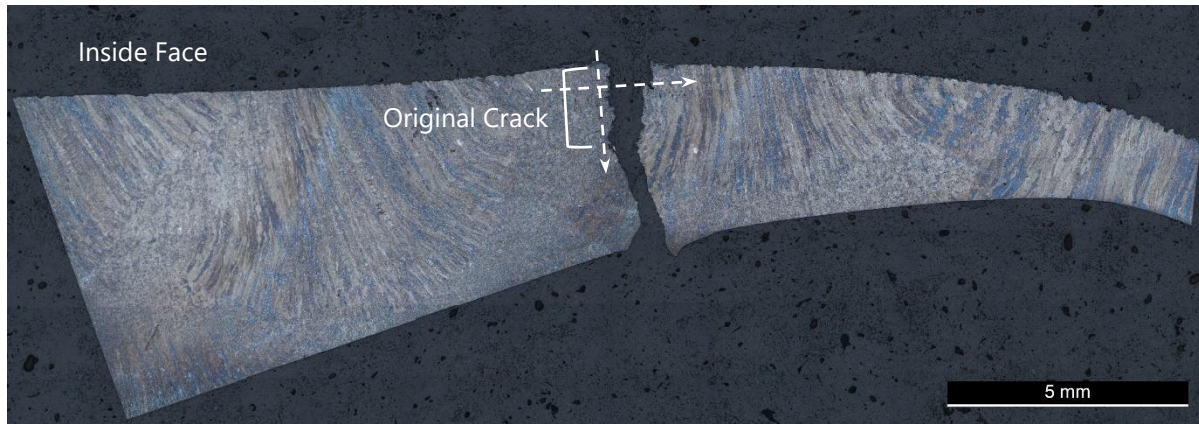
In addition to the 1982 detected flaw, another indication was identified using PAUT by WJE and exposed for metallography. This defect was identified as Indication #4. A montage of this sample is shown in Figure 42. The crack initiated in the weld metal on the bottom surface (relative to the micrograph) and progressed halfway through the sample. Figure 43 provides a closer perspective of the crack tip at 50X magnification. The cracking was predominantly intergranular with limited transgranular cracking. The microstructure of the weld metal is presented at 500X magnification in Figure 44. It is predominantly martensite.

Microhardness readings were taken at Indication #4. Both a vertical and horizontal hardness traverse were performed near the crack. The results are presented in Figure 42. The results exhibited consistent hardness measurements between 360 HV and 385 HV (36.9 HRC to 39.5 HRC).

Figure 42. Microhardness traverse locations (dashed lines)for defect Indication #4.

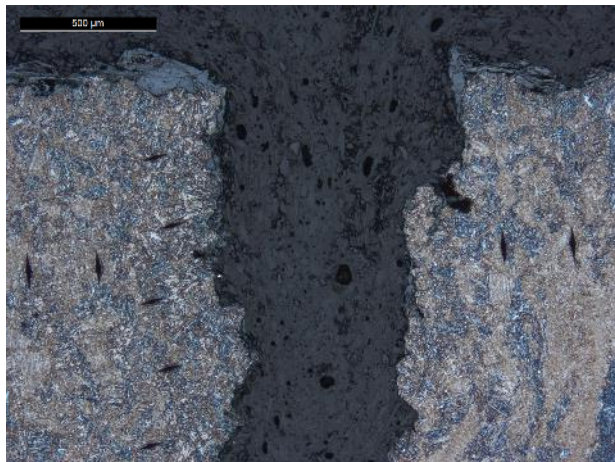
Figure 43. Micrograph at Indication #4 – 50X magnification.

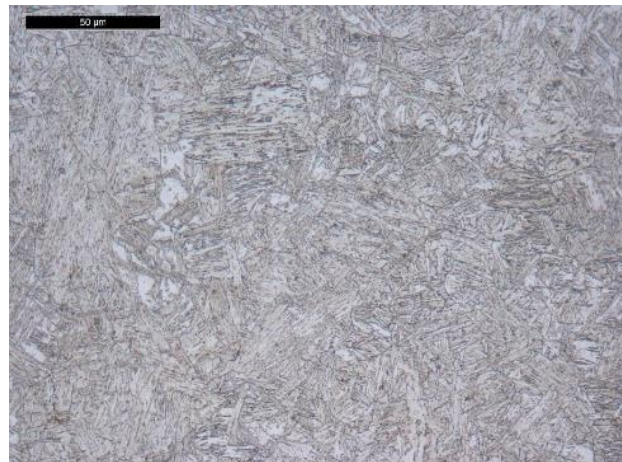
Figure 44. Micrograph at Indication #4 – 500X magnification.

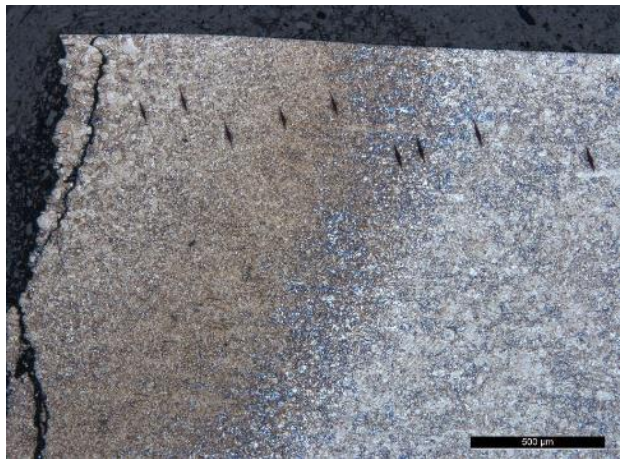
Figure 46 and Figure 47 were captured at 50X magnification near the toe of the weld. The crack exhibited an intergranular path through the GCHAZ and GRHAZ, but had not propagated beyond the ICHAZ. The base metal fracture visible in Figure 45 was caused intentionally in order to separate the crack faces for examination.

Figure 47. Core Sample SA158W on the base metal side of the crack – 50X magnification.

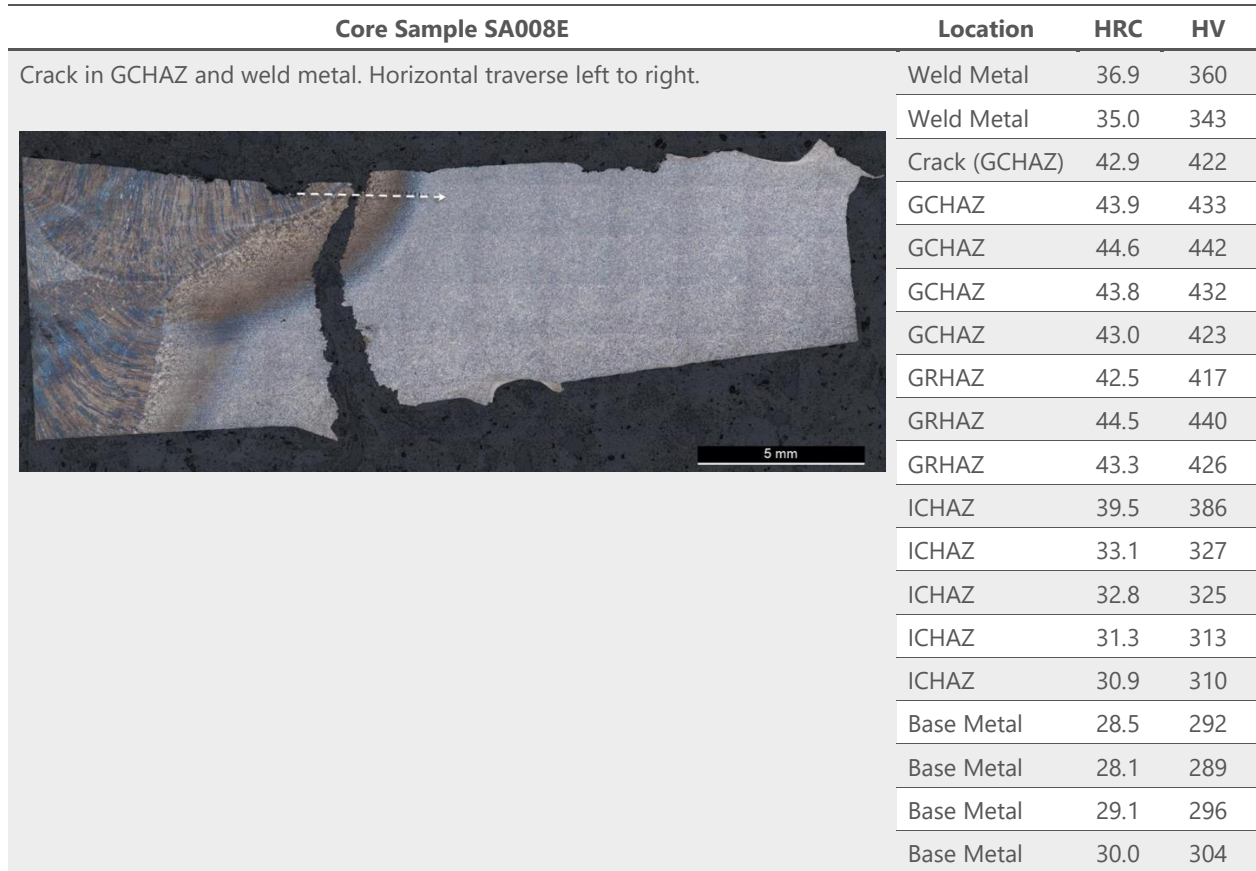
The intergranular path of the crack in Core Sample SA008E is clearly visible in Figure 49 and Figure 50. As in SA158W, it progressed through the GCHAZ and GRHAZ before arresting at the ICHAZ. The base metal fracture visible in Figure 48 was caused intentionally in order to separate the crack faces for examination. At 500X magnification, it was clear that the martensite in the GCHAZ had experienced significantly less tempering (Figure 51) than the base metal (Figure 52).

Figure 48. Microhardness traverse for Core Sample SA008E.

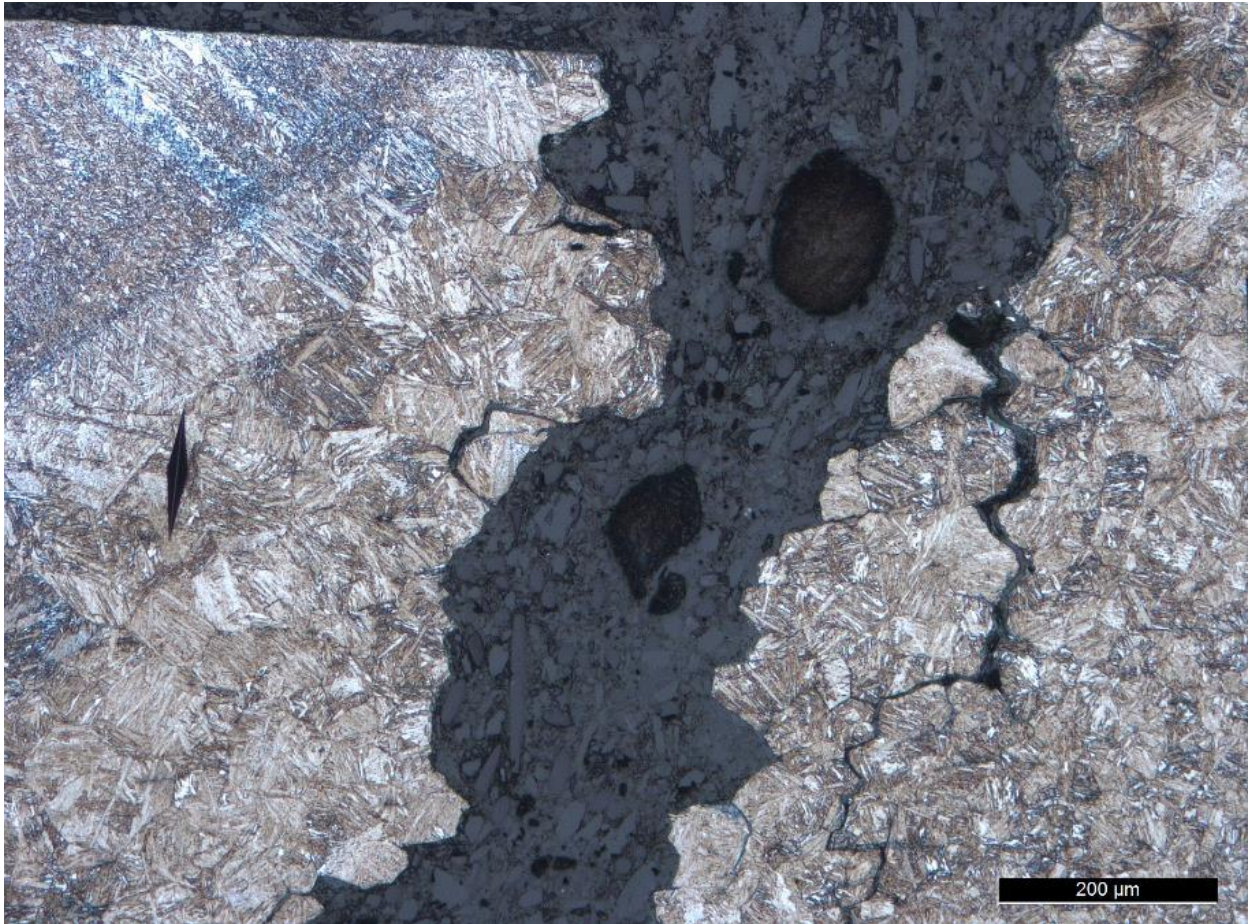
Figure 50. Core Sample SA008E at weld toe. A Knoop hardness indent is shown adjacent to the crack – 100X magnification.

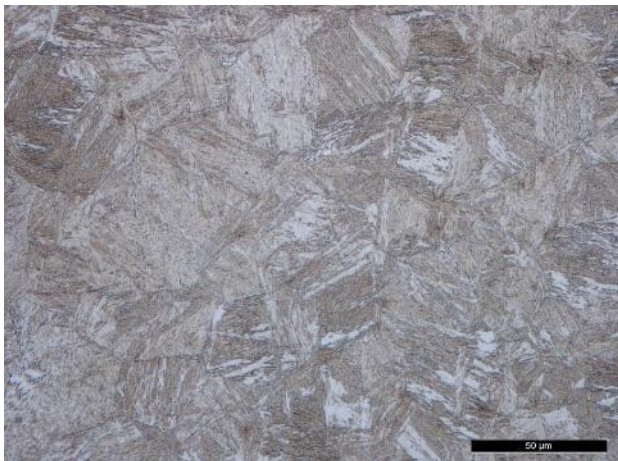
Figure 51. Core Sample SA008E GHAZ – 500X magnification.

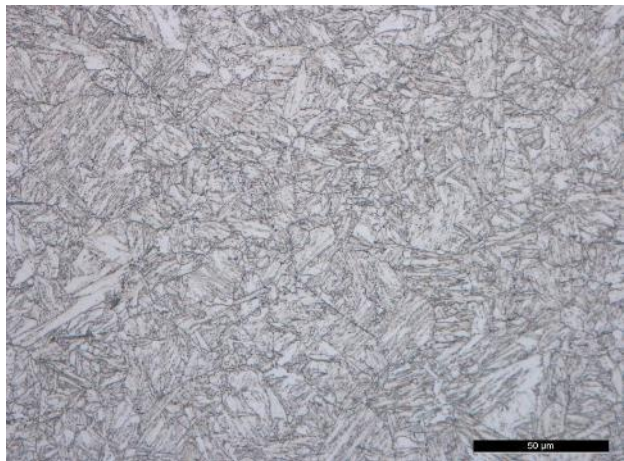
Figure 52. Core Sample SA008E base metal – 500X magnification.

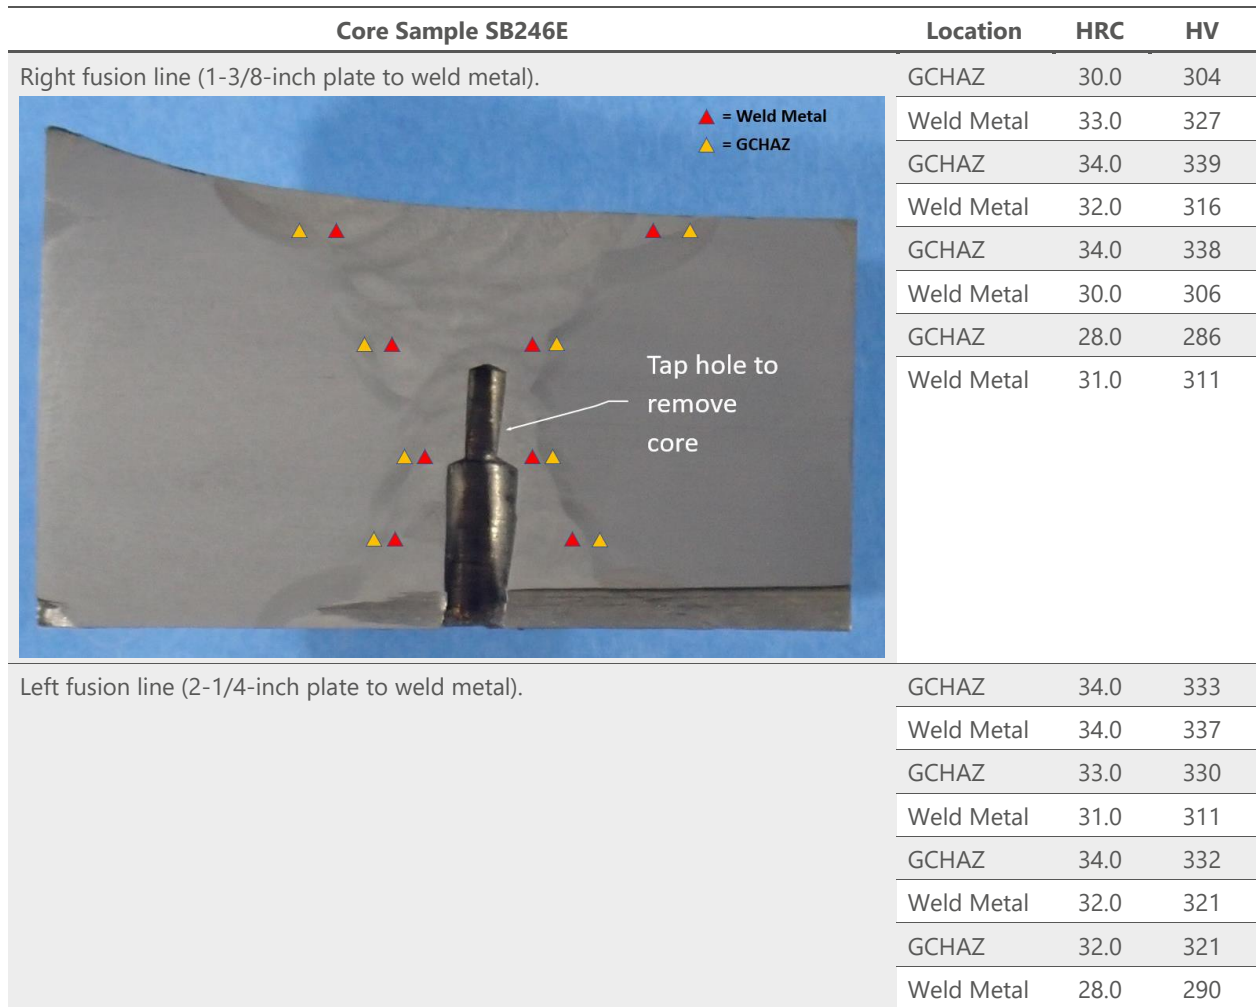
The core sample from weld location SB246E was sectioned across the weld, and Knoop microhardness readings were recorded on each side of the two fusion boundaries; one reading in the weld metal and the other in the GCHAZ. The results are shown in Figure 53.

Figure 53. Microhardness traverse for Core Sample SB246E

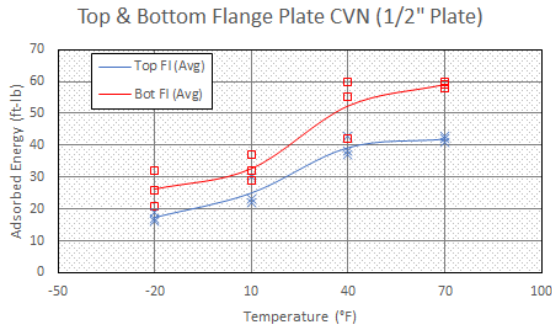
Plate samples were sent for Charpy V-Notch (CVN) impact testing. The tests were conducted in accordance with the ASTM A673-17 *Standard Specification for Sampling Procedure for Impact Testing of Structural Steel*. The test temperatures were set to -20 deg. F, 10 deg. F, 40 deg. F, and 70 deg. F to develop the upper and lower shelf toughness behavior of the material. The results of the base material tests for the cover plates and 1 3/8-inch side plate are shown in Table 5a and b. The initial test results were invalid for the 2 1/4-inch plate, thus additional 2 1/4-inch plate material was sent to another laboratory for testing. Those test results are presented in Table 5c. An upper temperature value of 100 deg. F was used for these tests. The CVN results for the base materials are plotted in Figure 56 through Figure 58. The average for each test was greater than 15 ft-lbs.

Figure 56. CVN test results for the top and bottom cover plate material.

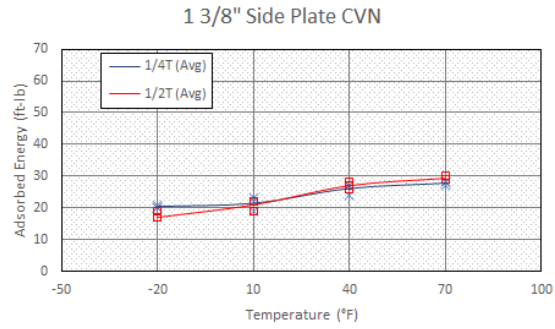
Figure 57. CVN test results for the 1 3/8-inch side plate material.

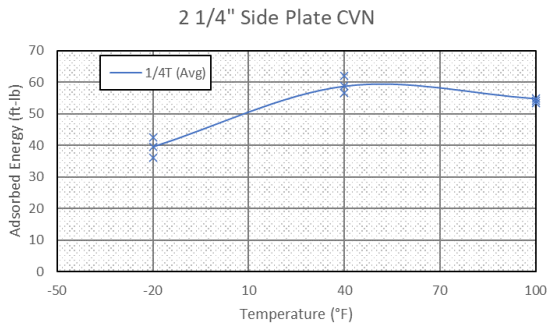
Figure 58. CVN test results for the 2 1/4-inch side plate material.

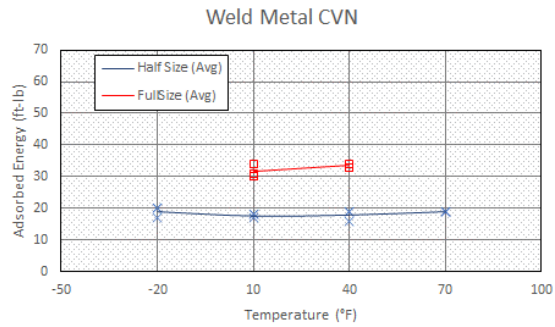
The weld and HAZ CVN samples were obtained from the 2 1/4-inch plate side of the weld. There was insufficient material available to obtain CVNs from the 1 3/8-inch side of the weld. To maximize the number of tests from the available weld and HAZ materials, a combination of full-size and half-size CVNs were machined. The half-size CVN test results have not been adjusted to represent full-size specimens. Results for the weld and HAZ CVN tests are presented in Table 5d and e. Figure 59 and Figure 60 are plots of these results. The variability in the test results for the HAZ specimens shown in Figure 60 suggests notch placement inconsistencies within the HAZ.

Figure 59. CVN test results for the weld metal material.
