I-40 Hernando deSoto Bridge

Fracture Investigation

Memphis, Tennessee

FINAL REPORT

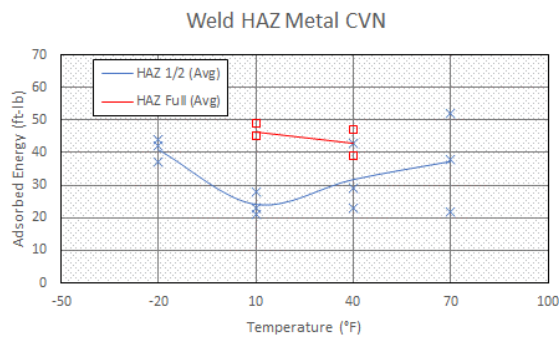
The weld and HAZ CVN samples were obtained from the 2 1/4-inch plate side of the weld. There was insufficient material available to obtain CVNs from the 1 3/8-inch side of the weld. To maximize the number of tests from the available weld and HAZ materials, a combination of full-size and half-size CVNs were machined. The half-size CVN test results have not been adjusted to represent full-size specimens. Results for the weld and HAZ CVN tests are presented in Table 5d and e. Figure 59 and Figure 60 are plots of these results. The variability in the test results for the HAZ specimens shown in Figure 60 suggests notch placement inconsistencies within the HAZ.

Figure 60. CVN test results for the material in the weld HAZ.

CVN results obtained from what had been intended to be HAZ material suggested a fracture toughness of 80.3 ksi $\sqrt{\text{in.}}$ with a temperature shift of 50 deg. F when a 110 ksi yield strength is used. However, the microhardness values suggest the HAZ had a much higher yield strength, and therefore, the above fracture toughness equations may not be applicable. Furthermore, examination of CVN specimen fracture surfaces indicated that only 20 to 30 percent of the notch length had been interacting with HAZ material. Therefore, the CVN values plotted in Figure 60 are not indicative of the predicted fracture toughness and for reasons given earlier are of minimal significance to the subsequent in-service fracture events demonstrated at the subject joint. However, it is possible that further in-depth study of the HAZ at representative in-service welded joints on this bridge could provide additional information with regard to fracture susceptibility.
