**PATHOLOGIES IN OLD BUILDINGS OF THE HISTORIC  
CITY CENTER OF VILA REAL**

Andreia Queirós<sup>1,a</sup>, Anabela Paiva<sup>2,b</sup> and Jorge Pinto<sup>3,c</sup>

**Abstract**

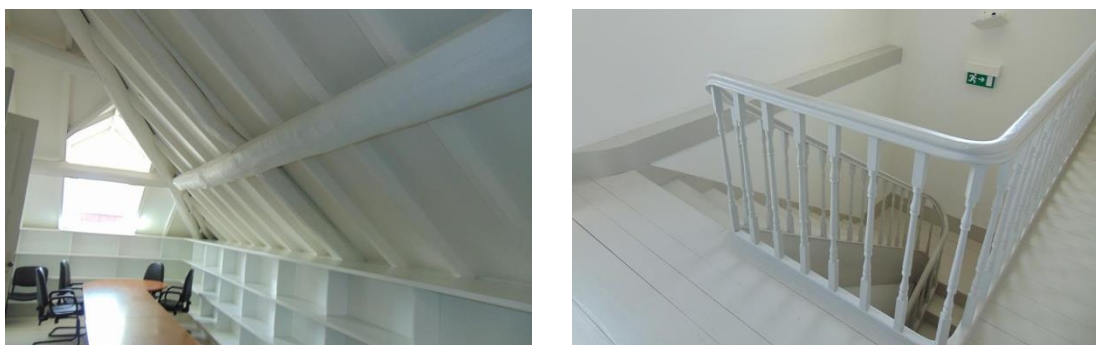
Figure 15 - Rehabilitated building

Although, the buildings pathologies identified, none of the buildings are in ruin or pre-ruin. This leads to the conclusion that the construction solutions used have great potential for rehabilitation. So, instead of replacing wood floors and ceilings with reinforced concrete lightened slabs with prestressed beams or the earth and lime based plaster of *tabique* walls with cement and lime based plaster or plasterboard or the windows wooden frames with aluminum or PVC frames, the ancient construction solutions could be preserved. Some of the buildings already rehabilitated are shown in Figure 15 and 16. The old wooden floors, ceilings, stairs, handrail, baseboard and door were restored. The facade was maintained, as well as windows frames and the balconies guardrails.
