U.S. CHEMICAL SAFETY AND HAZARD INVESTIGATION BOARD

# INVESTIGATION REPORT

## SUGAR DUST EXPLOSION AND FIRE

### IMPERIAL SUGAR COMPANY

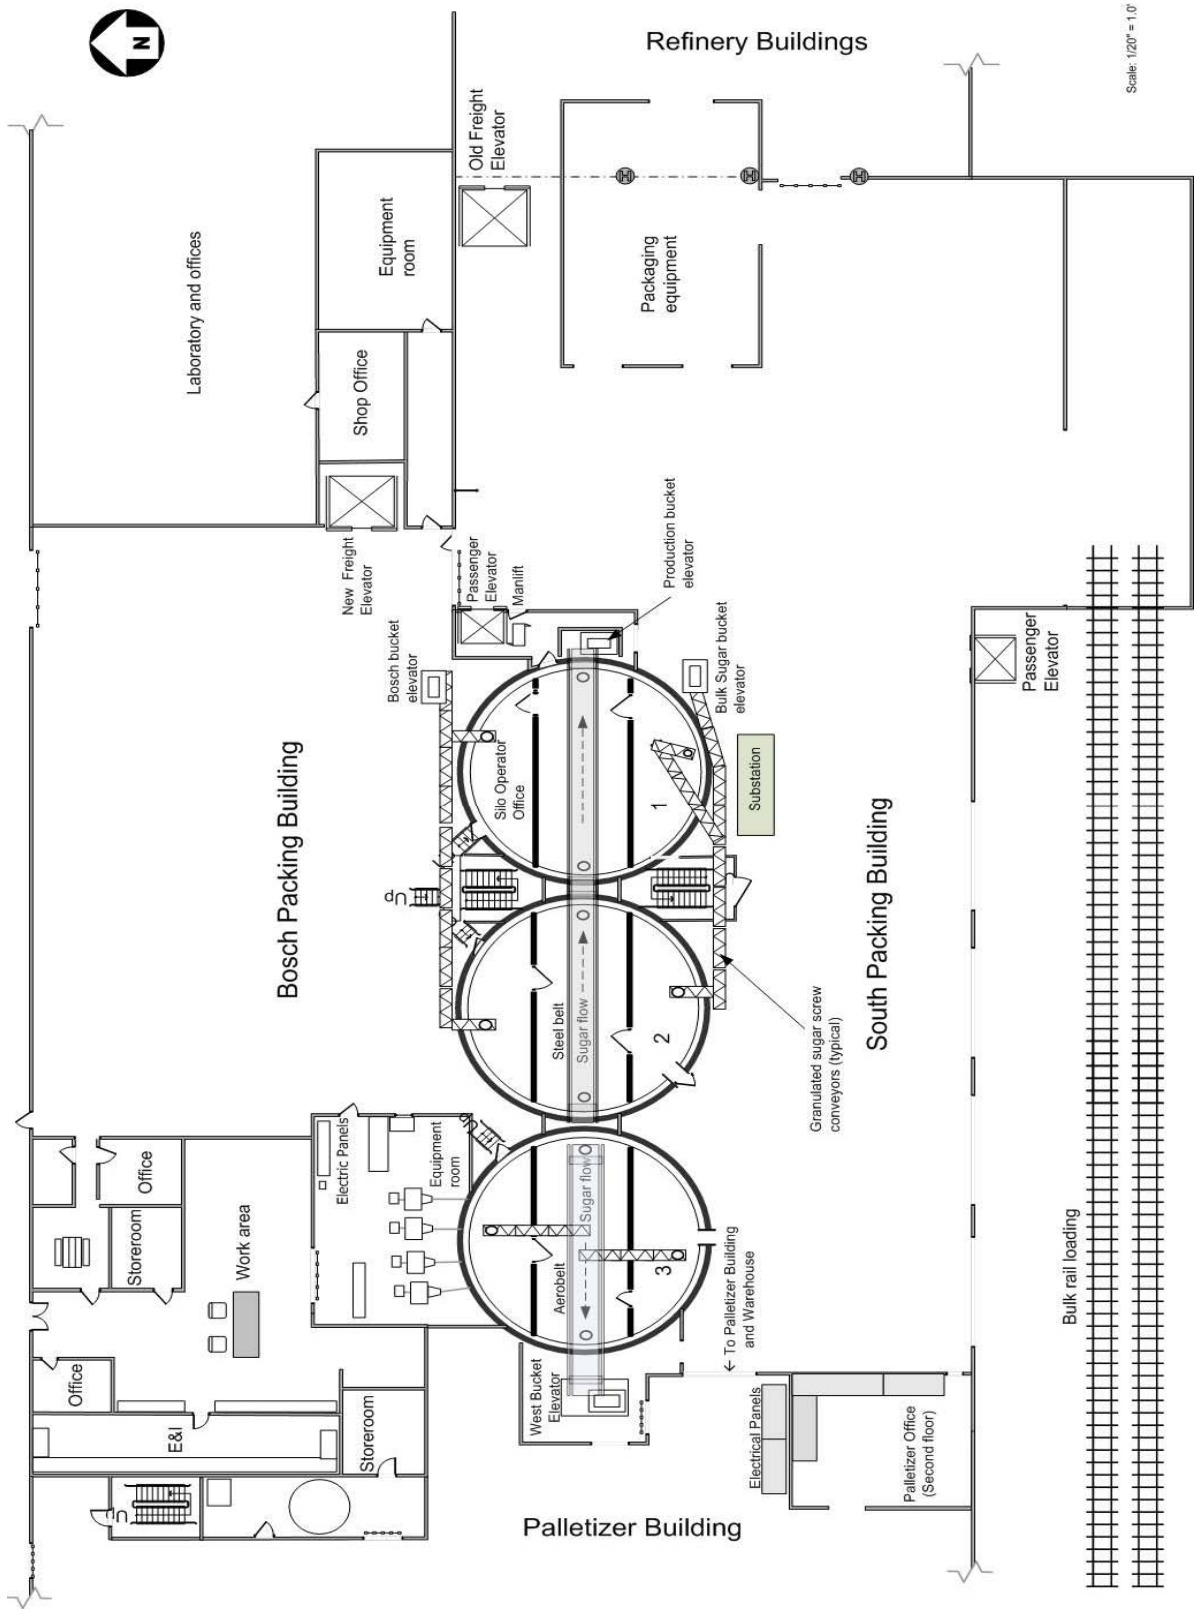
Dozens of screw conveyors,<sup>6</sup> bucket elevators,<sup>7</sup> and horizontal conveyor belts transported granulated sugar throughout the packing buildings (Figure 5). Although bucket elevators were enclosed and screw conveyors were covered, they were not adequately sealed to prevent releasing sugar dust and sugar into the work areas. Because the large open work areas were not equipped with airborne dust removal equipment, sugar dust accumulated on overhead conduit, piping, ceiling beams, lights, and equipment. The closed granulated sugar screw conveyors located throughout the facility were not

Figure 5. Packing buildings first floor plan

<sup>23</sup> Although the enclosure on the belt conveyors in the penthouse could have been designed to safely vent an explosive overpressure outside the building, designing a deflagration vent system for the belt conveyor in the silo tunnel was impractical. That conveyor was located on the ground floor in the center of the building (Figure 5) far from any building exterior wall or roof.

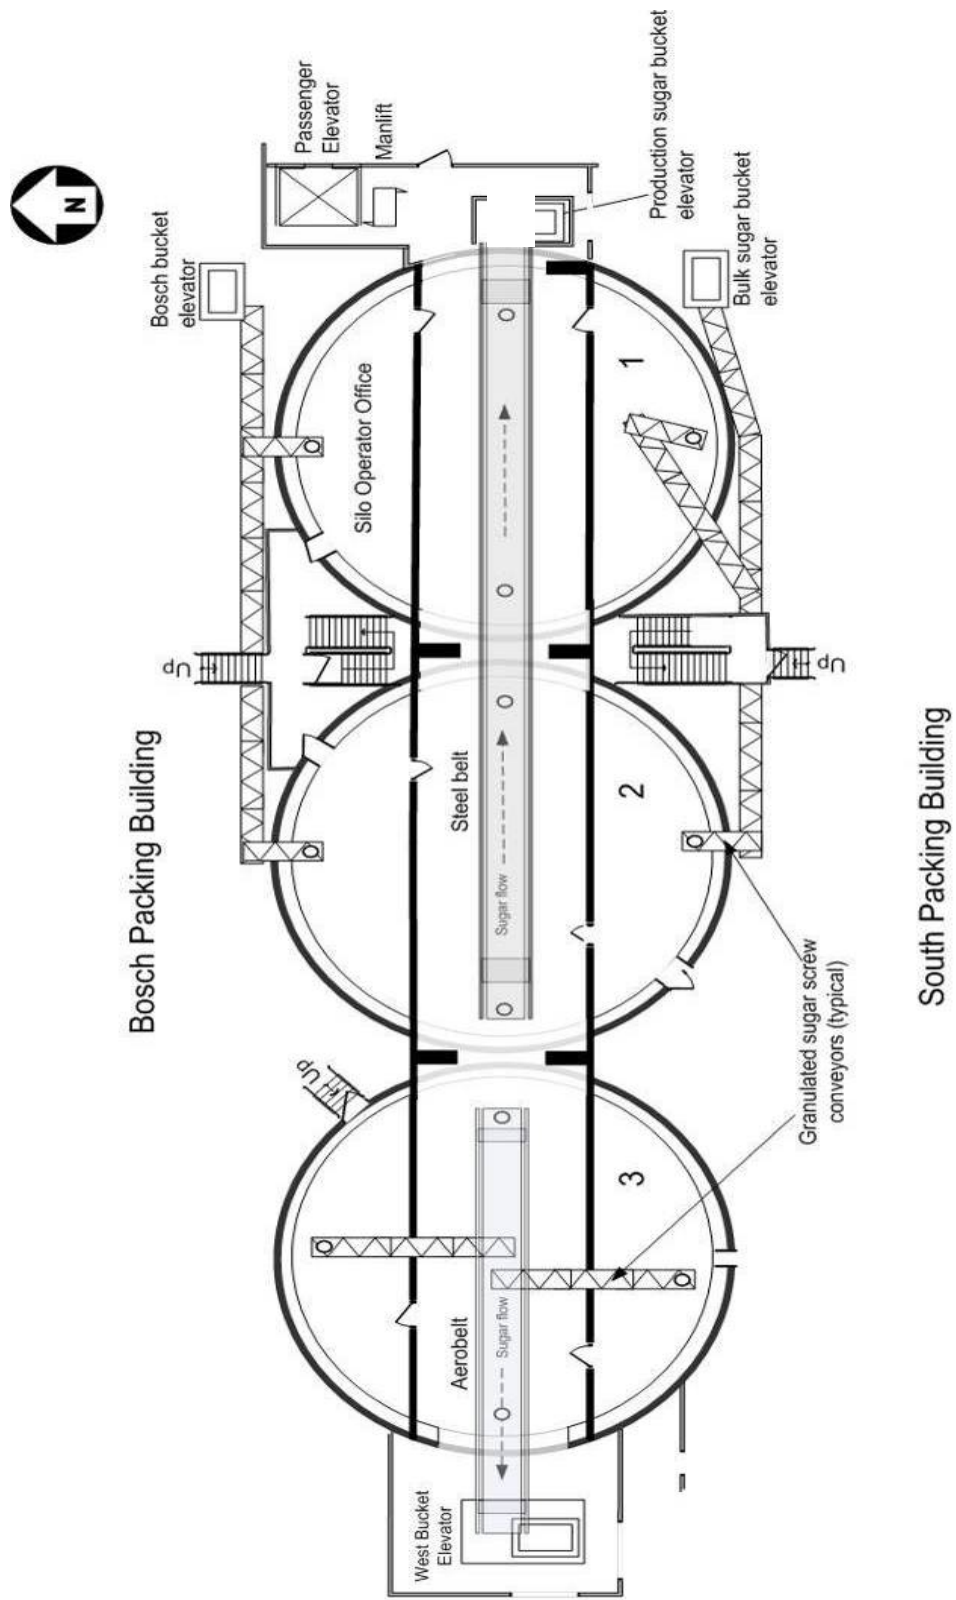
Figure 6. Silo tunnel and conveyor plan

above the silo tunnel (pantleg rooms, see Figure 7) and concluded that the primary dust explosion most likely occurred in the silo tunnel, approximately midway along the length of the steel belt.

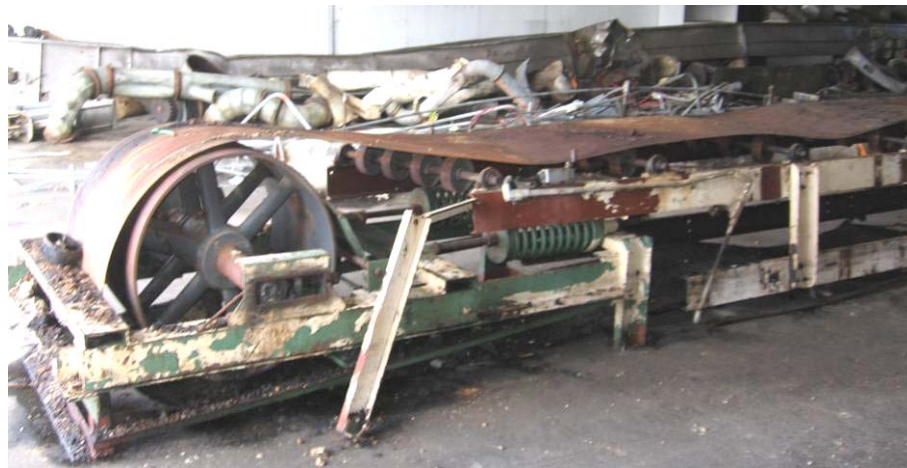
A 32-inch wide, 80-foot long steel conveyor belt (Figure 9) in the silo tunnel transported granulated sugar from silos 1 and 2 into the packaging production bucket elevator pit at the east side of silo 1. Similar steel belt conveyors were located in the penthouse above the silos.

Figure 9. Silo tunnel steel conveyor belt (removed after incident)

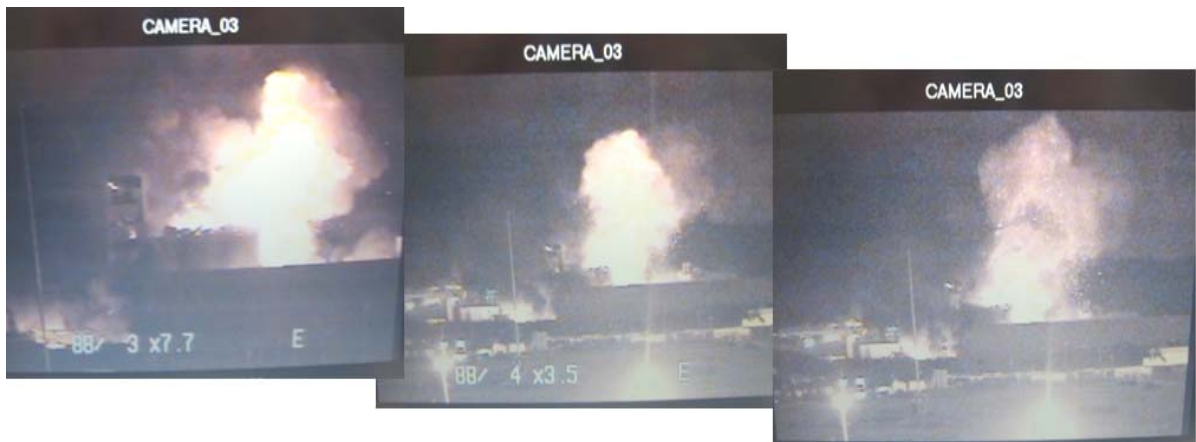
Intense fireballs advanced through the entire north and south packing and palletizer buildings as sugar dust, shaken loose from overhead surfaces, ignited. Heaving and buckling floors opened large crevasses. The piles of granulated and powdered sugar that had accumulated around equipment rained down and intensified the fires burning below. Fireballs advanced through enclosed screw conveyors and ignited fires in the refinery and bulk sugar building hundreds of feet from the packing buildings where the incident had begun. Violent fireballs erupted from the facility for more than 15 minutes as spilled sugar and accumulated sugar dust continued fueling the fires (Figure 11).

Figure 11. Large fireball and burning debris erupt from the packing buildings 15 minutes after first explosion (elapsed time - 10 seconds) (PCS Phosphate security video).
