Aviation Short Investigations Bulletin

Issue 41

ATSB Transport Safety Report
Aviation Short Investigations
AB-2015-043
Final – 10 June 2015

Main landing gear wheel failure involving a Boeing 737, ZK-ZQB

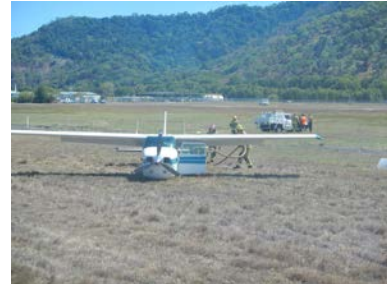
VH-JGA

The pilot of JGA conducted two practice approaches to assess the aircraft configuration and landing area before beginning the approach for a wheels-up landing. The pilot extended the flaps to help slow the aircraft and, after turning onto a long final, briefed the passengers for the landing and instructed them to take up the brace position. Just prior to touchdown, the pilot turned off the master switch and moved the engine mixture control to the cut-off position. At about 1416, the aircraft landed on the fuselage underside on the grass area abeam runway 33 and came to a stop. The pilot and four passengers were uninjured and the aircraft was substantially damaged (Figure 1).

Figure 1: Damage to JGA

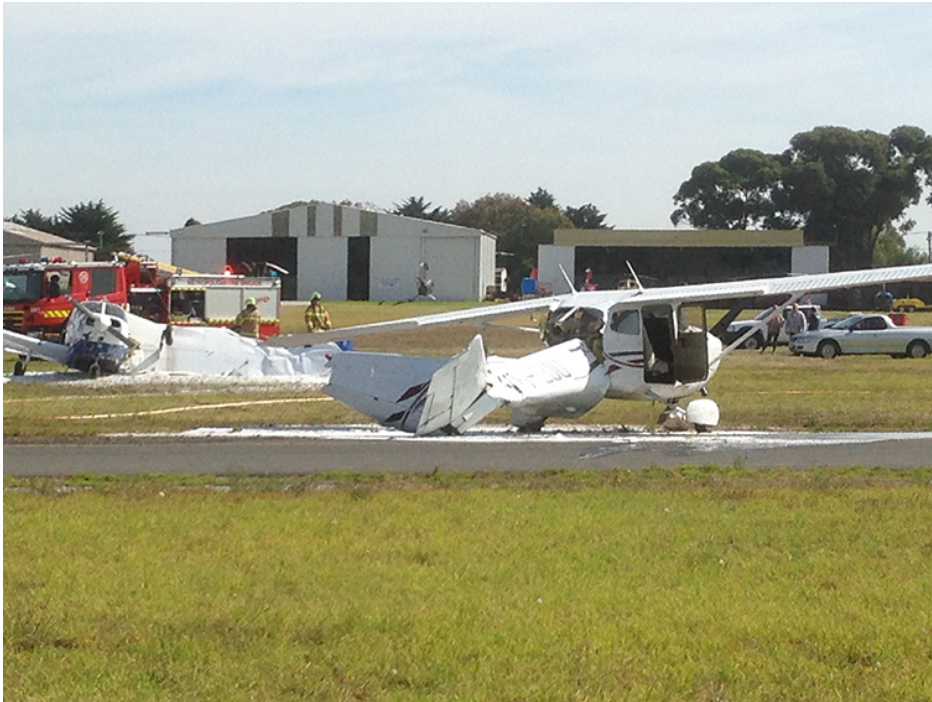
The pilot of EEU assessed that if he stopped there, TXH would collide squarely with EEU, so he released the brakes and progressed forwards. The left wing of TXH then struck the tail of EEU and spun EEU around through about 180°. TXH continued veering to the right for about 20 m further before coming to rest on a grassed area (Figure 2).

Figure 2: Accident site

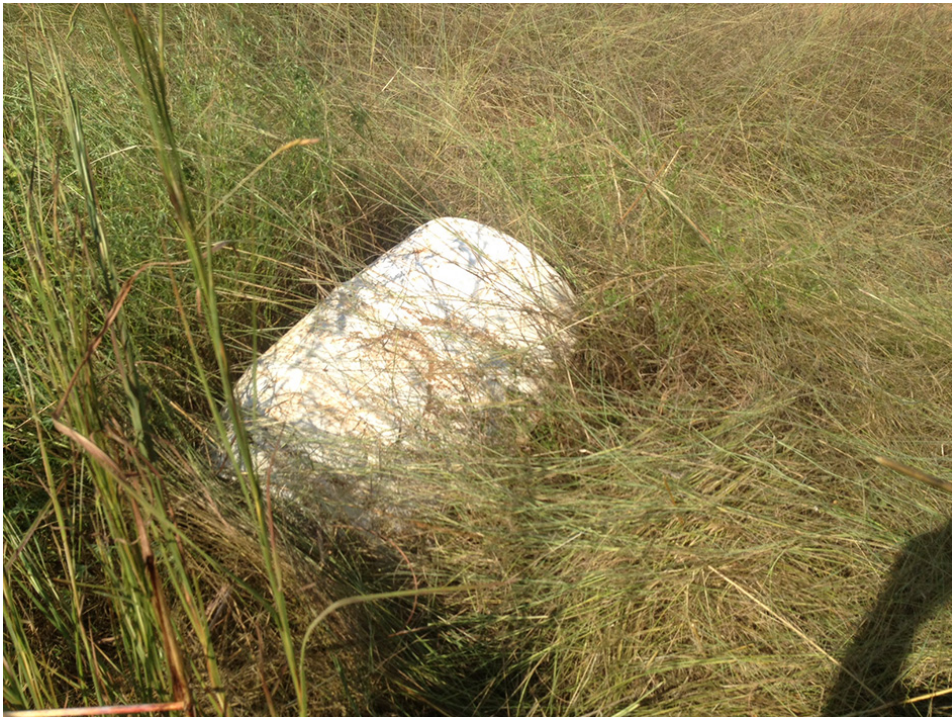
Following the accident, the pilot found that where he had commenced the left turn on the runway, the ground was soft and appeared to have previously held standing water, although the surface was dry at the time. The runway marker was a 44 gallon drum, cut in half longitudinally and laid on the ground and it was obscured by long grass (Figure 3).

Figure 3: Drum runway marker

The pilot stated that when facing similar circumstances, he would select a landing path that did not require any planned directional changes during the landing roll, until the aircraft has decelerated to a safe taxi speed.

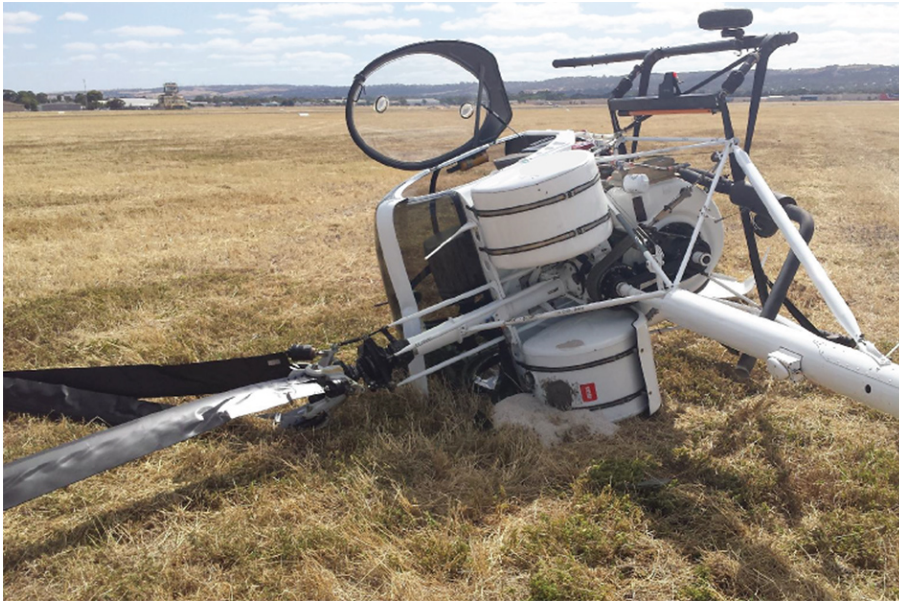
Figure 1: Orientation of helicopter following accident, facing to the north-east
