INVESTIGATION AND ELASTO-PLASTIC ANALYSIS OF AN RC BUILDING IN WHICH MAJOR SLIPPAGE OCCURRED ON THE 1ST FLOOR-SLAB DURING THE 1995 HYOGO-KEN NANBU EARTH-QUAKE

Tomoko ONODERA¹, Eiji MAKITANI², Akira MIZUKAMI³ And Wataru SHINAGAWA⁴

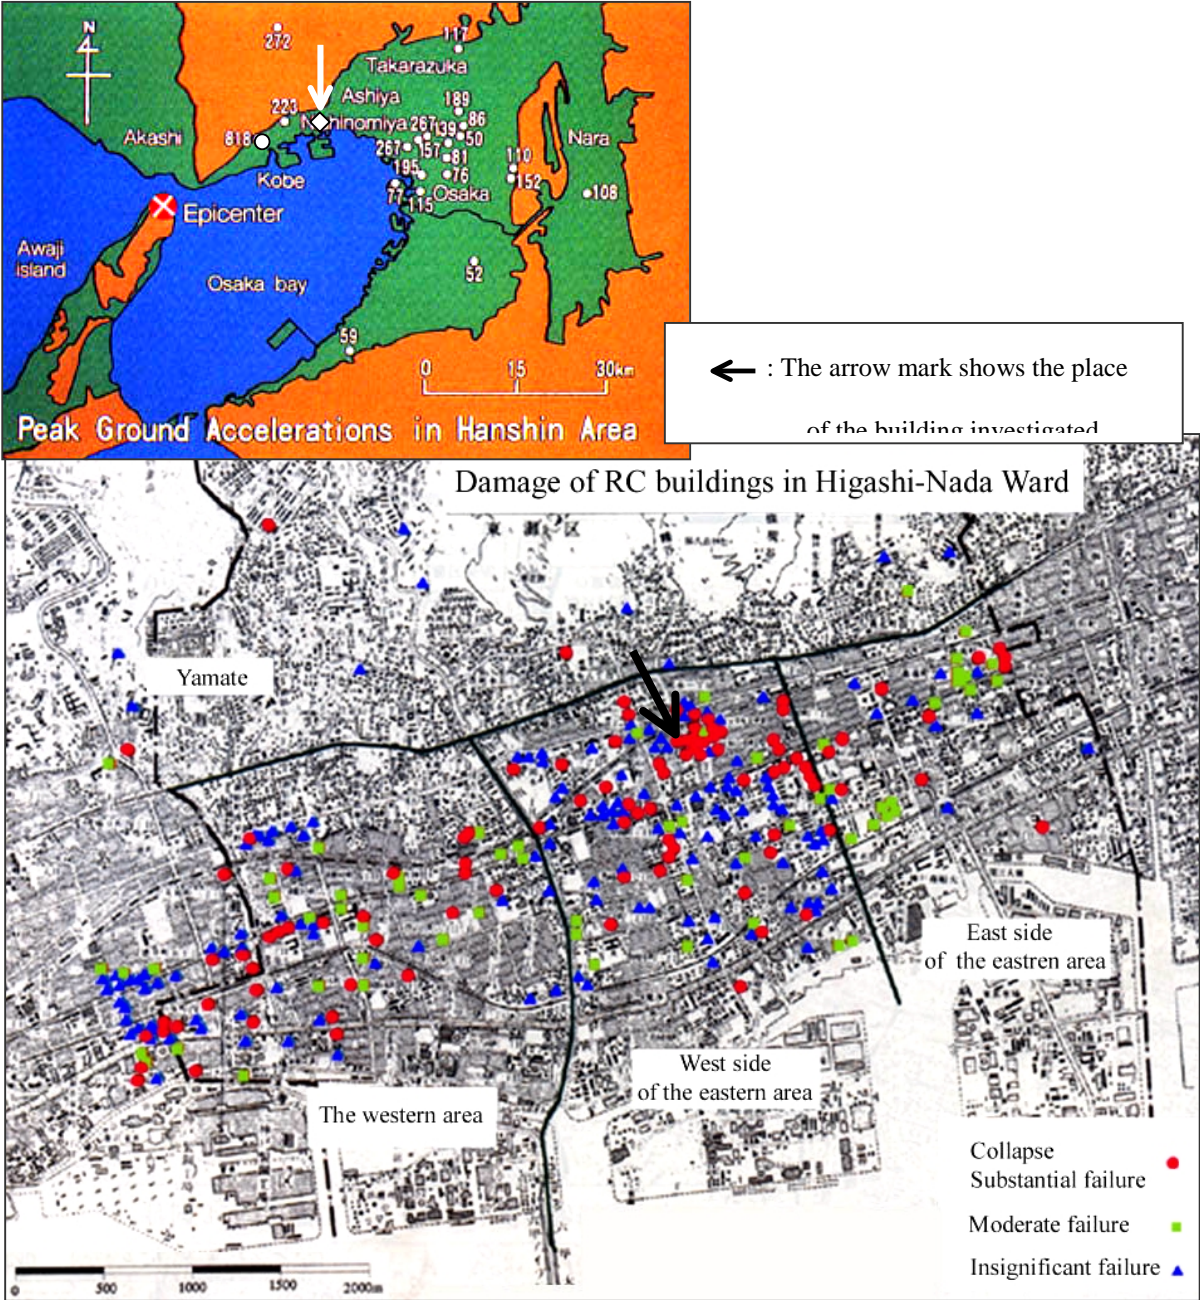
Fig.1 Distribution of collapsed buildings nearby

collapse of thirty RC buildings was caused nearby and also the great damage was brought to thirty-four other RC buildings. Many of those buildings were formed with an open space or fewer walls in the first story and typically collapsed at the first level. The distribution map of collapsed and greatly damaged RC buildings are plotted by circle and rectangular marks respectively in Fig.1. [1], [4]
