Middle School

Summary update of diagnostic
work performed from 7/5/05
through 7/26/05

Report on work performed from 7/20/05 through 7/26/05.

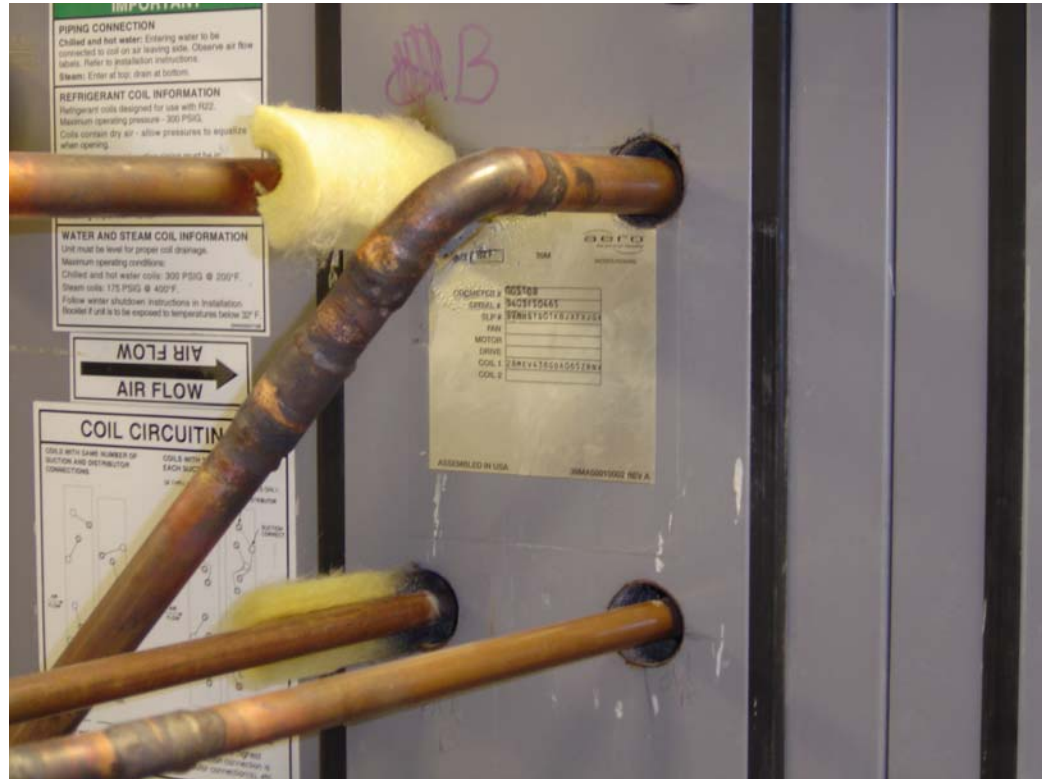
Air handler 6, photo #1411

- Copper tubing in contact with sheet metal.
- Penetrations not sealed.

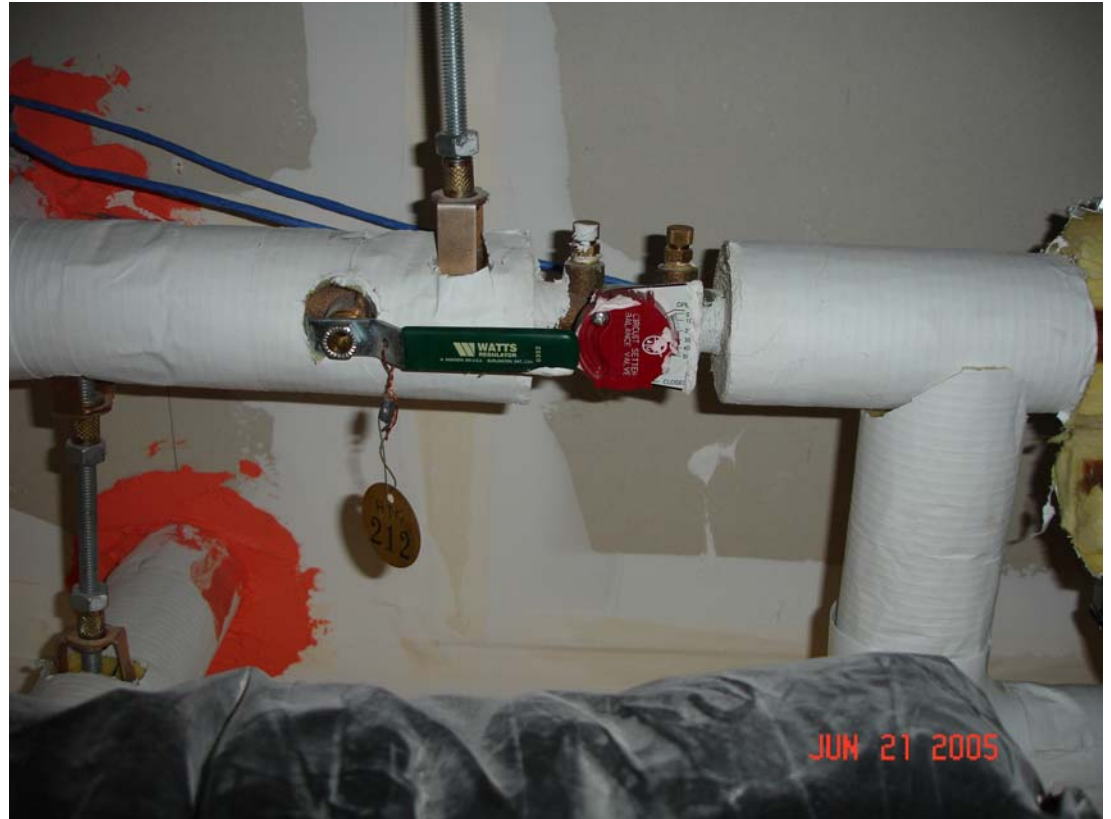
VAV 104 , Photo #1547

View of balancer's flow reading location. AI took flow readings on the other side of the tee and read 0.75 GPM. The balancer reported 0.1 GPM. Flow is available, but the 3-way will not permit it to flow through the coil.

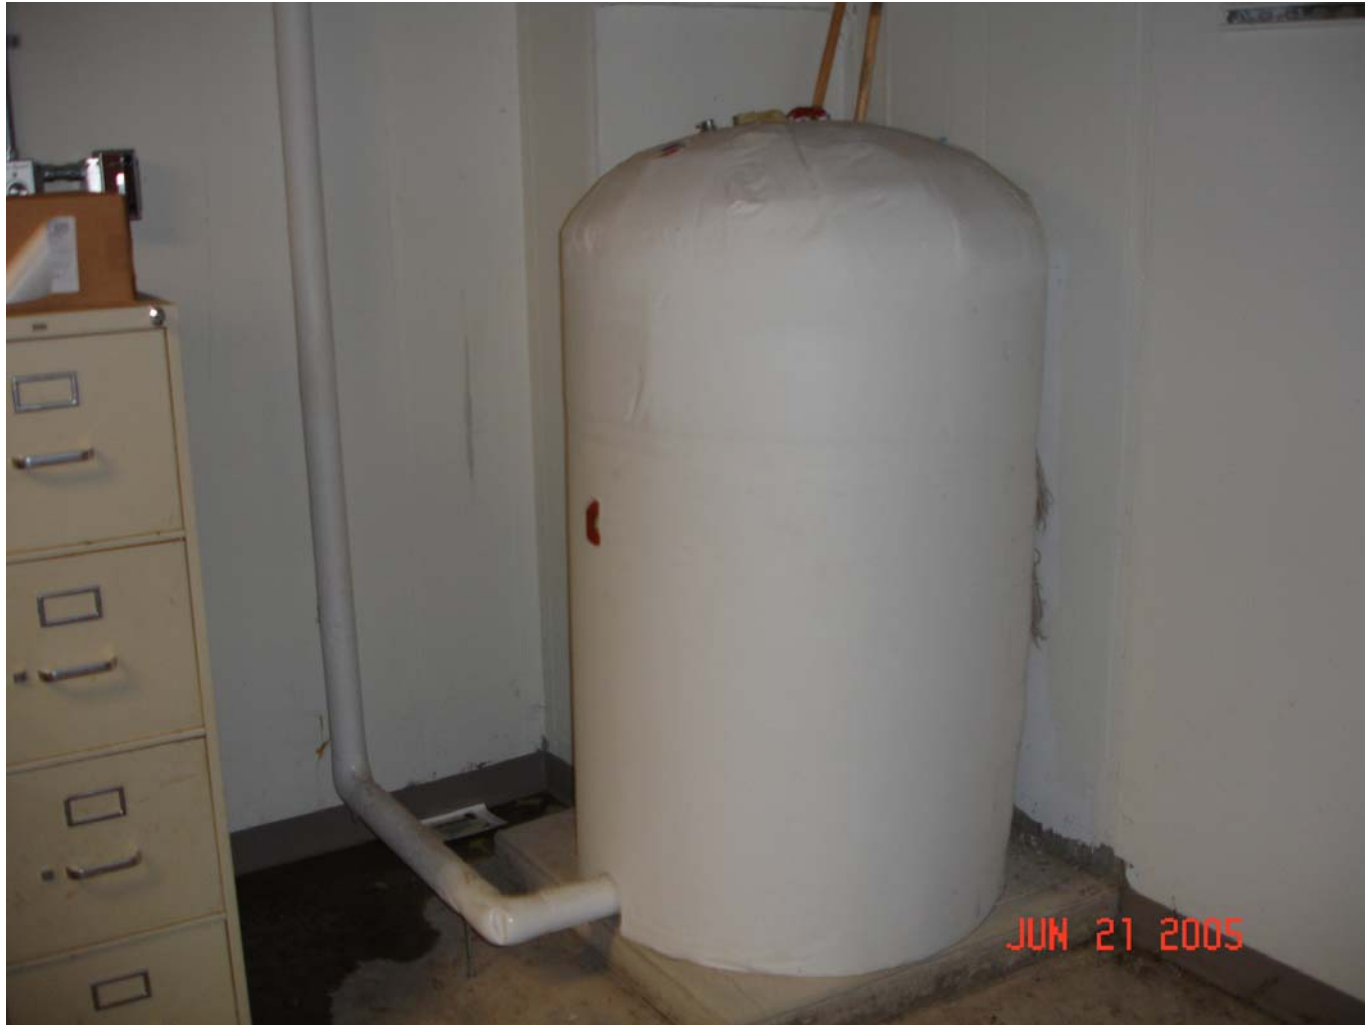
Boiler photo #1527

Expansion tank
