MAIB TRILOGY REPORT

***Korenbloem***

***Osprey III***

***Optik***

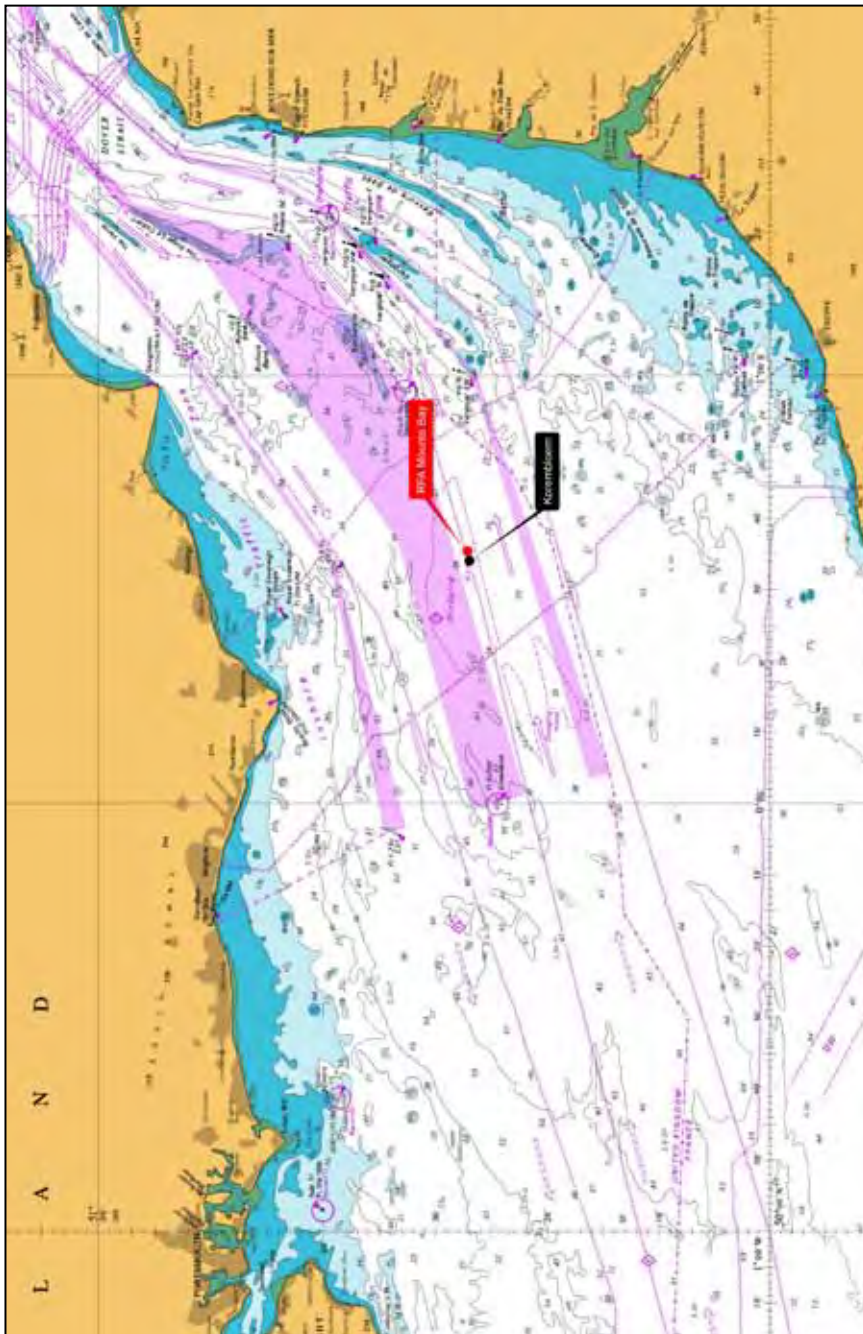
Figure 2

Location of the vessels just before airlifting the casualty

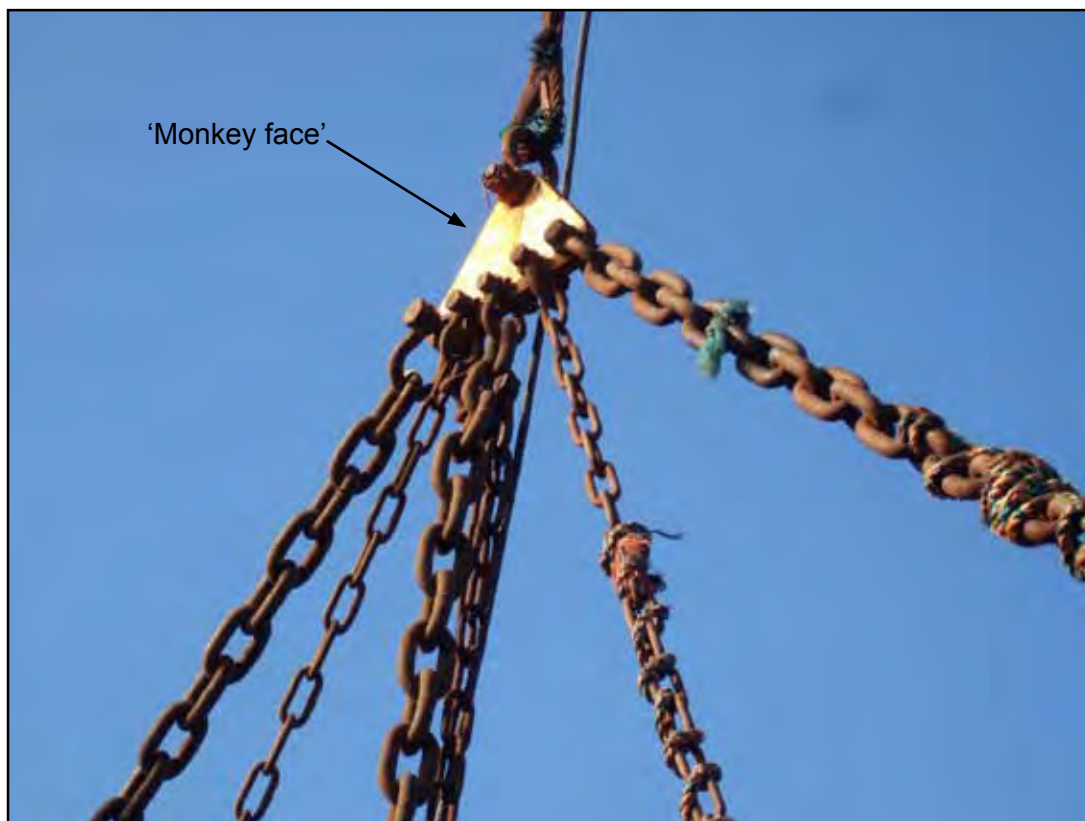
Figure 3

*Korenbloem* had a 30cm diameter hollow steel towing beam on both port and starboard sides, each equipped with 12 dredge bags. The towing beams were suspended from 'monkey face' plates (**Figure 3**), and were fitted with solid rubber wheels on both ends. The bottom ends of the dredge bags were connected via chains to tipping bars, which also were suspended from the 'monkey face' plates. The tipping bars could be lifted independently of the towing beams by using G-clips to attach the gilson wires (**Figure 4**). The tipping bars were of a lighter construction than the towing beams, and were suspended at the same level as the towing beams when out of the water (**Figure 5**).

'Monkey face'

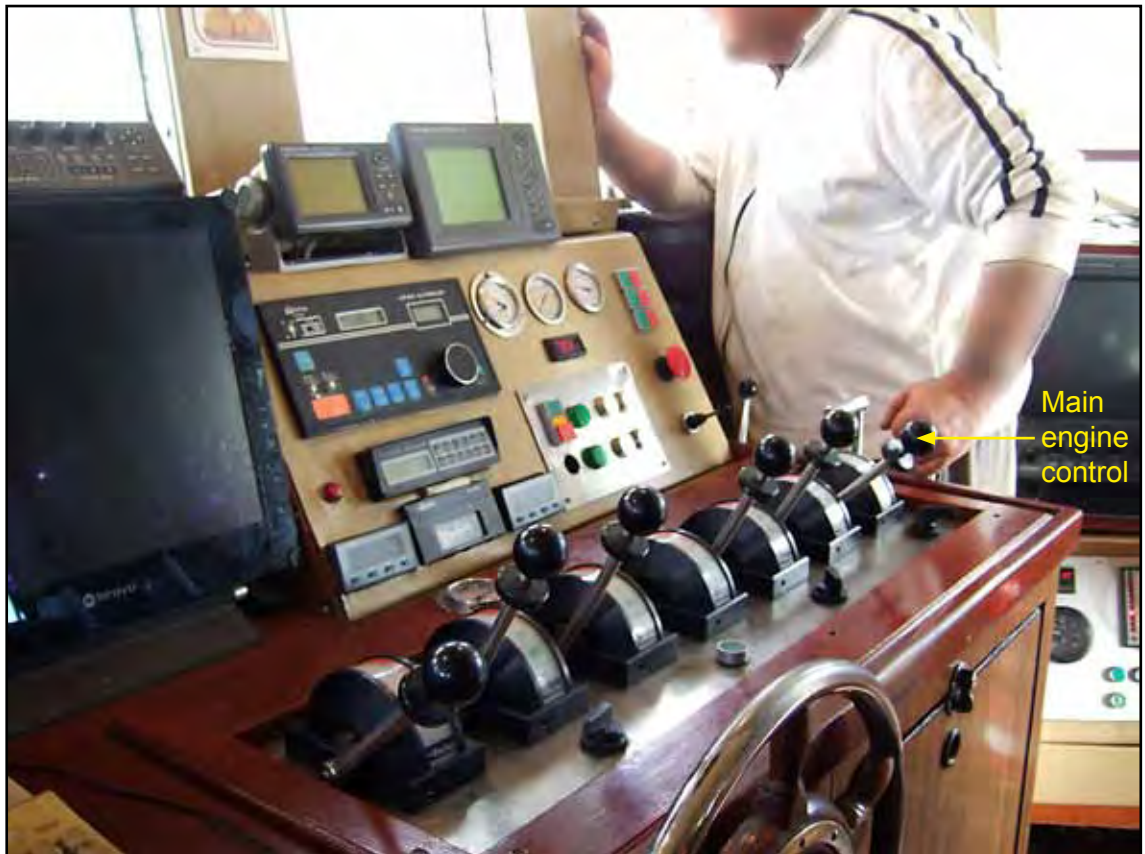
Figure 6

Each of the six winches could be individually clutched in or out; but they were operated simultaneously using a single lever located next to the main engine speed control lever (**Figure 6**).

Winch controls for operating fishing gear

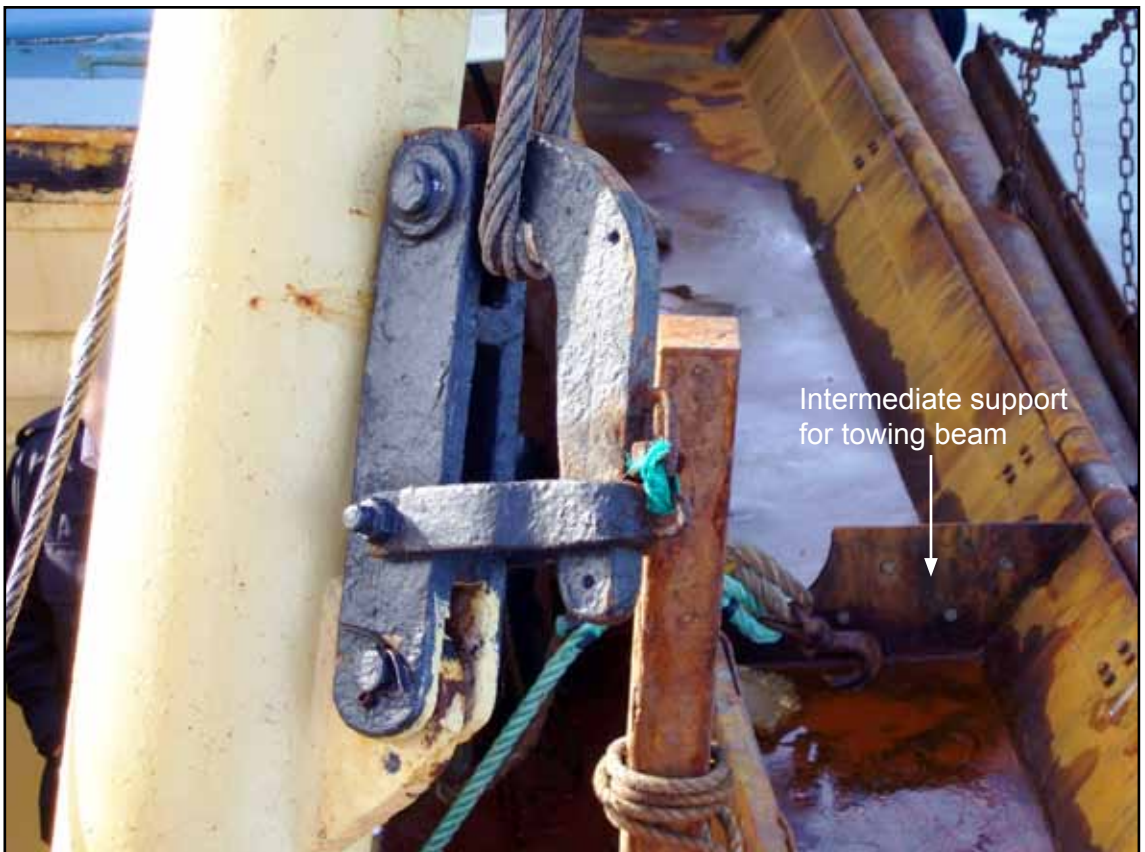
Figure 7

Catches of scallops were emptied into large bins on each side of the main deck. The bins had hydraulically operated rams under them which allowed them to be tipped for emptying any waste material overboard. When not in use, the fishing gear, including the tipping bars and towing beams, were stowed in cradles positioned directly over their respective bins. Intermediate supports for the towing beams were built into the cradle (**Figure 7**).

Intermediate supports for towing beam cradle arrangement

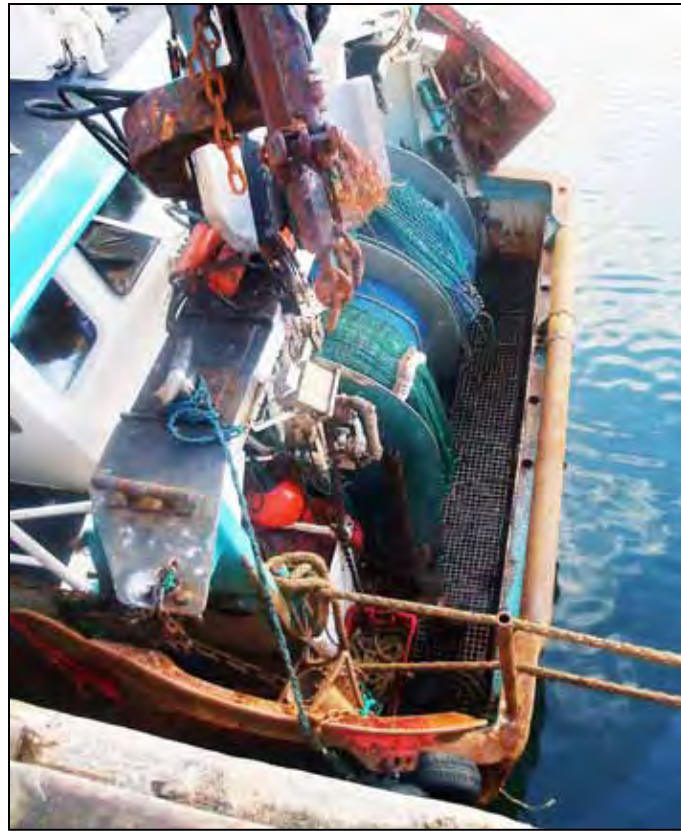
Figure 13

Photograph of the aft deck

The working area on the aft deck of *Osprey III* was very confined (**Figures 13, 14 and 15**). This resulted in her deckhands being close to the moving gear when working with the nets. William Antonio had been on board for over 6 months and was familiar with the vessel's work practices. However, the sudden loss of the net over the stern following repair was unexpected and was an event not previously seen by him.

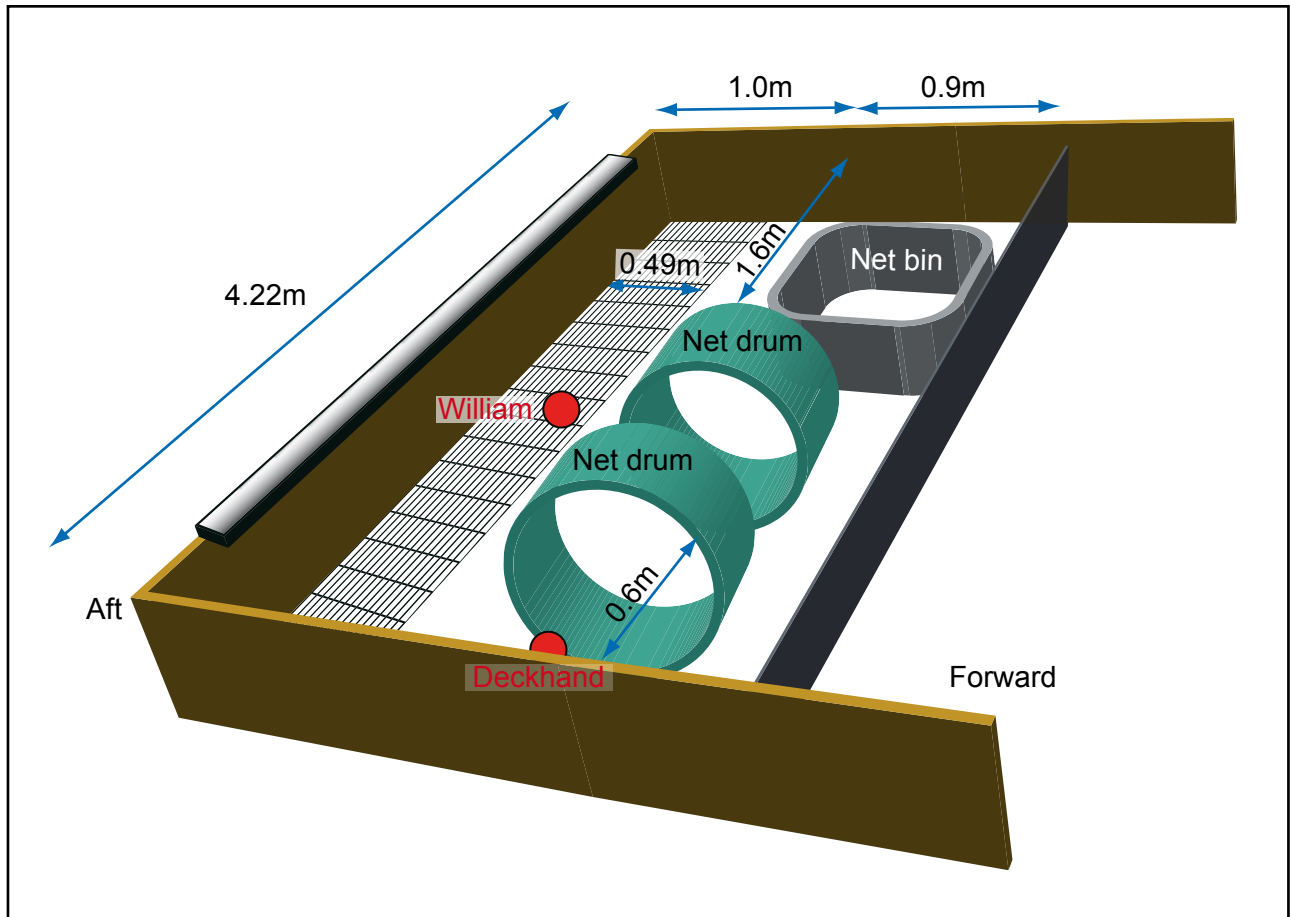
Figure 14

Diagram showing the position of deckhands

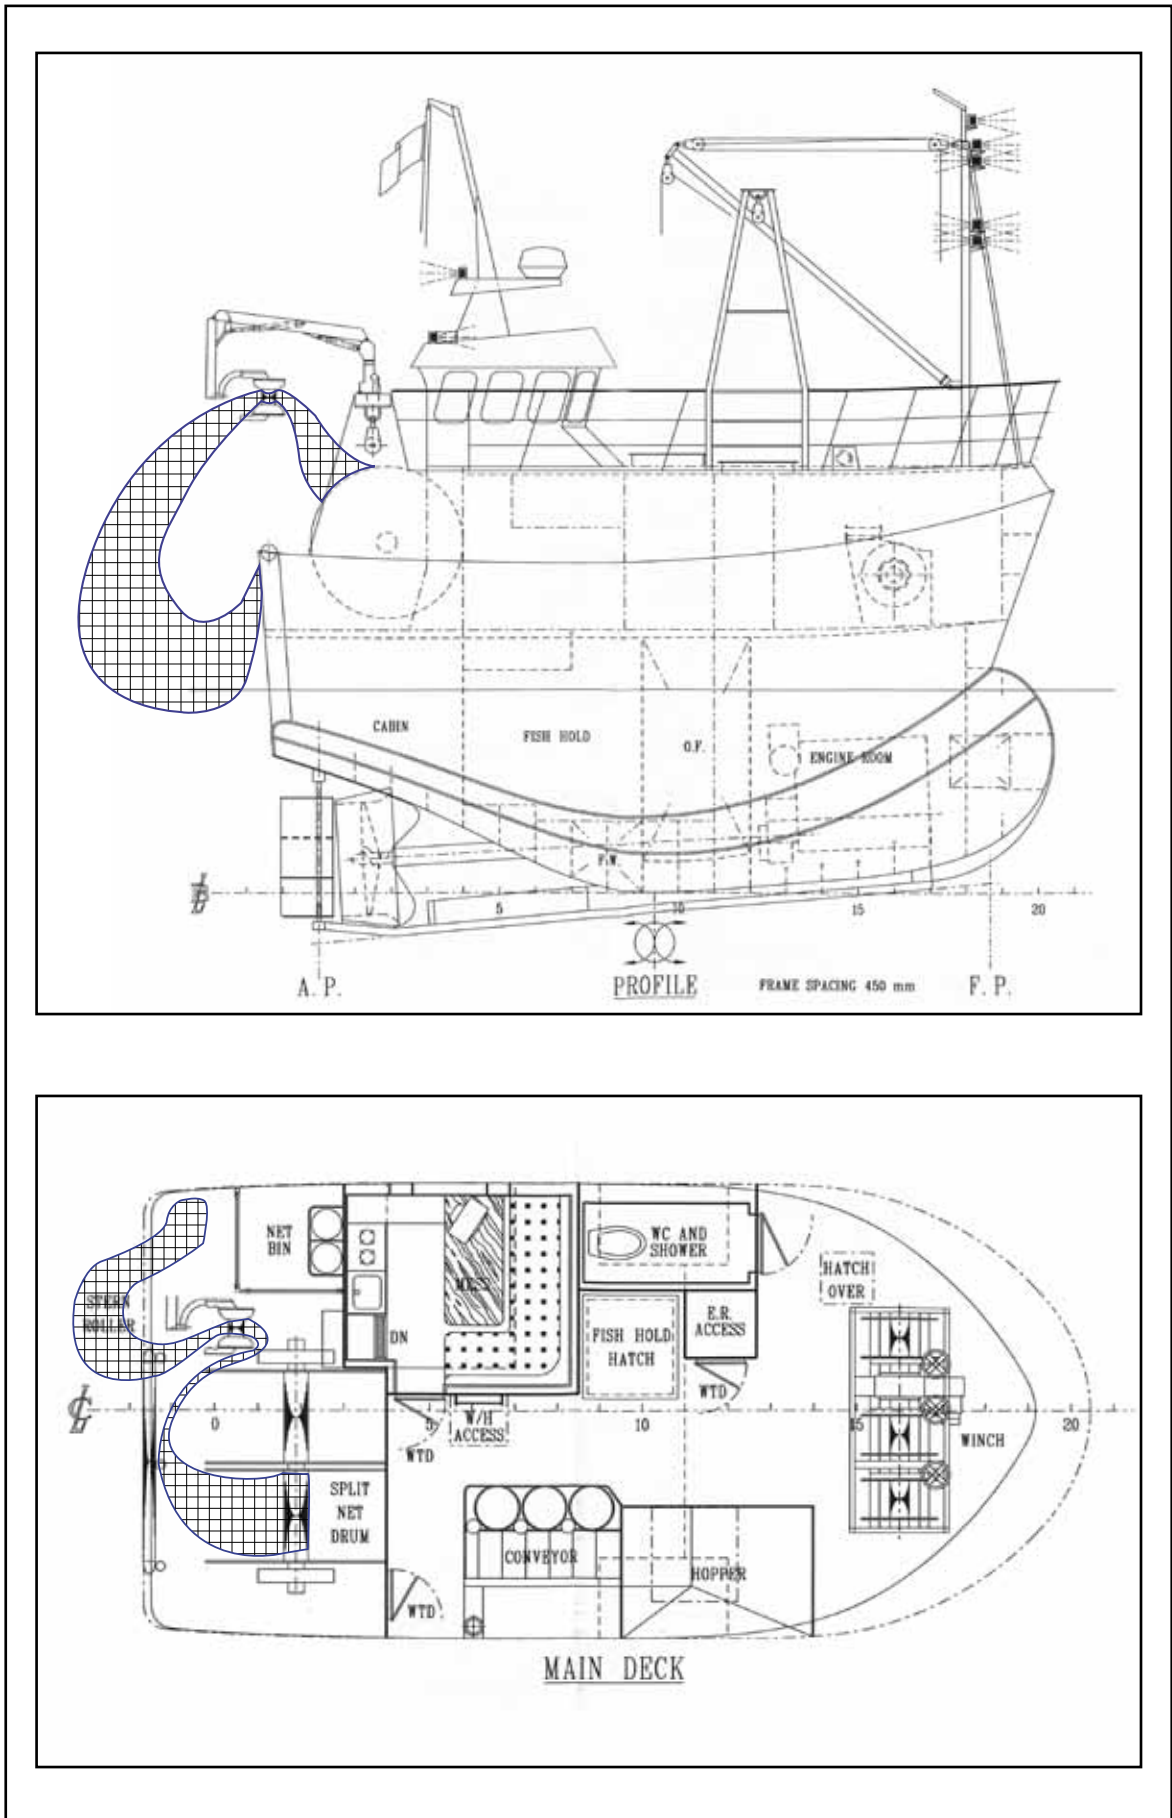
During the evening of 11 November 2009, the UK registered stern trawler *Osprey III* was returning to Macduff, Scotland after a day's fishing. When lowering a damaged net back to the deck following repair, a bight of the net entered the water. This caused the portion of the net flaked on the deck to run over the stern and into the water. William Antonio, a Filipino deckhand, became entangled in the net and its ground gear, and was dragged overboard.

Diagram showing arrangements when net entered the water

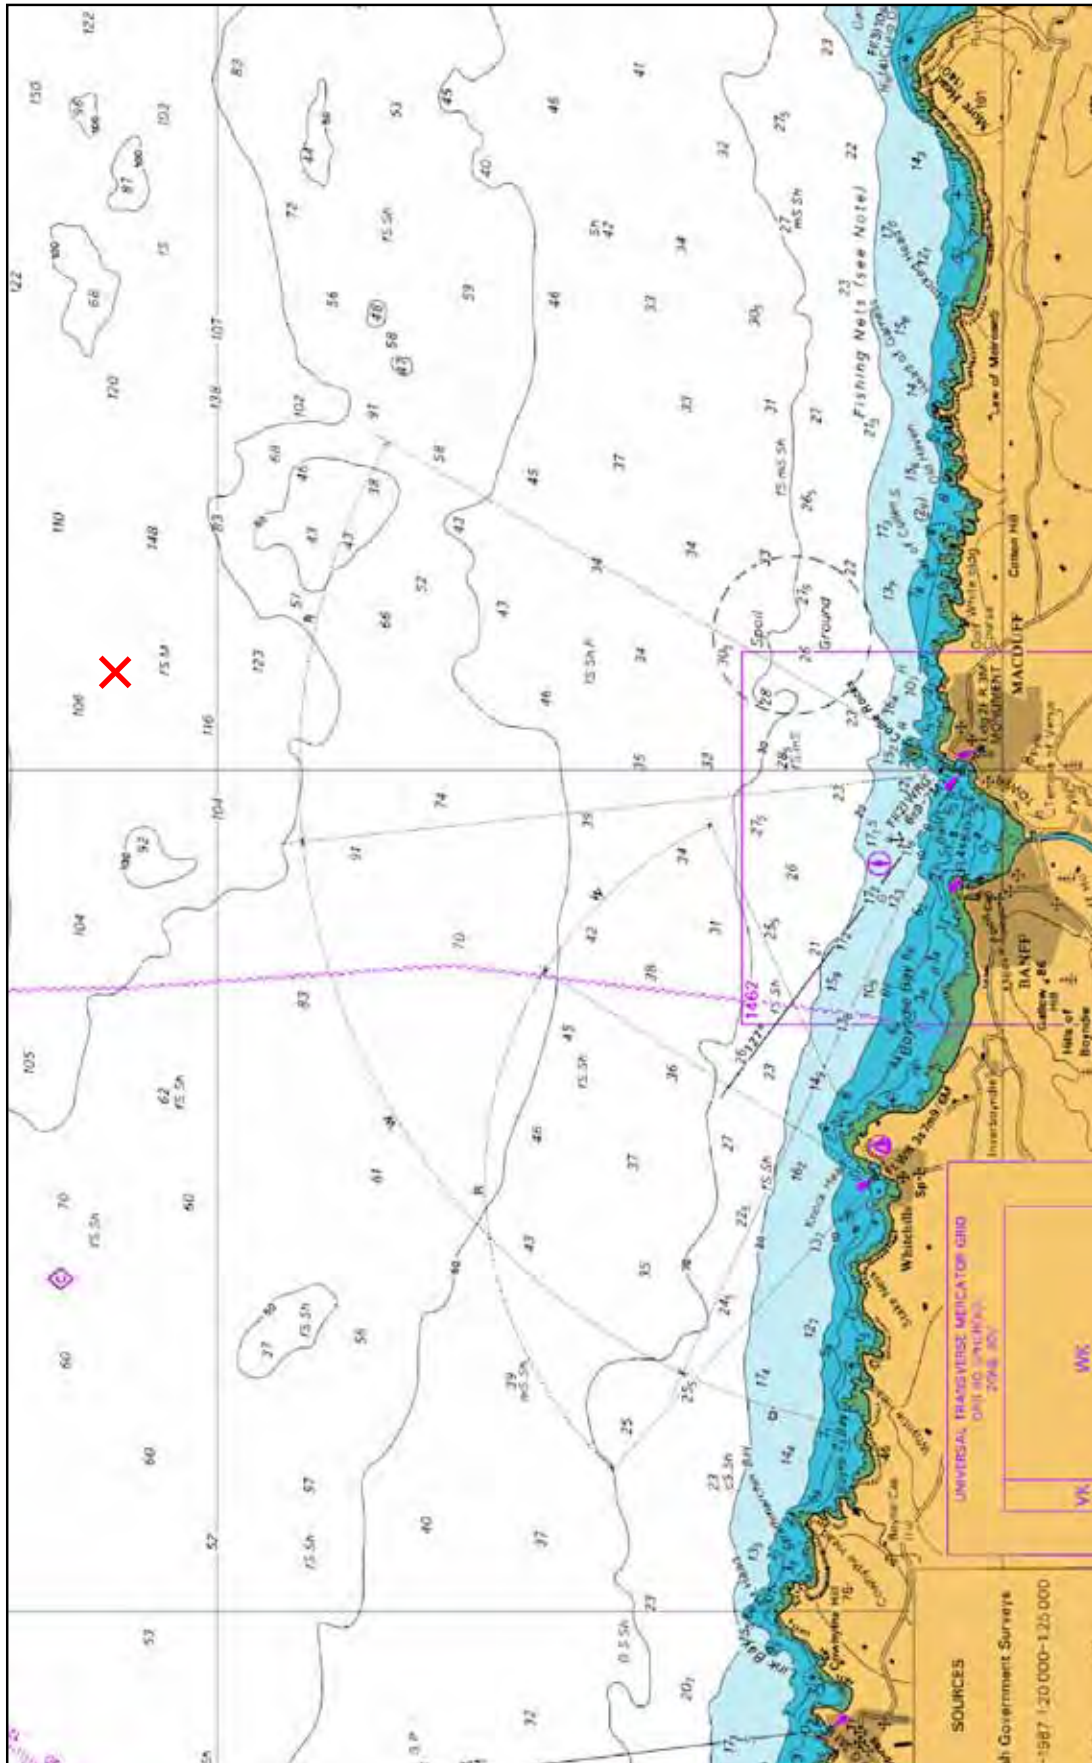
Chart extract showing position of maneuverboard

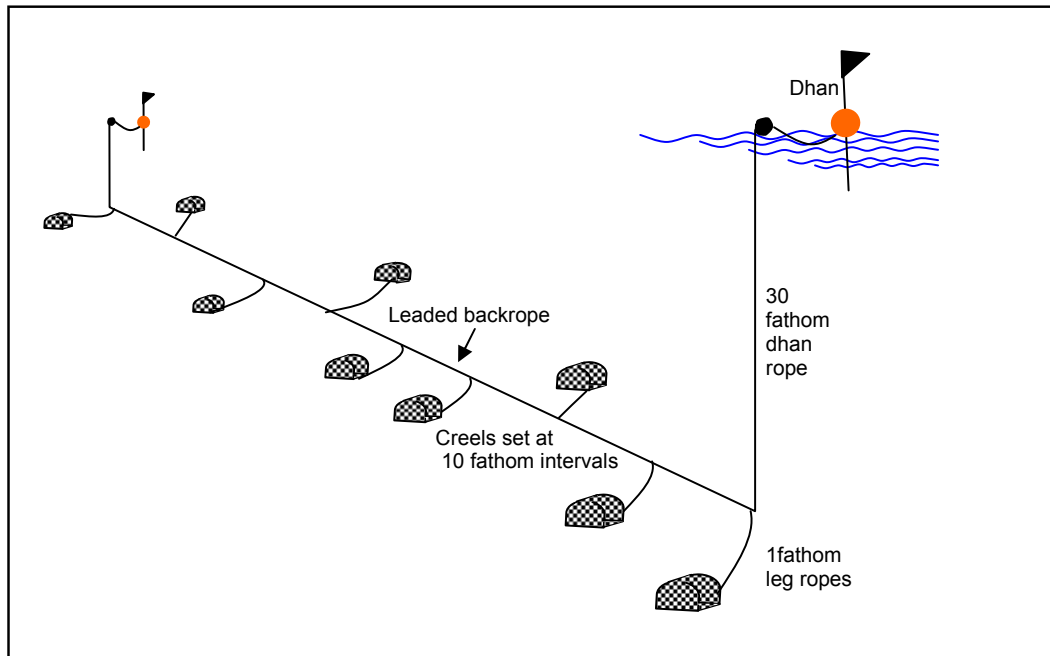
Each fleet consisted of 20 creels of typical dimensions 66cm x 48cm, which fitted comfortably onto *Optik's* shooting table. The creels were set at 10 fathom (18.3m) intervals on the seabed, attached to a 10mm diameter leaded back rope (main line) by 1 fathom (1.83m) long leg ropes. At the end of each fleet was a 30 fathom (54.9m) dhan rope leading to the surface, attached to a dhan and marker buoy to facilitate retrieval from the sea (**Figure 23**).

Diagram of a typical creel fleet

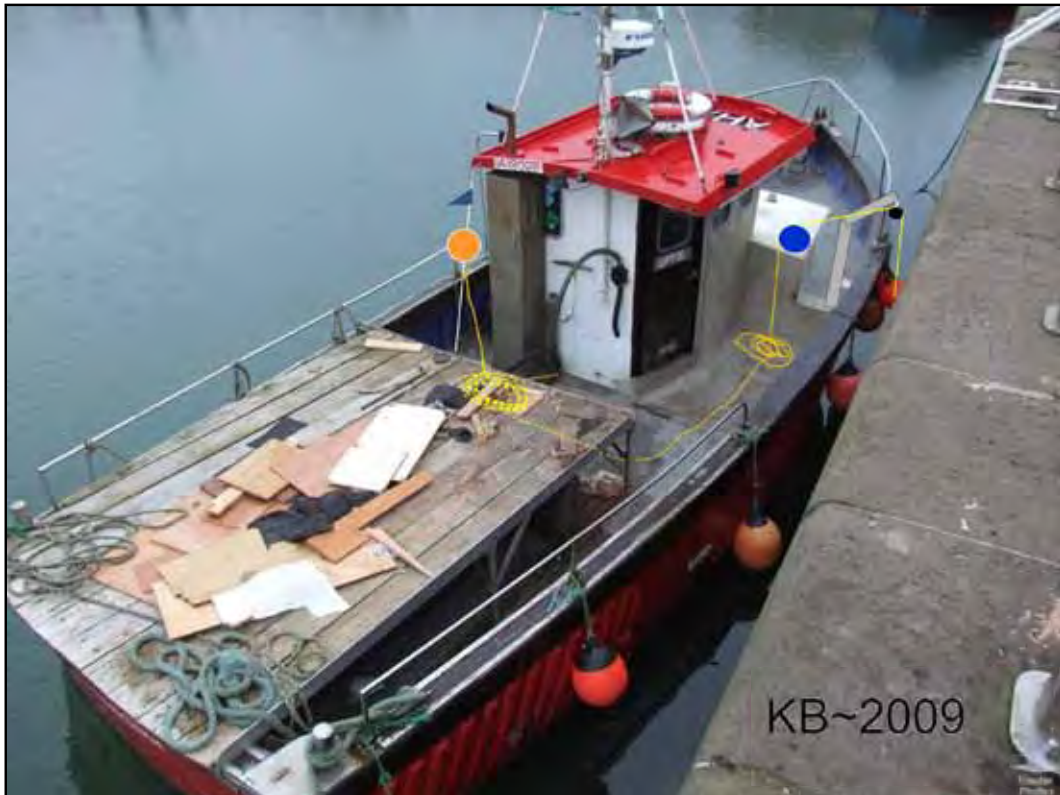
Representation of dhan buoy in recovered position with section of rope obscured between shooting table and wheelhouse

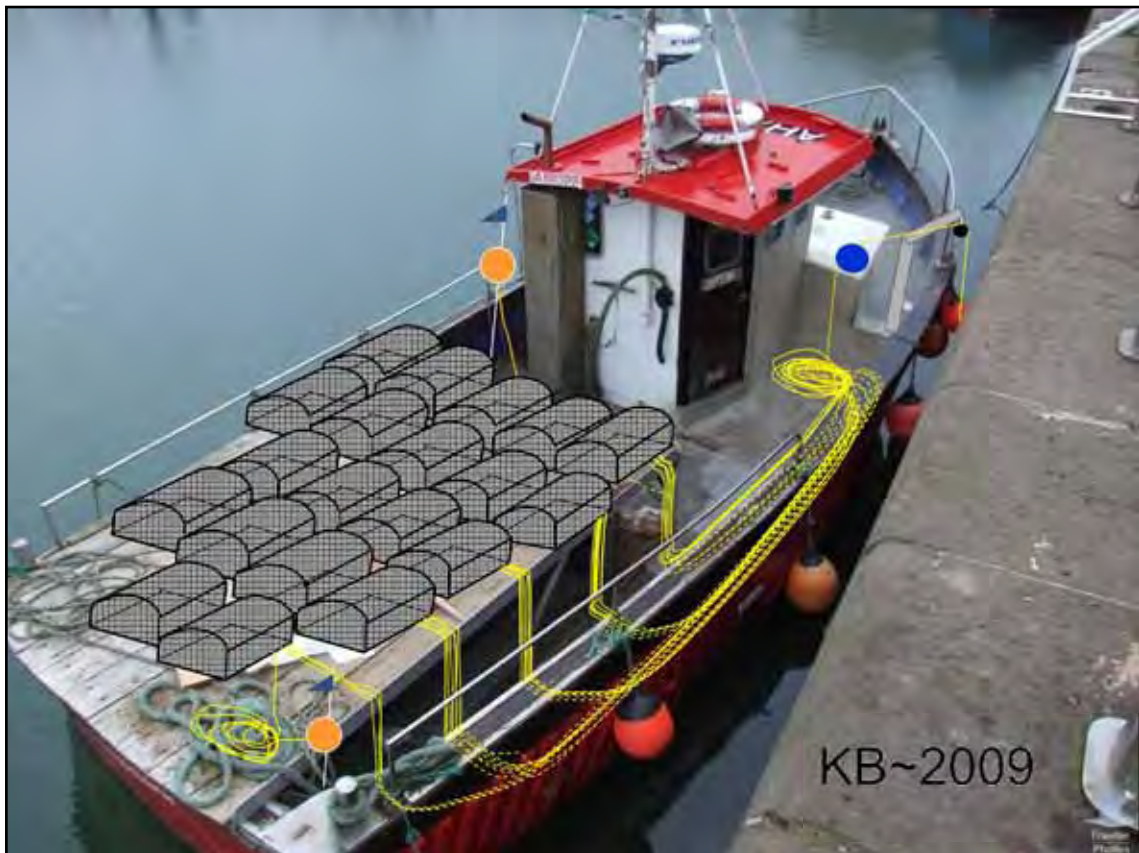
The accident happened during a routine creel shooting operation which, despite having been carried out many times, had never been properly evaluated to make the operation as safe as possible. During the shooting operation, the casualty was required to work in close proximity to unguarded ropes on deck; during this operation his foot became entangled in a rope and he was dragged overboard and down to the seabed by the weight of attached fishing gear.

Representation of fleet of recovered creels stowed on the shooting table in preparation for shooting

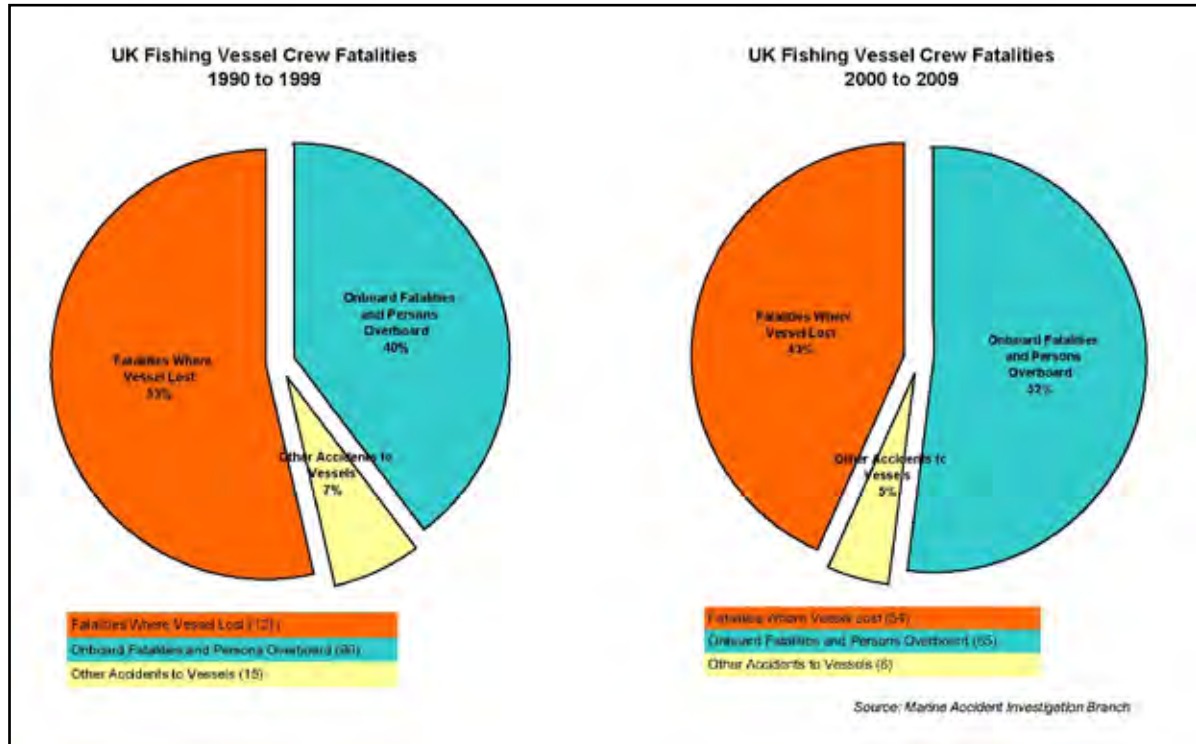
Figure 25

Between 1990 and 1999, the majority of fishing crew fatalities occurred when a vessel was lost. Since 2000 the majority of fatalities have been due to occupational accidents which have occurred on board the vessel, or as a consequence of fishermen falling or being dragged overboard as demonstrated by the three tragic cases detailed in this report (**Figure 25**). This shift should be recognised and the focus of safety authorities should be adapted accordingly.

UK Fishing Vessel Crew Fatalities 1990 - 1999 and 2000 - 2009

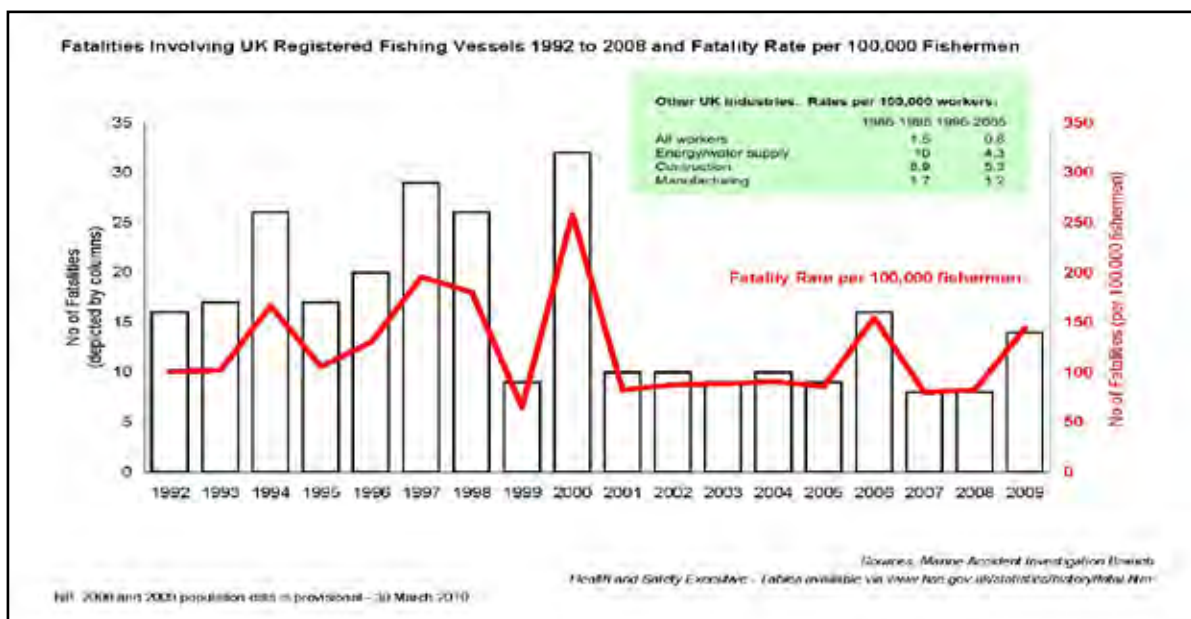
Figure 26

Sadly, the above comment still has resonance in 2010. Between 1992 and 2009, the ratio of deaths occurring in the fishing industry has been many orders of magnitude greater than the level of comparable industries ashore (**Figure 26**). Some industry observers argue that such comparisons have limited value because of the relatively small numbers of fishermen under scrutiny. However, an indisputable and telling statistic is that, throughout this period, the ratio of fishermen who have died has remained broadly constant, while other comparable industries ashore have all shown significant reductions in their fatality rates.

Chart of Fatalities Involving UK Registered Fishing Vessels 1992 - 2009 and Fatality Rate per 100,000 Fishermen
