# Large Steam Turbine Vibration Resonance of Pedestal and Linkage System RCA, Detail Vibration Investigation / Measurement at Site and Countermeasures

## **Preface**

**A Large Steam Turbine had been in operation for several years and this turbine experienced the wear damage of governor linkage.**

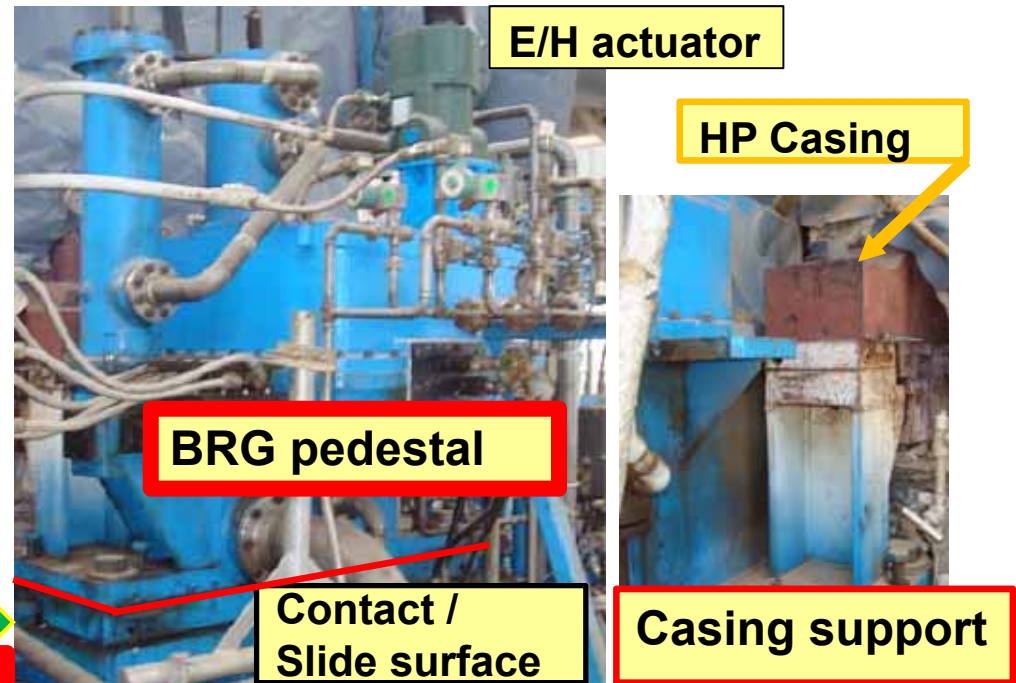
Gov, side brg, pedestal with cover, linkage assembly

- Turbine start up in 2002
- Gov, side pedestal Vibration increase from around 2005
- Vibration up to 20 mm/s in 2012 by turbine load/speed up
- Vibration causes linkage lever wear and required control limit

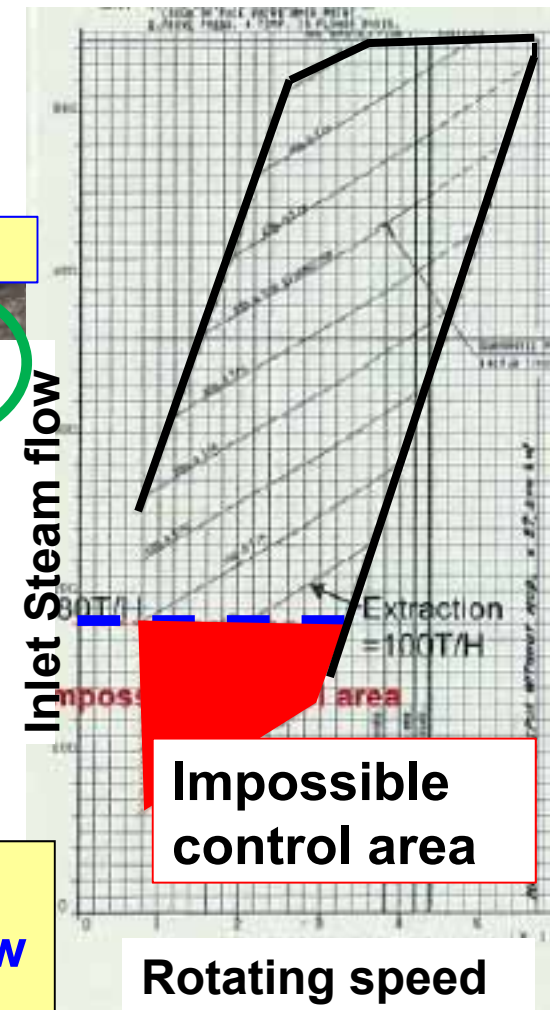
**Operation condition ;**  
It was shifted actual inlet steam flow against E/H actuator signal.  
Occurred Impossible control area.

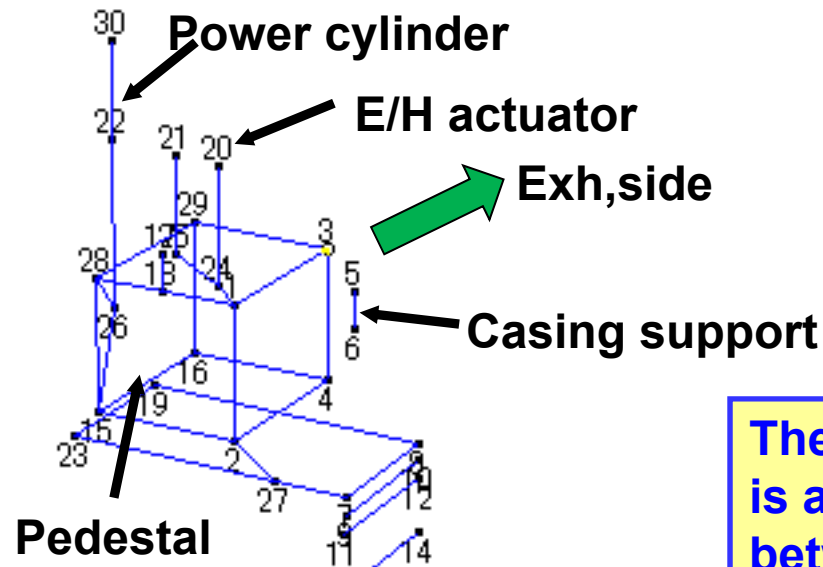
**Site measurement points  
(No,30)**

**The main characteristic of the vibration mode is an out-of-phase (counter-motion) mode between main pedestal and casing support**

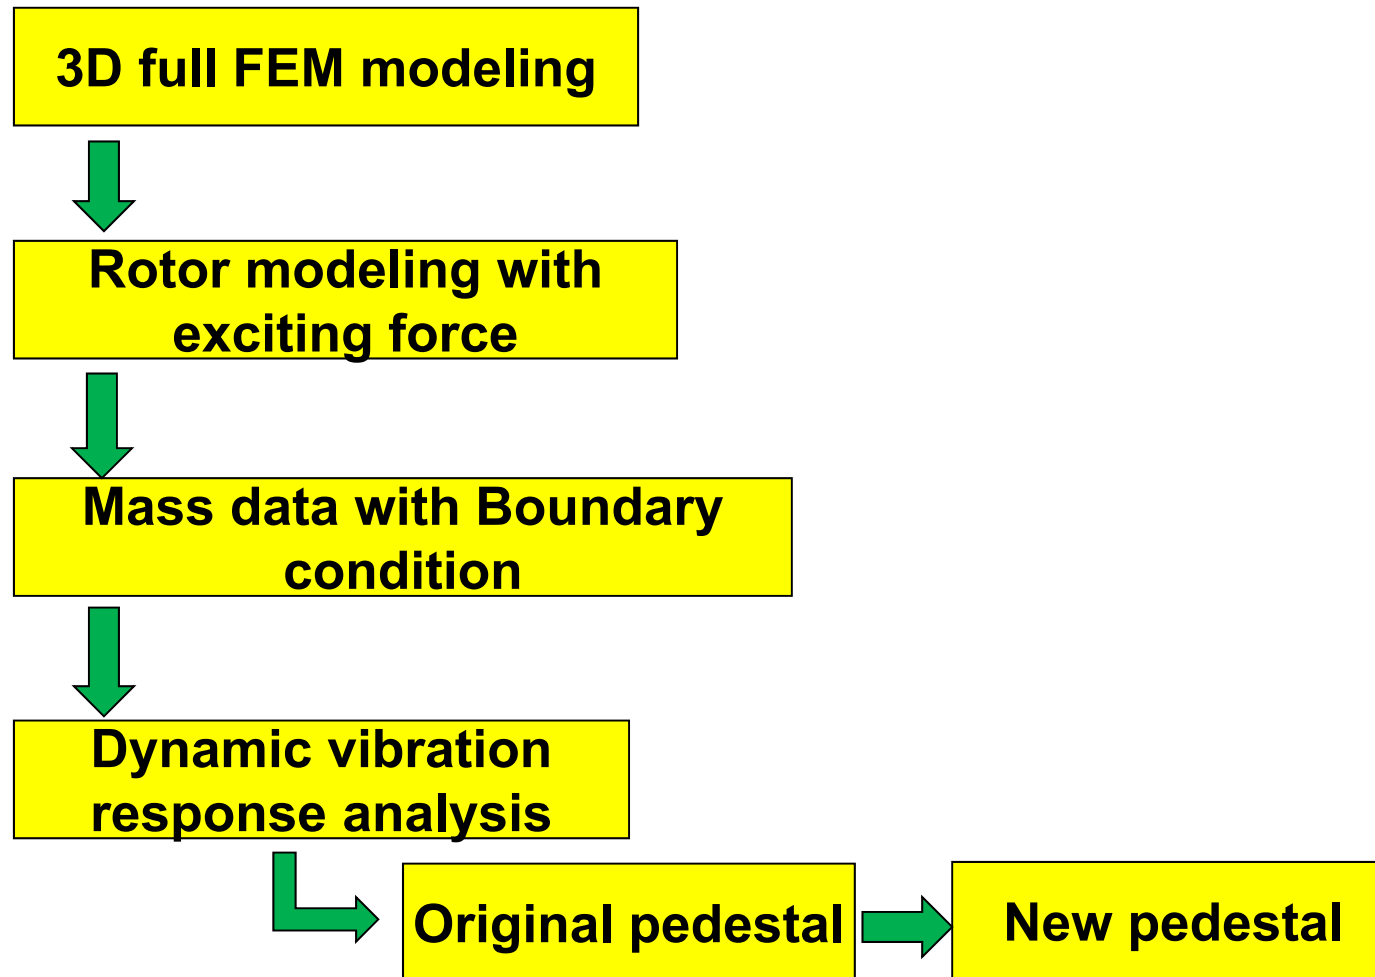
In order to clarify the vibration mechanism, it performed vibration 3D response analysis(cod-Nastran) with current bearing pedestal.

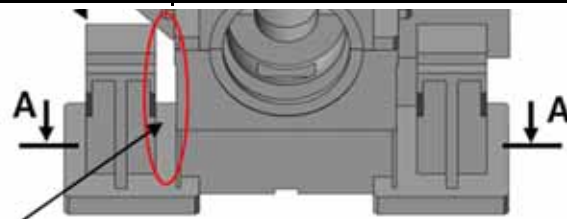
Free standing of pedestal and casing support

Optimized thickness support

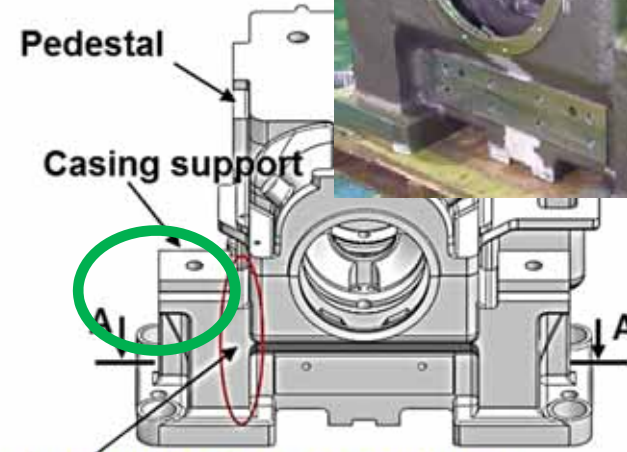
Cross section A-A

Integration between pedestal and casing support

- 1) Full contact condition of pedestal surface.
- 2) Rigidly connection between pedestal body and casing support without freestanding.

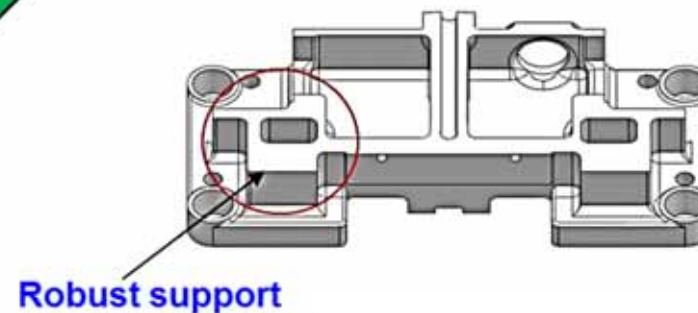
Robust support

**Casting pedestal type has more high stiffness than original type**

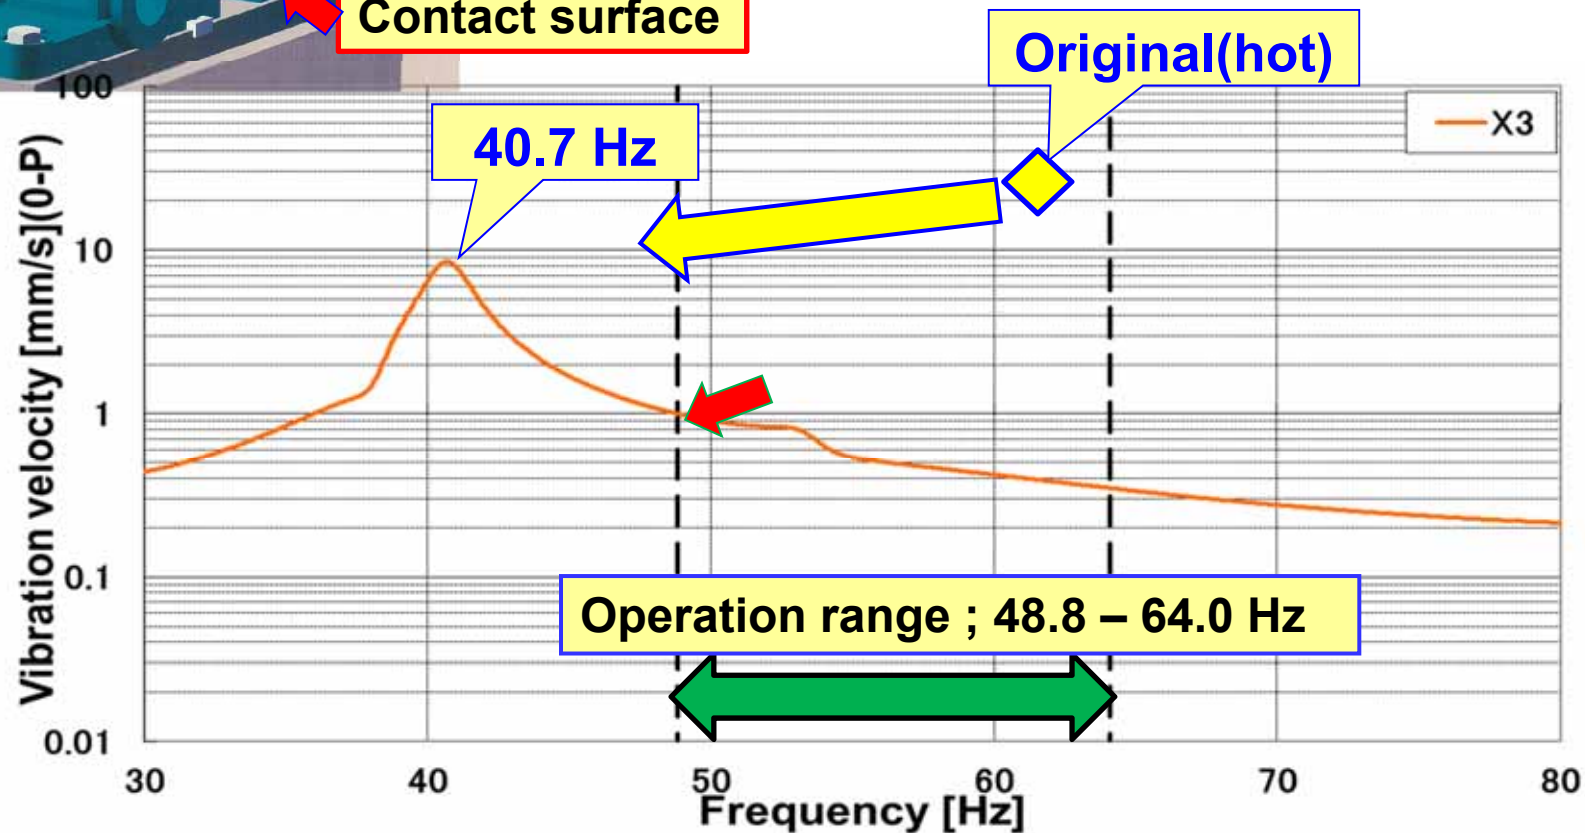
- a) Natural frequency 40.7Hz to be out of operation range, and satisfied with API standard (less than 41Hz).
- b) Vibration level in operation to be much lower at 0.3 to 1 mm/s 0-P even by 5-times of API unbalanced limit

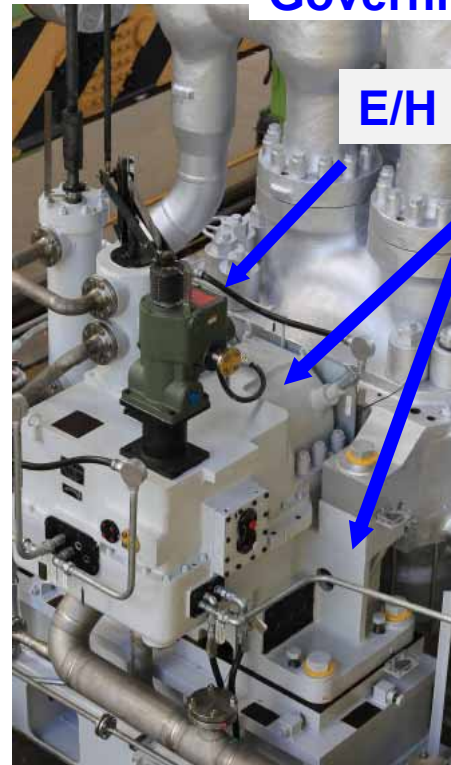
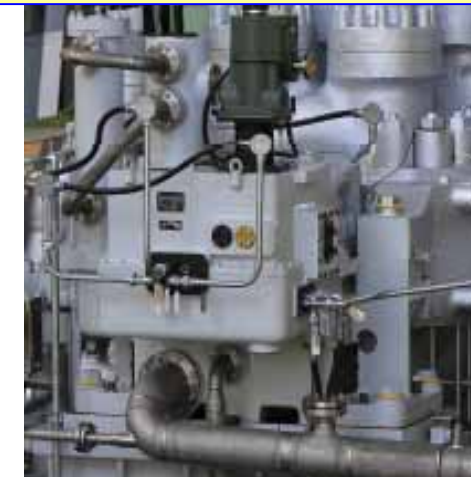
**Result ;**  
Vibration level in rotating speed to be much reduced to less than 3.0 mm /sec (0-P) , which means reduction of 80% compared with the existing pedestal vibration level.

Improved pedestal with cover
