Level I Accident Investigation  
Report  
March 1, 2010  
Fatal Bobcat/Backhoe Accident  
At the White Bluffs Substation

**Report Date:  
March 31, 2010**

**BPA**  
**Level I Bobcat/Backhoe Accident, March 1, 2010 at White Bluffs Substation**  
**Final Report**

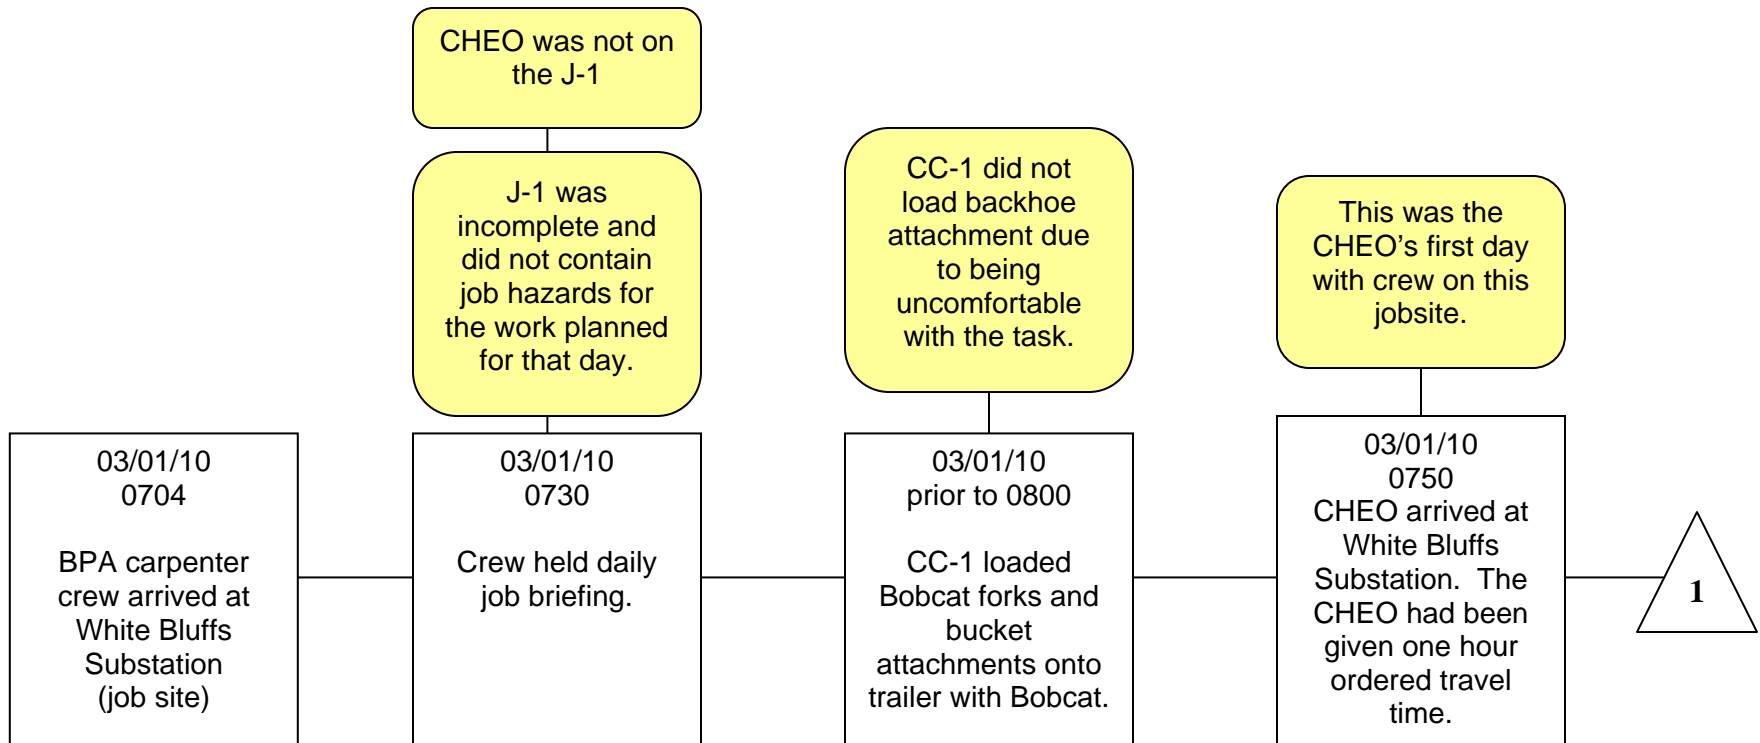
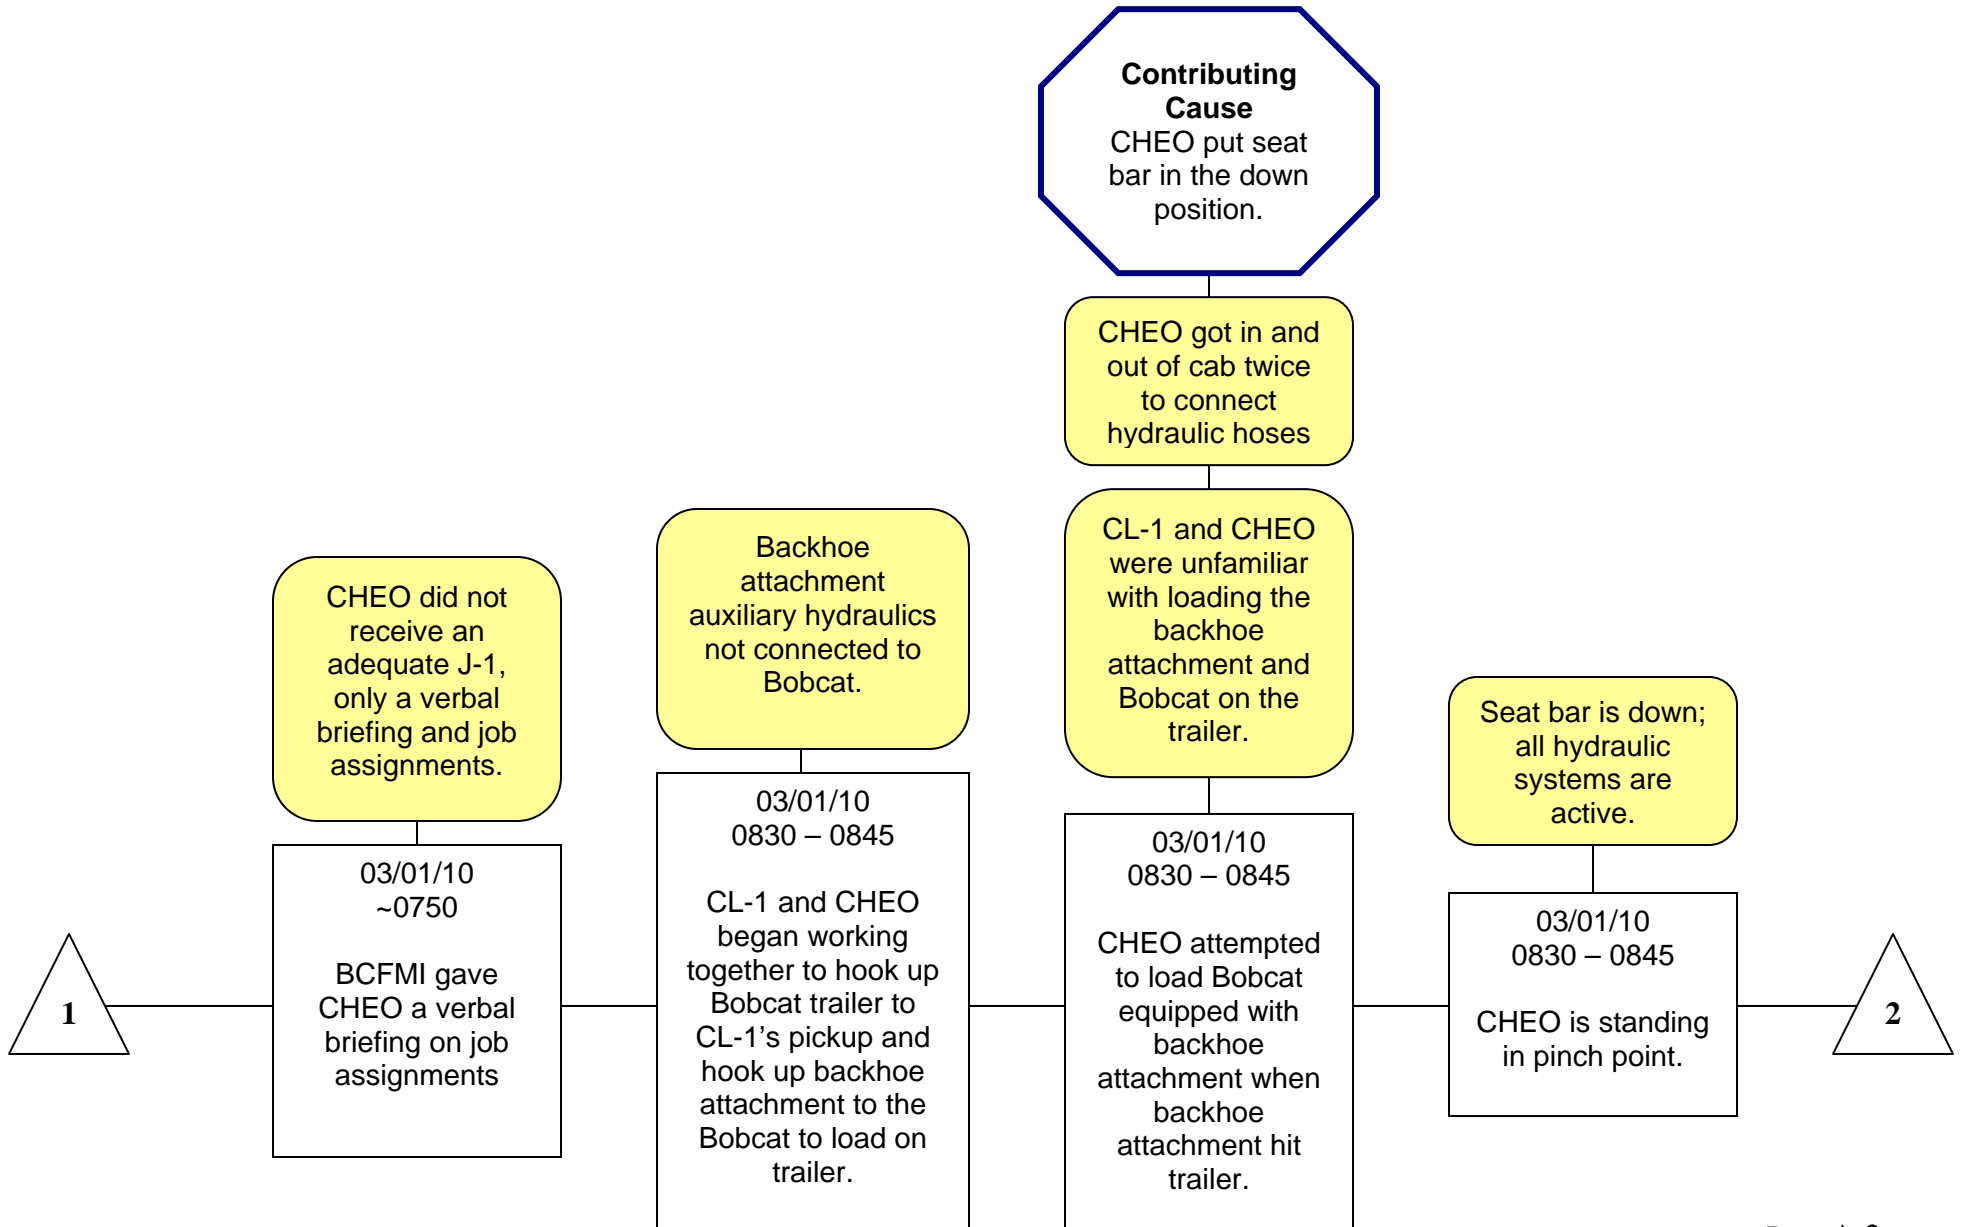
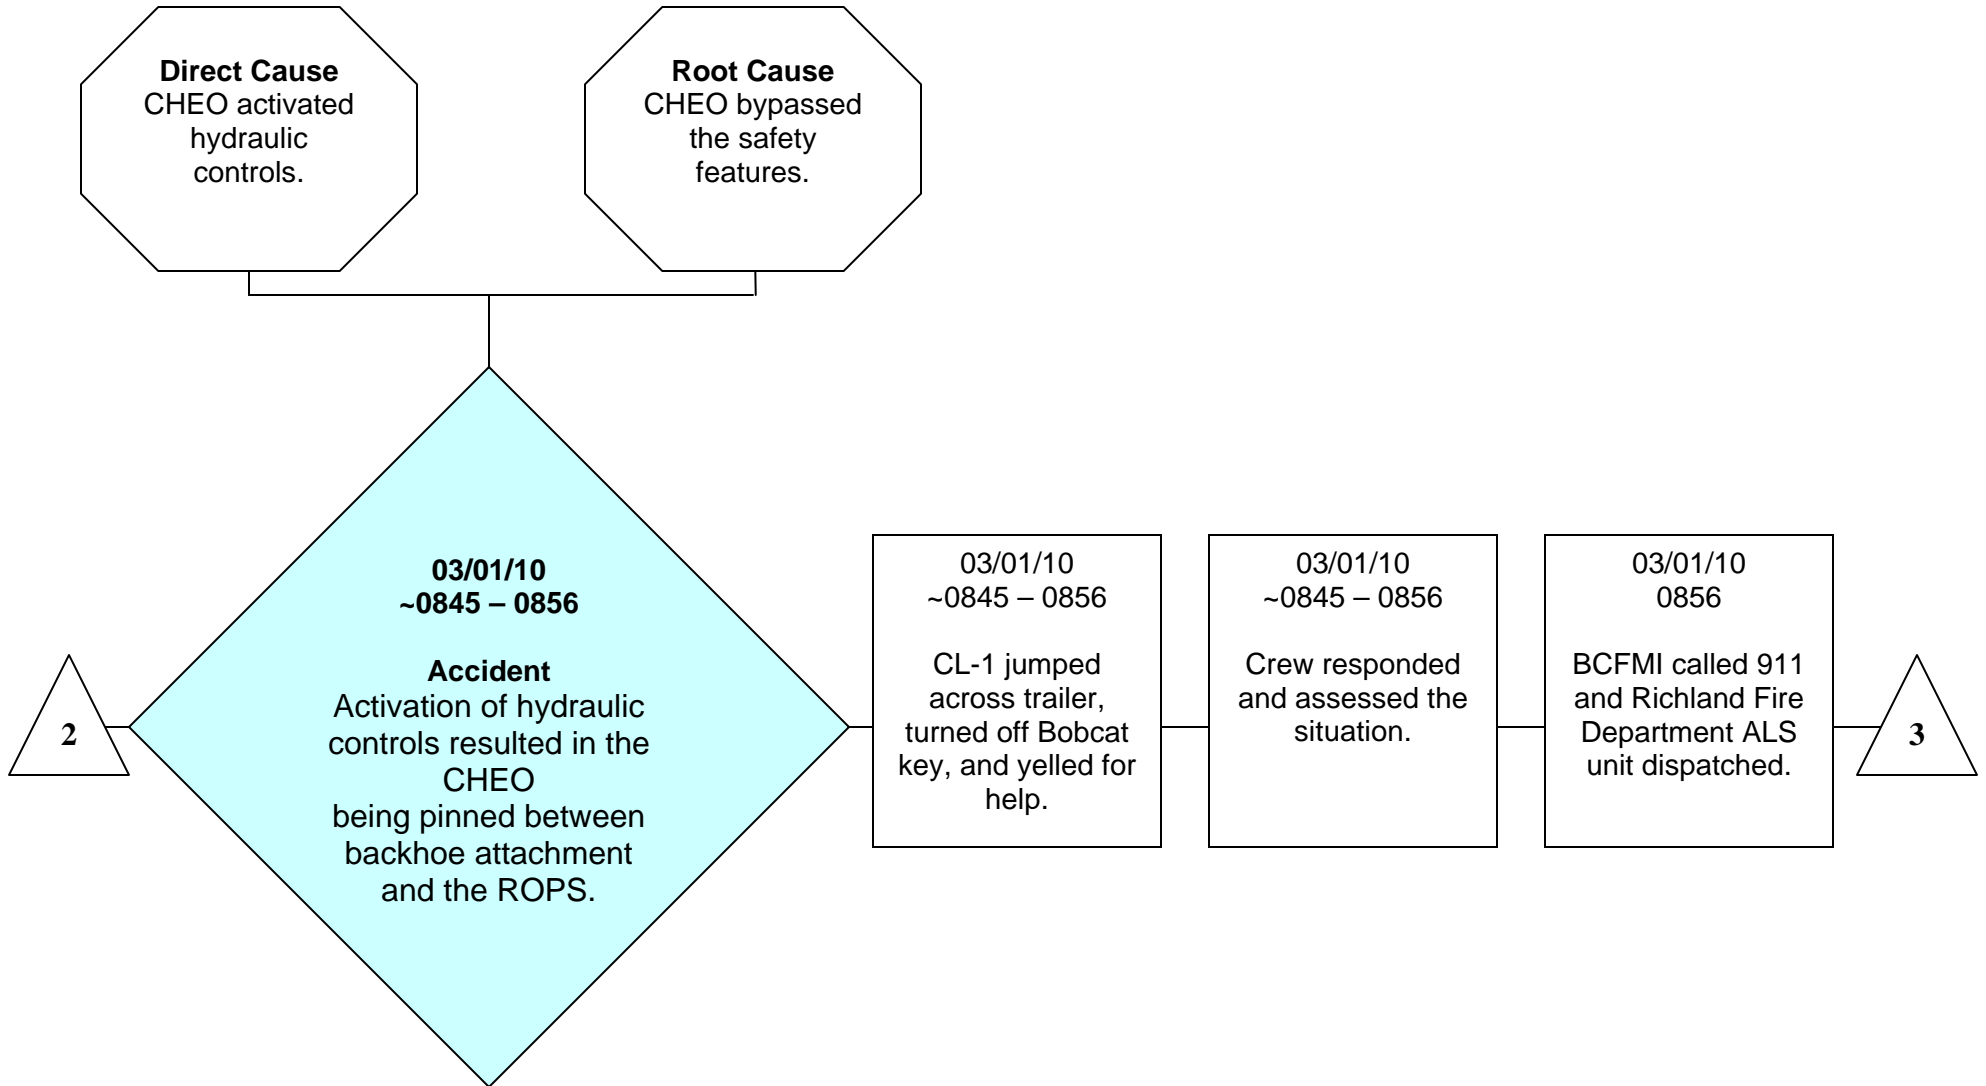
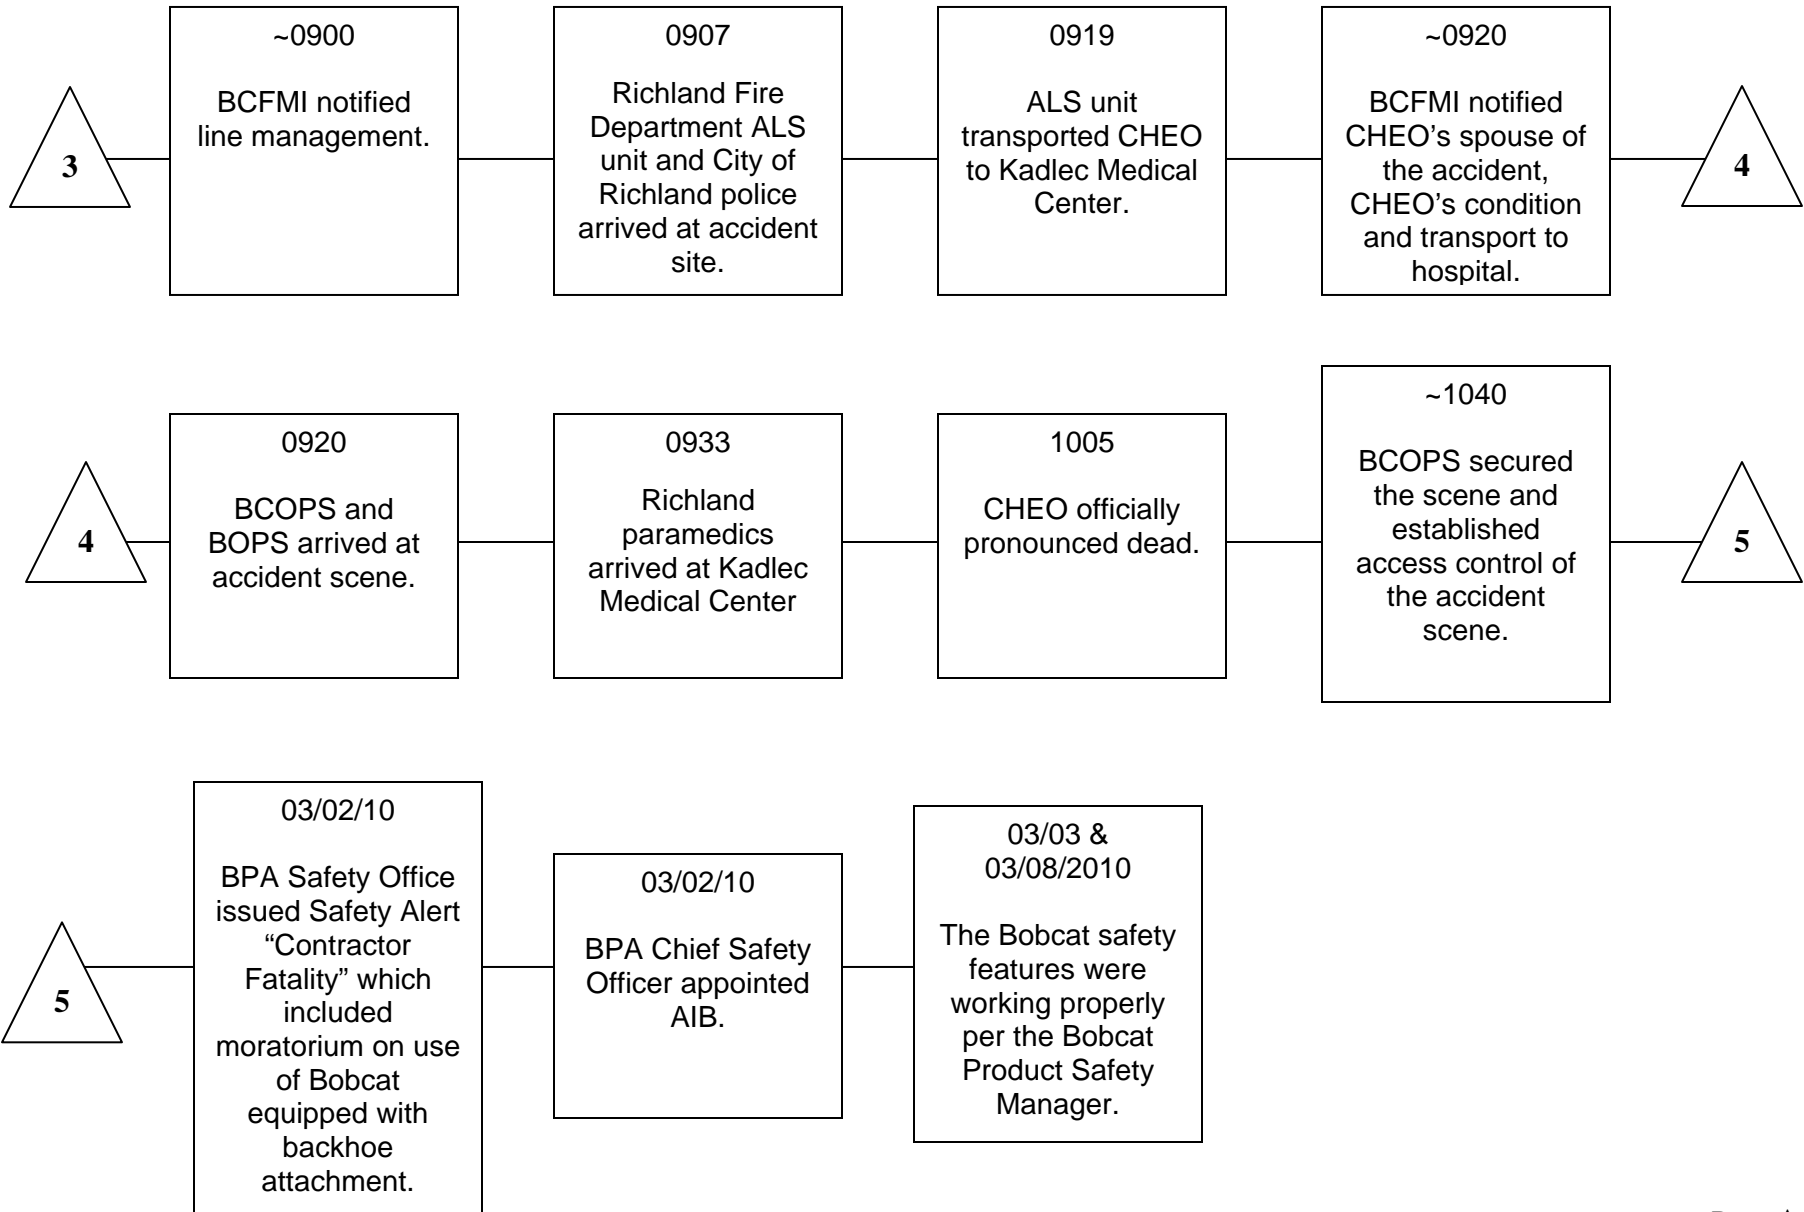
**Figure A-1: Events and Causal Factors Analysis**

An events and causal factors analysis was performed in accordance with the DOE workbook *Conducting Accident Investigations*. The events and causal factors analysis requires deductive reasoning to determine those events and/or conditions that contributed to the accident. Causal factors are the events or conditions that produced or contributed to the accident, and they consist of direct, contributing, and root causes. The direct cause is the immediate event(s) or condition(s) that caused the accident. The contributing causes are the events or conditions that, collectively with the other causes, increased the likelihood of the accident, but which did not solely cause the accident. Root causes are the events or conditions that, if corrected, would prevent recurrence of this and similar accidents. The causal factors are identified in Figure A-1: Events and Causal Factors Analysis on pages A-1 through A-4.
