Report on the investigation of
a fatality on board the workboat

Llanddwyn Island

1 March 2010

Report No 14/2010
November 2010

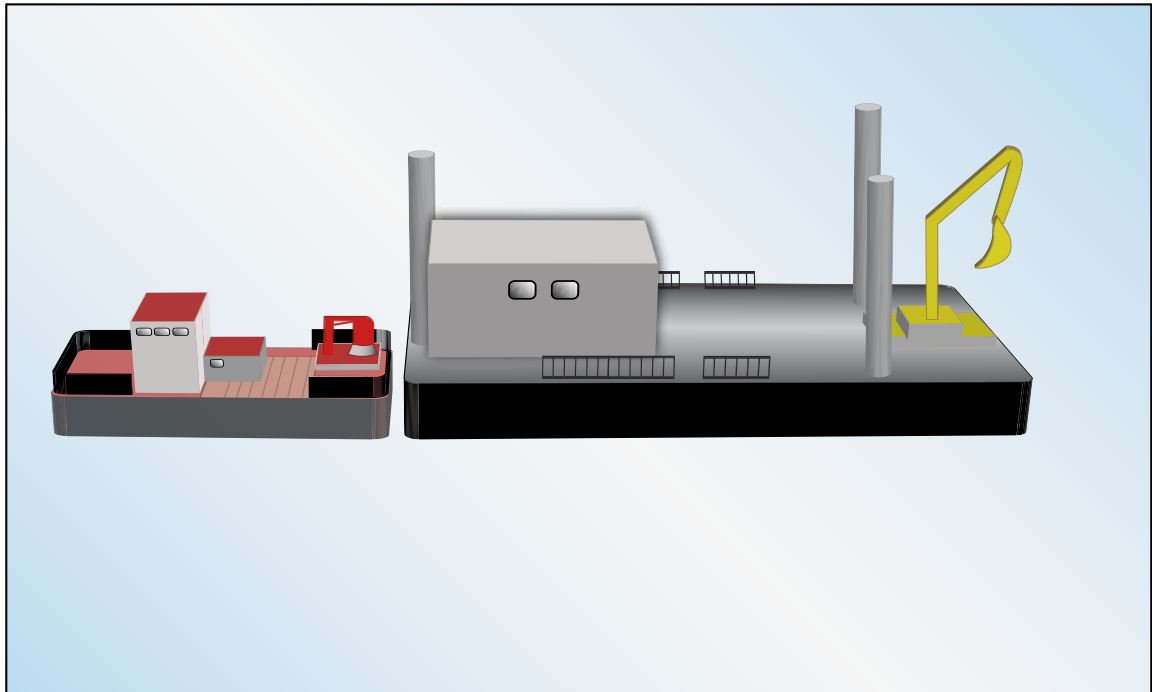
Pushing position

Llanddwyn Island's day skipper found it much quicker and easier to manoeuvre the barge when pushing from astern (**Figure 6**) as he did not need to rely on the direction of the tow being controlled by the backhoe operator using the excavation bucket as a pivot on the seabed. The single hawser continued to be used during several further moves conducted by the day and night crews. It was usual practice for the skippers to signal to the deckhands when the operation was complete and therefore safe to proceed forward to disconnect the chain.

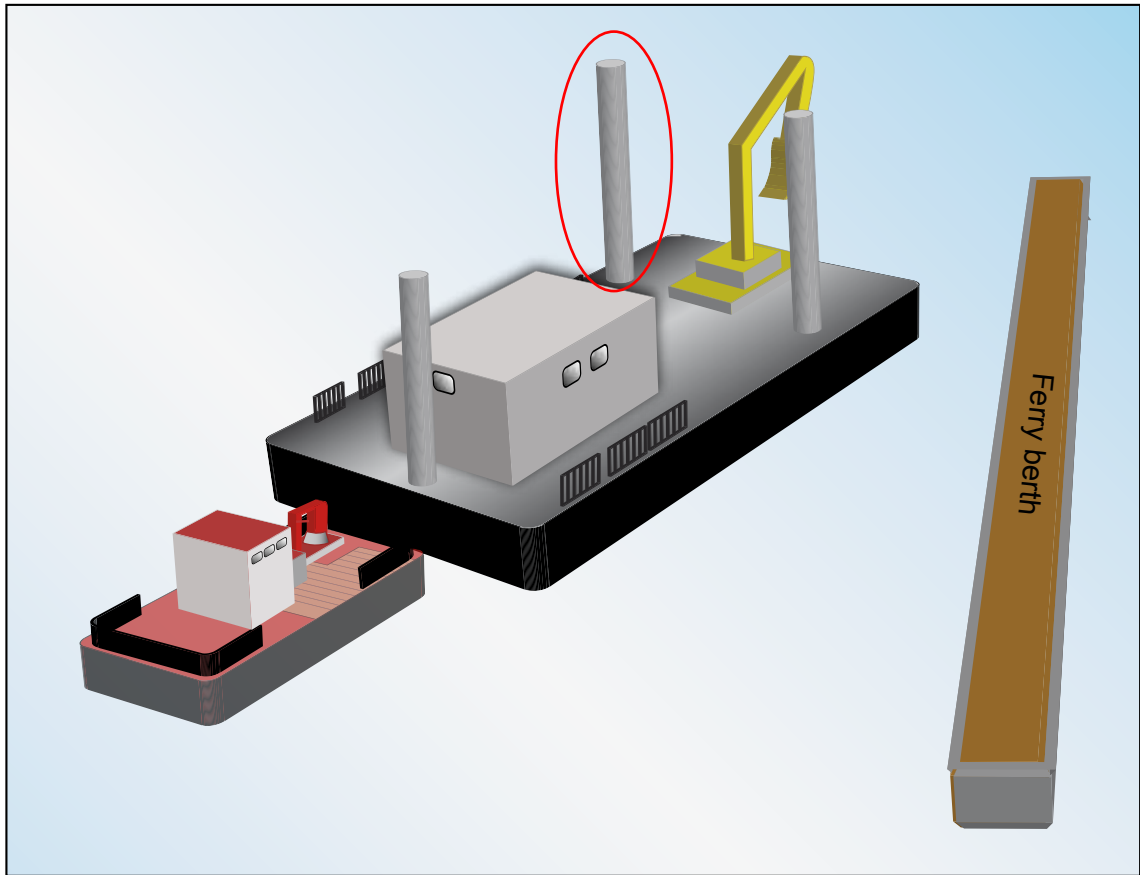
Port spud leg

As *Llanddwyn Island* pushed *Manu Pekka* towards her intended position, the backhoe operator lowered the excavator bucket into the water and informed *Llanddwyn Island* on Very High Frequency (VHF) radio that he was slowing the move. *Llanddwyn Island*'s skipper reduced engine power and the dredger's port spud leg was lowered (**Figure 8**). Both the skipper and the dredging superintendent then went below to join Edward in the wheelhouse. Shortly after, Edward went on to the deck; the skipper assumed that he would not go forward to disconnect the hawser until the manoeuvring was completed.

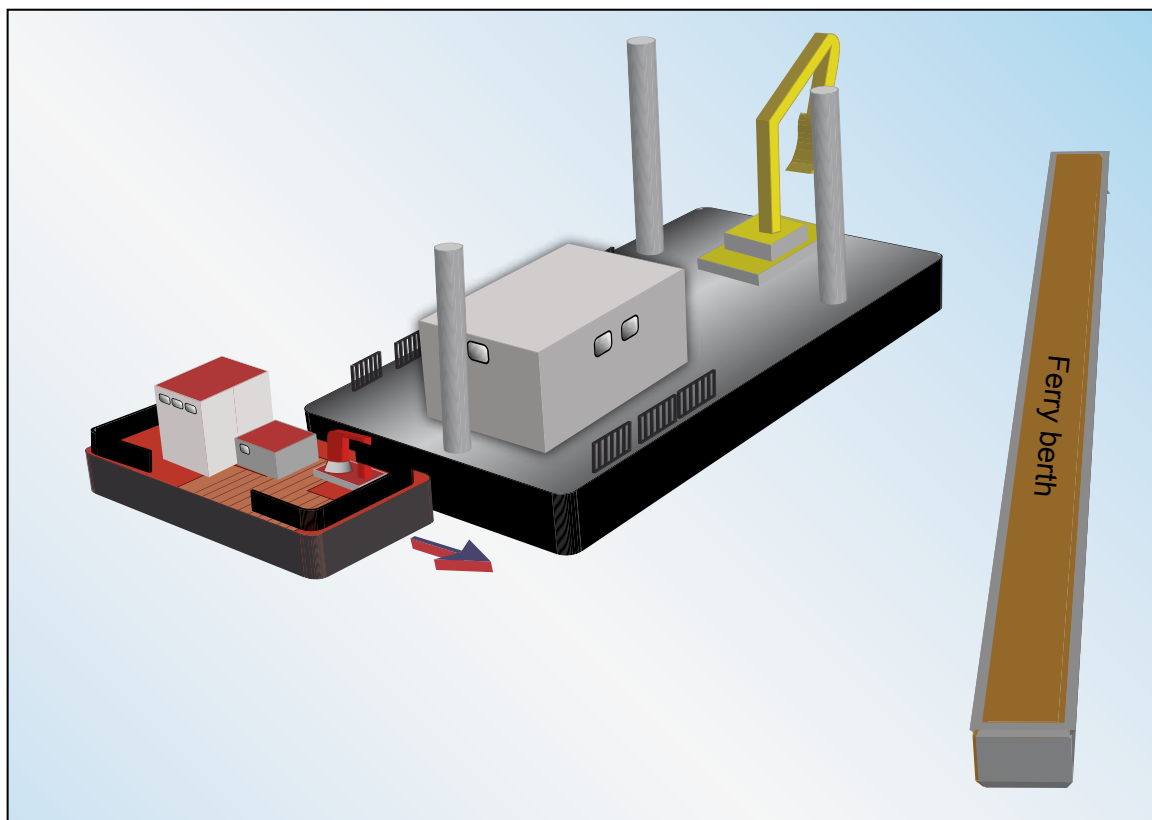
Turning *Manu Pekka* into position

The backhoe operator requested that *Llanddwyn Island* turn the dredger in an anticlockwise direction. To achieve this, *Llanddwyn Island's* skipper veered the winch to ensure that the hawser was slack, and then manoeuvred *Llanddwyn Island's* port side parallel to the stern of *Manu Pekka* with her bow level with the dredger's centreline (**Figure 9**). In this position, *Llanddwyn Island's* skipper was able to assess the dredger's movement by looking down the dredger's port side. The skipper then went ahead on the port engine, applying between a quarter and half power.

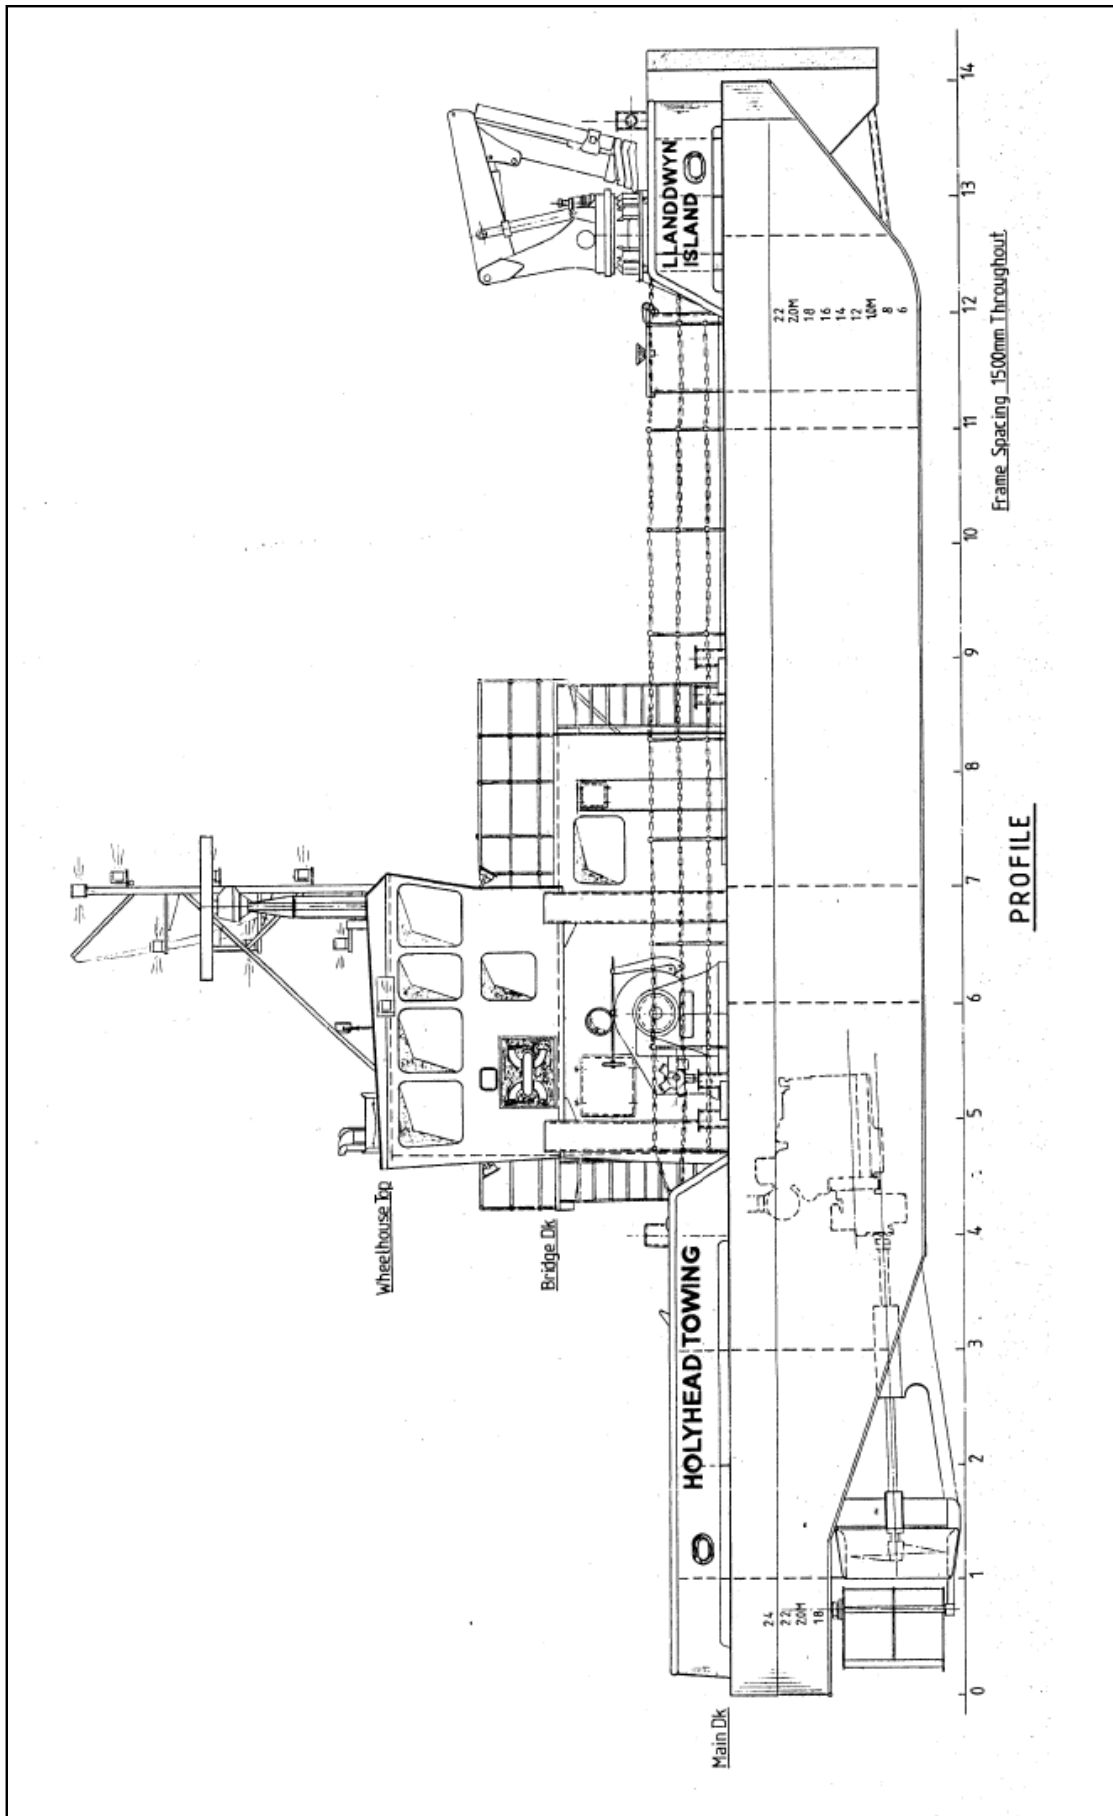
Llanddwyn Island - profile

A hydraulic crane with a safe working load (SWL) of 11.4t was sited on the main deck, forward of the accommodation. An anchor-handling winch with a pulling power of 30t was also sited on the main deck and could be controlled locally or from the wheelhouse. Other deck fittings included a towing hook, sited aft of the winch; a guard on the starboard side of the wheelhouse to protect crew when lines were under tension (**Figure 15**); and two removable dolly pins at the bow which were used when working wires and hawsers. A horizontal deck roller was also fitted on the bow, forward of the dolly pins. The vessel had substantial tyre fendering on her sides and bow.
