Report on the investigation of the
fatal man overboard from fishing vessel

North Star

16nm north of Cape Wrath, Scotland

5 February 2018

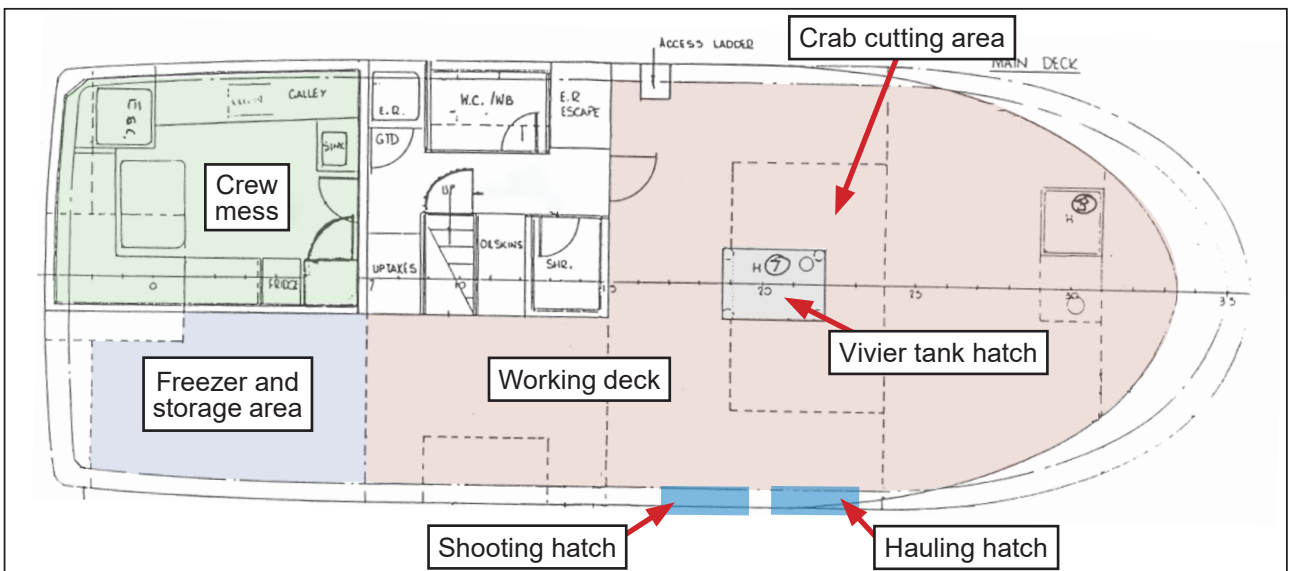
Figure 2: Plan of *North Star*'s main deck level

There were two methods of shooting creels employed on *North Star*. The self-shooting method, which could be used in sea conditions up to sea state 6, and the manual shooting method. The manual shooting method involved Deckhand 1 moving the creels one at a time from the stow to the launching table where Mark Elder was stationed (**Figure 1**). Mark then removed a leg rope from the shooting poles and toggled the creel to it before Deckhand 2 moved the attached creel to the vessel's side ready for it to be launched. Deckhand 3 was stationed at the cutting table, processing the crabs from the previous haul. The skipper was alone in the wheelhouse monitoring the vessel's speed and the closed circuit television system (CCTV) that showed what was happening on the working deck. There was also a tannoy system that enabled the skipper to communicate with the crew and vice versa. The sixth crewman was off-watch and in the crew mess room (**Figure 2**).

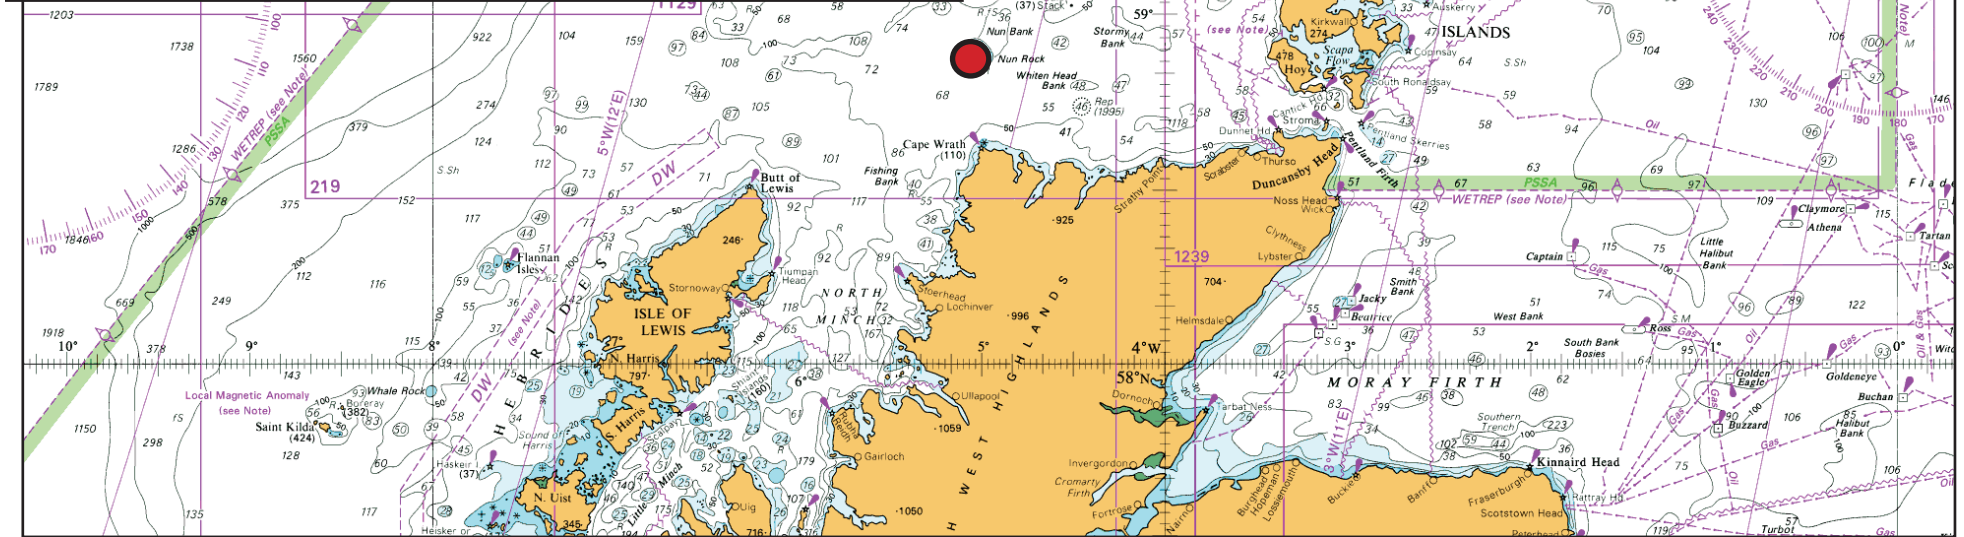
Figure 3: BA Chart 002 showing the location of *North Star* at the time of the accident, with inset of location on BA Chart 2720

At about 1815 on 5 February *North Star* was approximately 16nm north-west of Cape Wrath (**Figure 3**), following a north-easterly course at a speed over the ground (SOG) of 5 knots (kts). Its engine throttle was set to 'ahead'. The four deckhands were on the working deck (**Figure 2**) manually shooting a fleet of creels when the skipper heard a shout of "Easy"¹ over the tannoy. In response, he placed the engine throttle to 'neutral', and *North Star's* SOG gradually reduced, although the vessel continued to make headway.
