Marine Casualties Investigative Body

COSTA CONCORDIA

Marine casualty on January 13, 2012

Report on the safety technical investigation

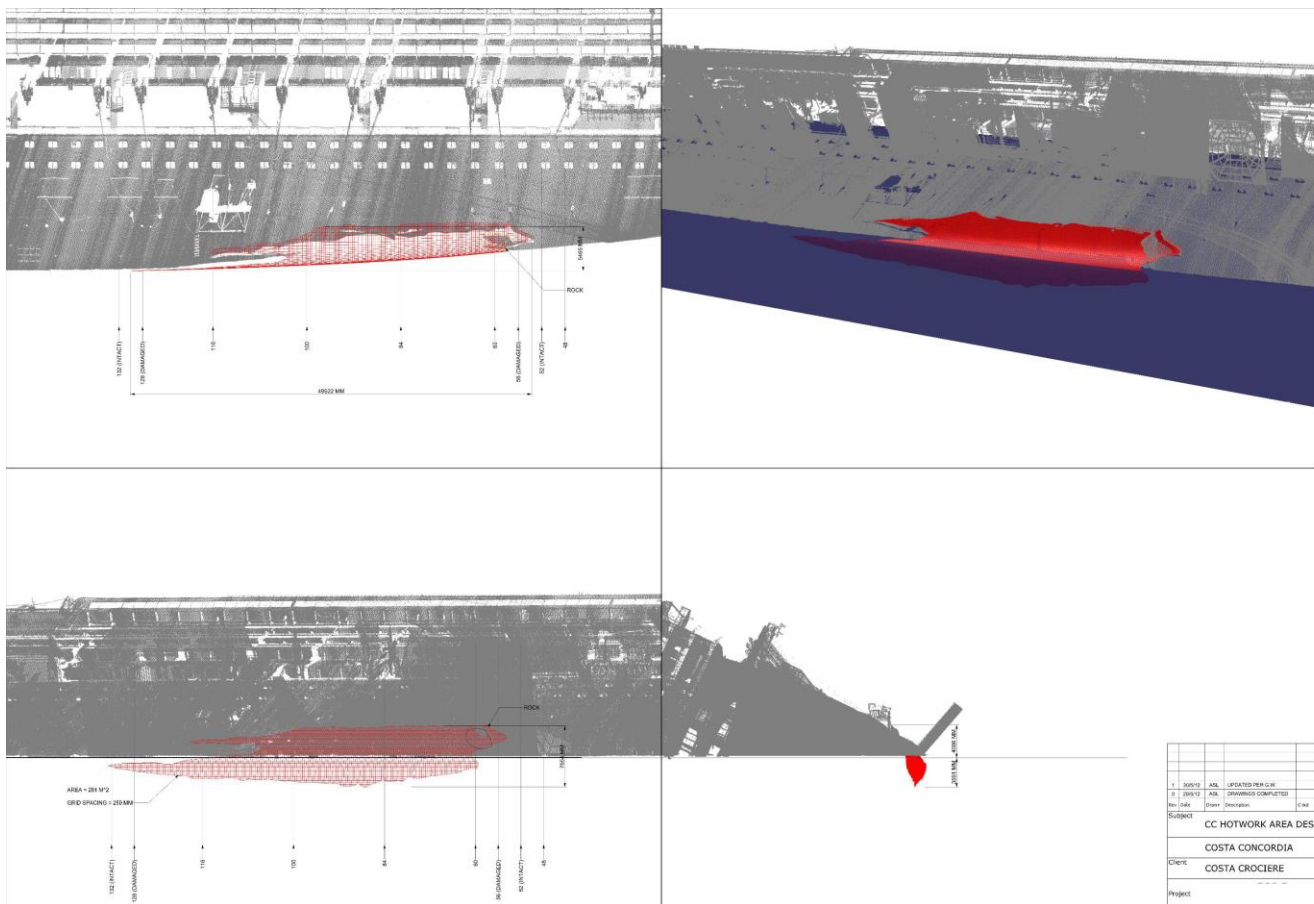
Survey data from salvors

According to the VDR data it results that the impact of the ship against the rocks of Le Scole occurred at 21.45.07 hours, immediately after the Master's order "hard to Port".

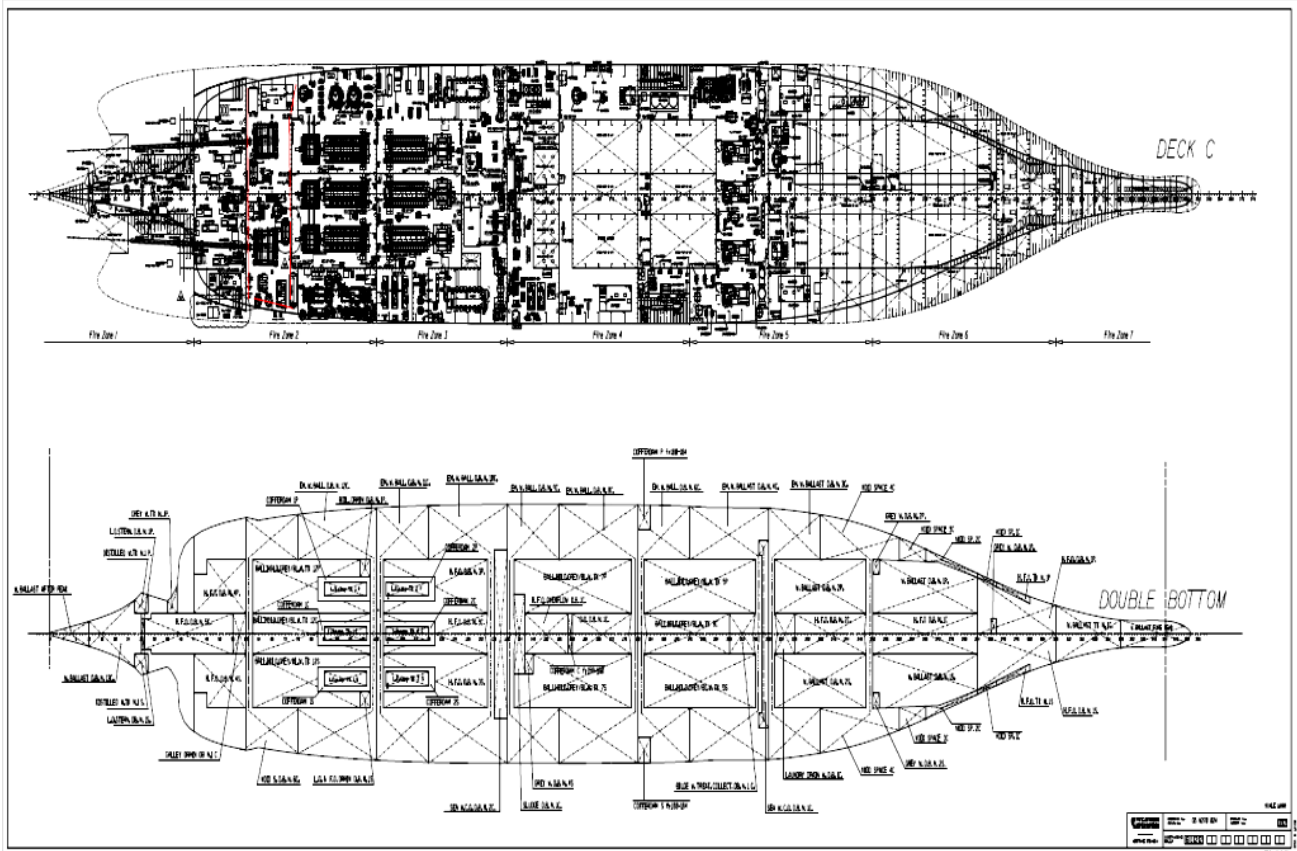
4.7.11 Distribution Equipment-board

The compartments involved by flooding contain the machinery that in Enclosure no 3 attached to Appendix no 9 and reproduced in the following arrangements:
