MARINE SAFETY INVESTIGATION REPORT

**Safety investigation into the lifting sling failure
and subsequent damage to the rescue boat on board the
Maltese registered chemical / oil tanker**

SICHEM LILY

MARINE SAFETY INVESTIGATION REPORT NO. 02/2014

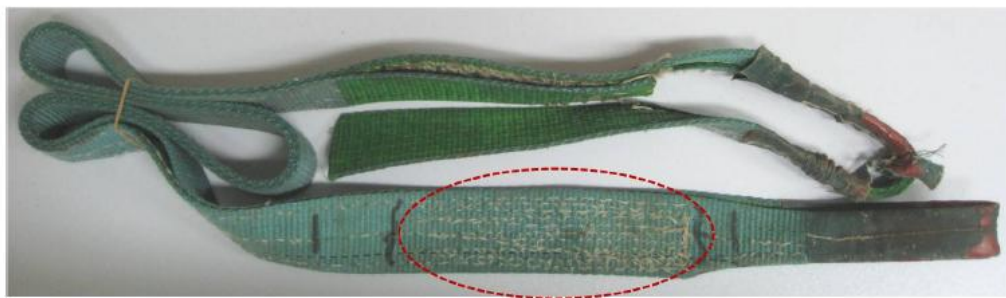
Figure 5 Sling leg used for tensile testing.

Considering that damage to the stitching could not be attributed to say attrition against other bodies one can therefore conclude that the stitching present prior to the sling failure, most importantly at the splice, was already severely degraded. In fact, stitching at the other end of the sling i.e. of the remaining unbroken loop eye was also observed and this showed that the vast majority of the stitches were completely broken or significantly worn (encircled region in Figure 5). The broken stitching is evidently prone to slip through the webbing when relatively low loads are applied.

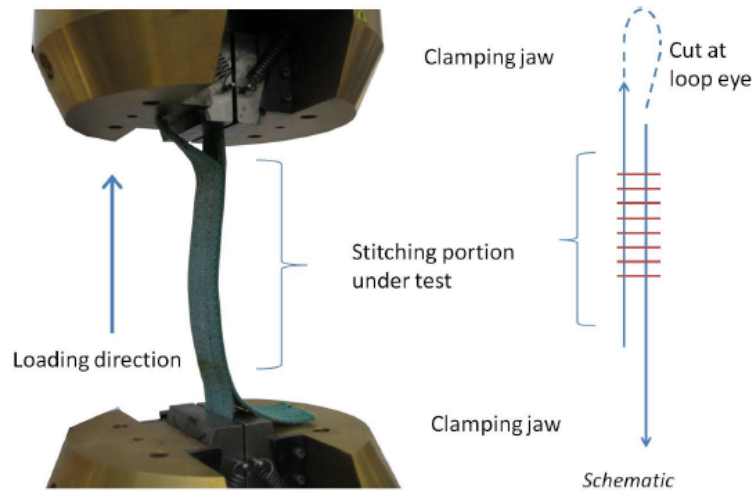
Figure 6 Tensile testing setup.

Tensile tests were conducted in such a way as to measure the (shear) loading which could be sustained by the stitches along the sling splice prior to these being pulled through the webbing. In order to design such an experiment the leg ends were cut at the loop eye and at around 30cm into the length of the sling. This allowed the stitching portion to be tested. The clamping arrangement is shown in Figure 6.
