Marine Surveys UK
Matt West
4 Brook Cottages
Mill Lane
Westbourne
Emsworth
Hants
PO10 8RT

Survey Report no: 10652

Type of Vessel: Jeanneau Arcadia

This survey was carried out in 2010 at Marina, United Kingdom. The above named being a prospective purchaser of the vessel.

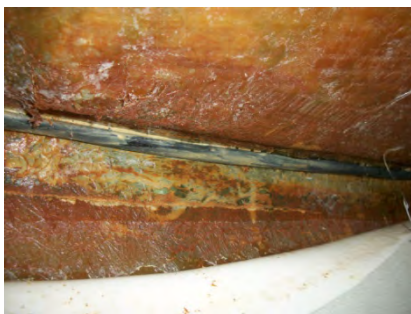
Fig 13 Hull deck bond from inside

- a) This is of mechanical type. The hull moulding has an inward turning flange with the deck moulding lying on top. Stainless bolts are set through an aluminium toe rail on 100mm centres vertically through the deck and the hull flange as well as horizontally every 180mm through the hull. The whole joint is then heavily bonded with FRP laminated. This is visible in the anchor locker, fore cabin, cockpit locker and aft cabin. There are no stains in any area either material linings or wood linings indicating a very secure bond.

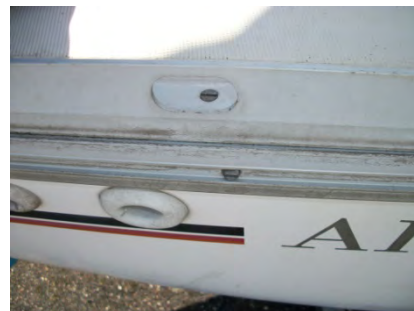
Fig 14 Toe rail fixings external

- b) Toe rail of aluminium extrusion, lying fair and secure except where noted.
c) Starboard Toe rail amidships, evidence of slight crushing causing rail to lift slightly. Checked with moisture meter, no evidence of water ingress.

Suggest both c & d are acceptable as removal will be expensive and probably damage the currently secure bond. Toe rail can be polished to make more acceptable.

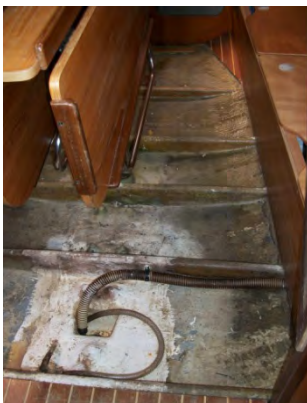
Fig 16 Floors facing

- e) 3 knees where chain plates attach on either side of the hull are bonded to hull and deck.
- f) The cabin soles were lifted, all floors visually checked and hammer tested, all lockers opened and bonding checked. No stress cracks, fractures or failure of bonding was noted.

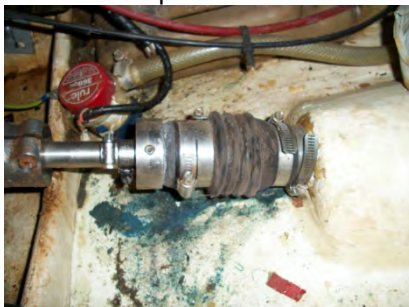
Fig 20 PSS Stern Gland and seal

- f) Stern gland and seal. This is an aftermarket PSS seal, attached to the stern tube which is bonded into the hull. The security of the stern tube could not be checked due to attachment of bellows. Fixing clips were all hammer tested and viewed underside with a mirror. The bellows were checked for splits and as far as can be ascertained are in good condition.
