New MTS 4100 NVH Analyzer Identifies Vibration Sources

New Design Rear Axle Output Seal and Axle Shaft

Under Body Noise on Uneven Road Surface

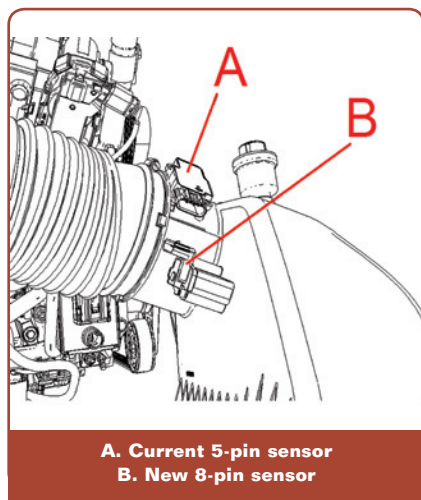
A. Current 5-pin sensor
B. New 8-pin sensor

The gasoline engines replace the Mass Air Flow/Intake Air Temperature (MAF/IAT) 5-pin sensor with the 8-pin Multifunction Intake Air sensor.

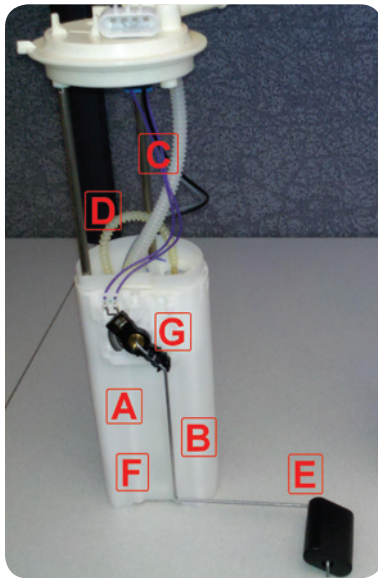
- A. The pump changed from a Gerotor pump to a Generation 4 Turbine pump, which is quieter and more durable.
- B. The module plastic material changed to a more fuel resistant Acetyl plastic that provides an improved high alcohol fuel tolerance.
- C. Guide rods were reduced from 3 to 2, which retains proper alignment while reducing pinching.
- D. Jet pump has been added to help maintain fuel in the reservoir.
- E. The float material is more fuel resistant for longer life.
- F. The external strainer has been moved inside the fuel module to help reduce the chance of puncture.
- G. Some float arms and pivot points have changed; however, the fuel level sensor output has not changed.

While the appearance of the fuel modules has changed, the fit, form and function has not. In addition, the part numbers did not change.

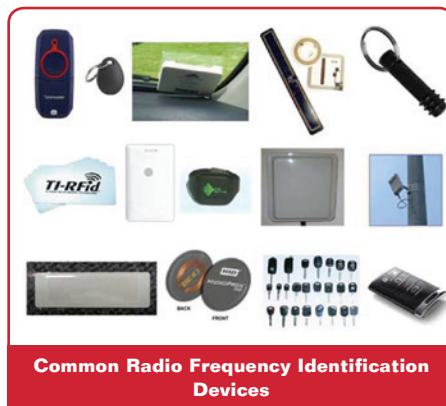
Common Radio Frequency Identification Devices

With the advancements in today's technology, there has been a great increase in the number of Radio Frequency Identification Devices (RFID) found across many communities, businesses, and automobiles. It is possible that another RFID device may

interfere with the Passkey system. The range of the interference can vary based on the strength of the RFID, which may affect the key-to-exciter module communication. The most common devices found are: vehicle immobilizer keys from other vehicles, keyless access transmitters from other vehicles, highway/bridge toll passes, gate passes, community/parking access cards, fuel station speed passes, and building access swipe cards/transponder devices.

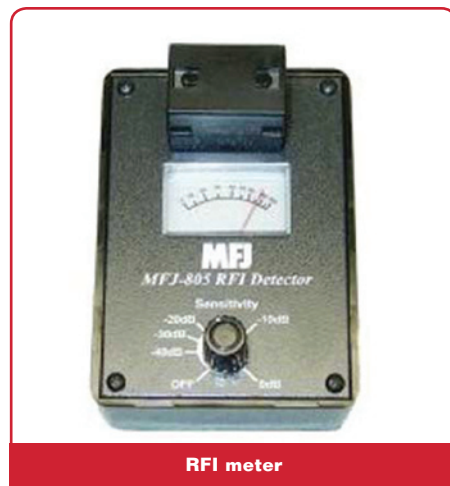
For vehicles with Passive Entry/Passive Start, it is possible to get RFI from

transponders or other frequency-emitting devices in the area. An aftermarket RFI meter can be used as an aid to locate the stray RFI signals.
