Mays Consulting & Evaluation Services, Inc.

BUILDING ENVELOPE ASSESSMENT
COLUMBUS METROPOLITAN LIBRARY
SOUTH HIGH BRANCH
COLUMBUS, OHIO
DECEMBER 12, 2018
MAYS PROJECT # COH44-011

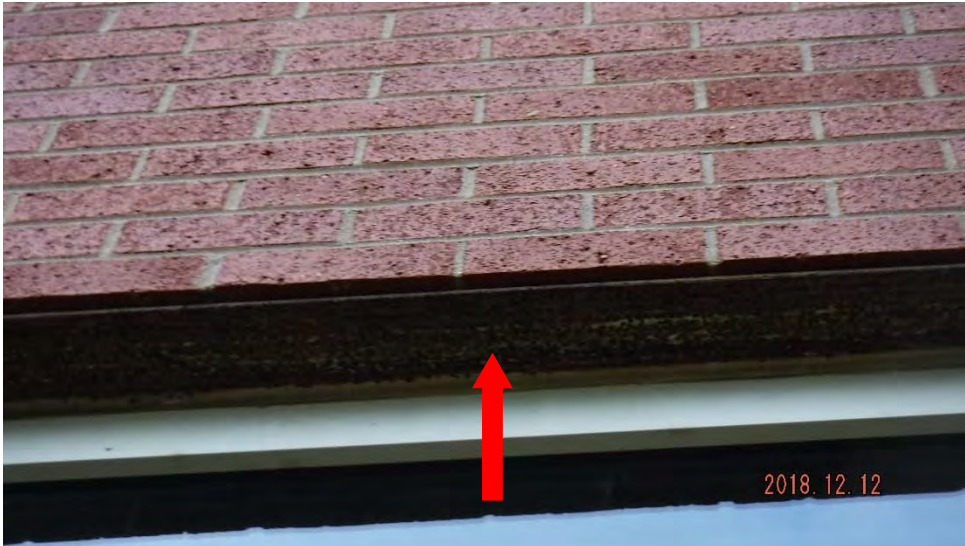
3. Finding – Window Lintels: The window lintels were found to have moderate to heavy corrosion at several locations on building.

3b. Corrosion on window lintel (see #3 on elevation photo for location).

Recommendation – Window Lintels: Properly prep and clean, then re-paint the lintels.

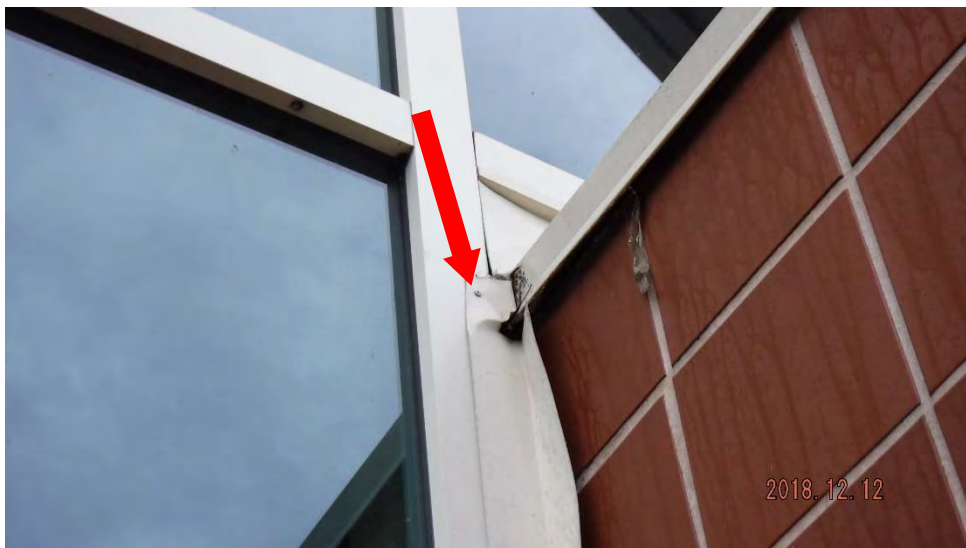
7b. Fastener through fastened into window frame (see #7 on elevation photo for location).

Recommendation – Metal Flashing: Remove the flashing and determine area of leakage. Make necessary repairs to the window framing, and seal the areas between the wall and window to alleviate the need for the metal flashing.

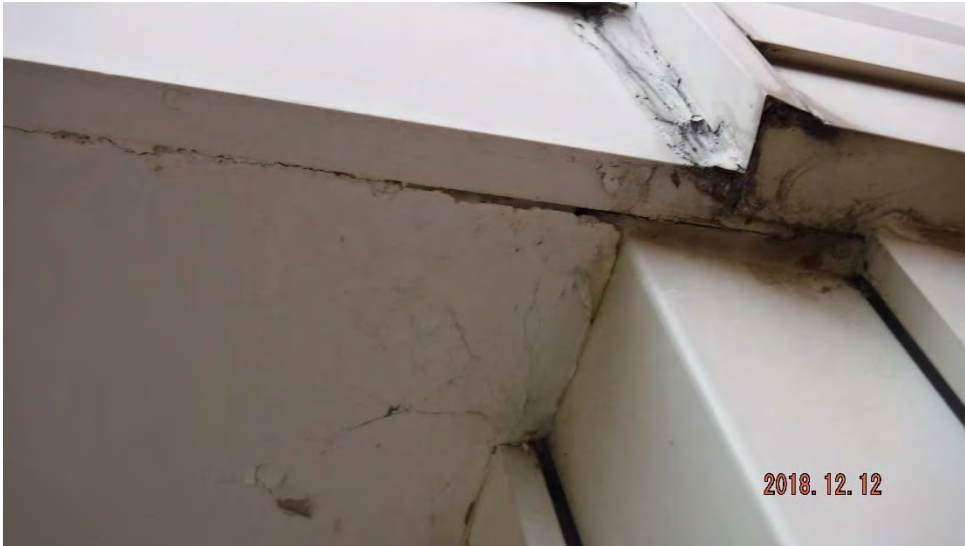
2c. Deterioration of soffit ceiling and chipping/flaking paint (see #2 on elevation photo for typical location).

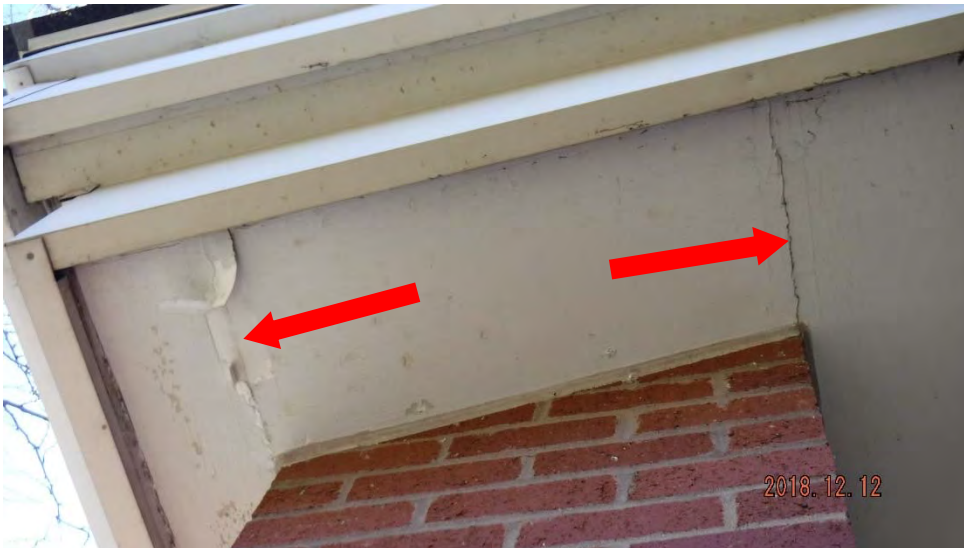
4d. Cracked joint, delaminating tape, and chipping/flaking paint (see #4 on elevation photo for typical location).

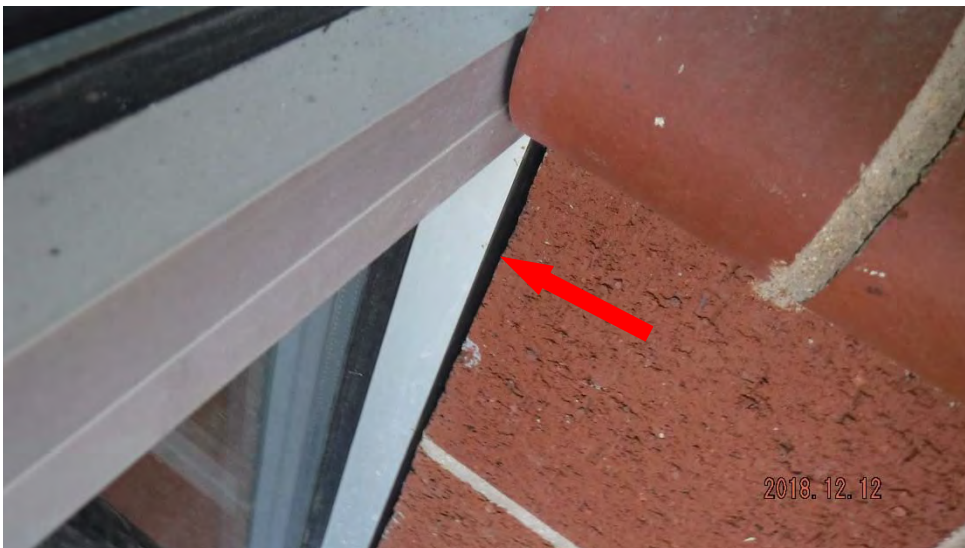
6b. Gap between masonry and window/door frame (see #6 on elevation photo for location).

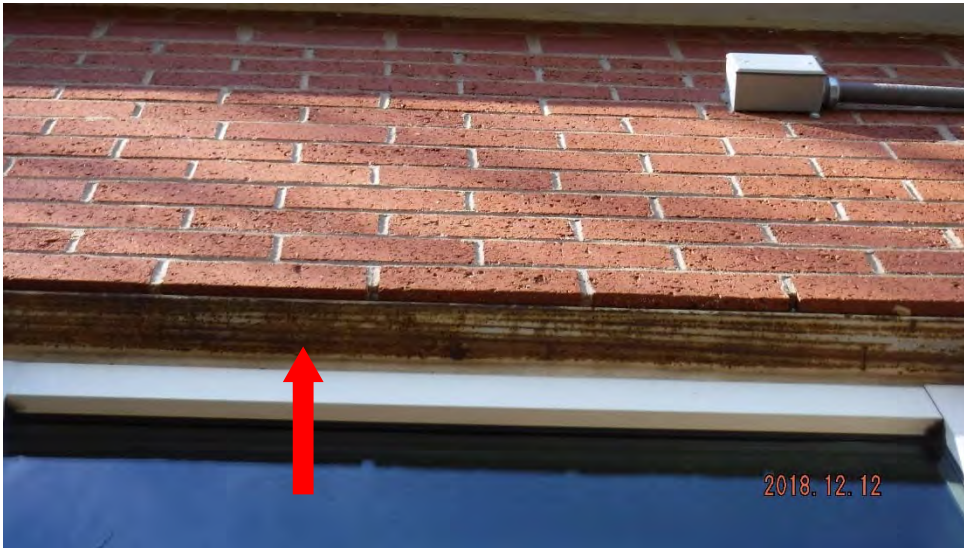
7. Finding – Window Lintels: The window lintels were found to have moderate to heavy corrosion at several locations on building.

7a. Corrosion on window lintel (see #7 on elevation photo for location).

Recommendation – Window Lintels: Properly prep and clean, then re-paint the lintels.

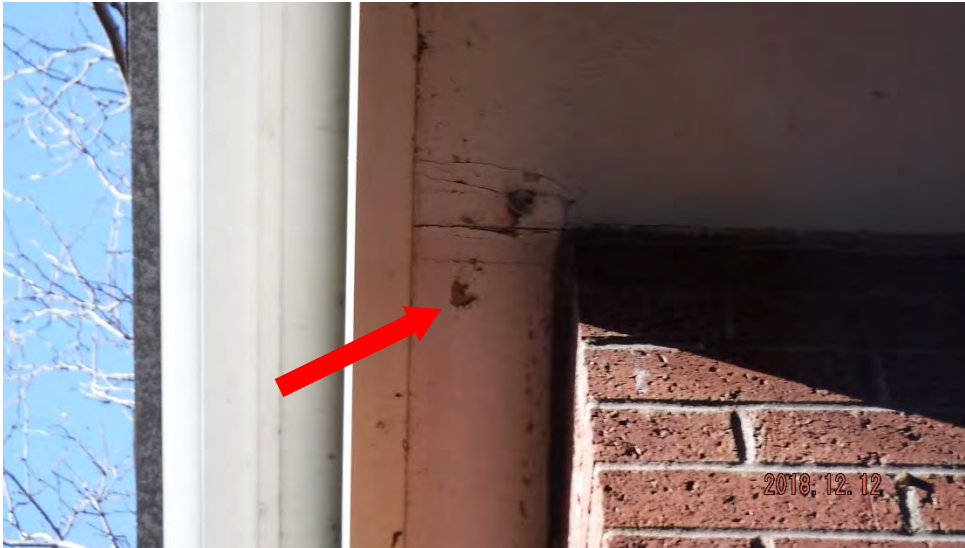
3b. Disrepair of soffit and chipping/flaking paint (see #3 on elevation photo for typical location).

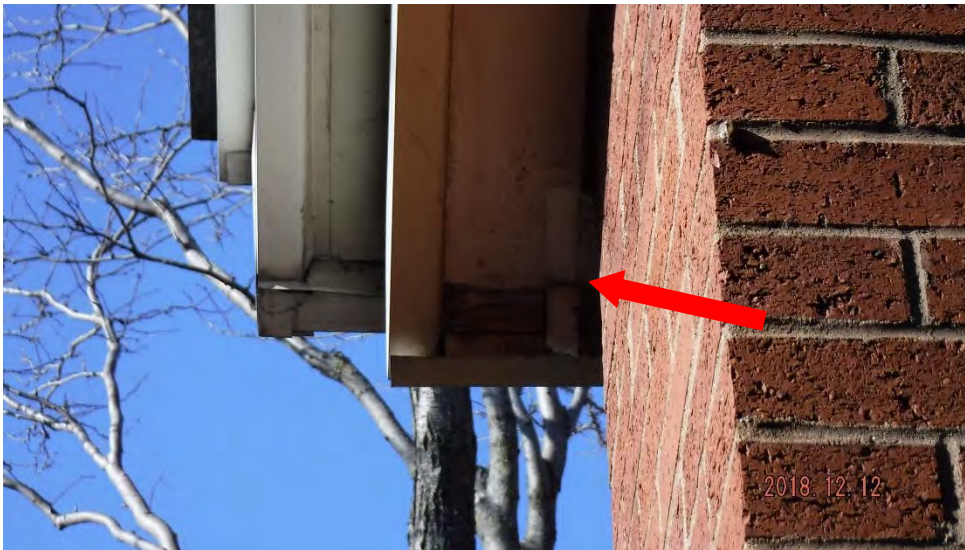
3c. Disrepair of soffit and chipping/flaking paint (see #3 on elevation photo for typical location).

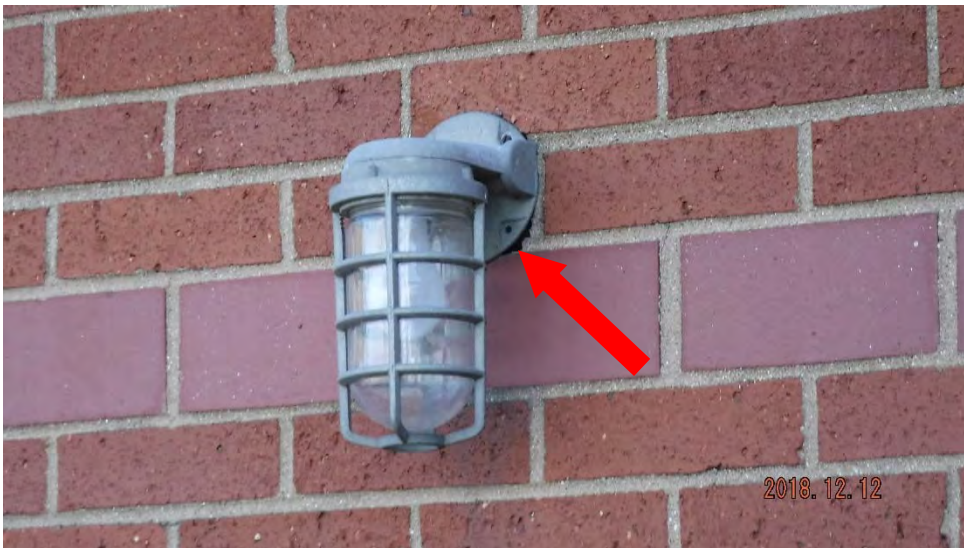
1. Finding – Wall Penetrations: There are some penetrations protruding through the masonry veneer that are not sealed.

1b. Open joint between penetration and veneer (see #1 on elevation photo for location).

Recommendation – Wall Penetrations: Prep the joint between the protrusion and the veneer, then install backer rod and sealant as needed.

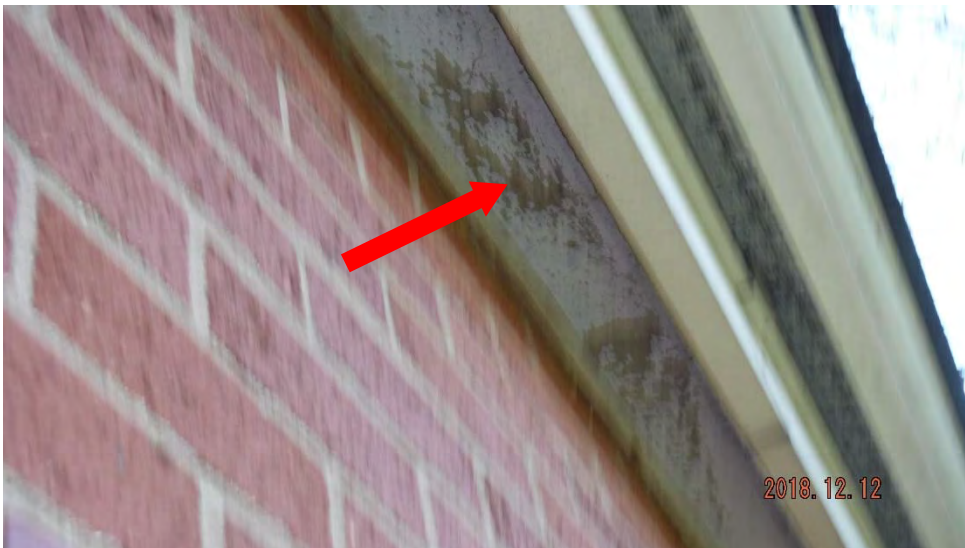
2. Finding – Overhang Soffit: The overhang soffits around the building are in disrepair. There is deterioration, exposed fasteners, cracked joints, and chipping/flaking paint.

2b. Chipping/flaking paint (see #2 on elevation photo for typical location).

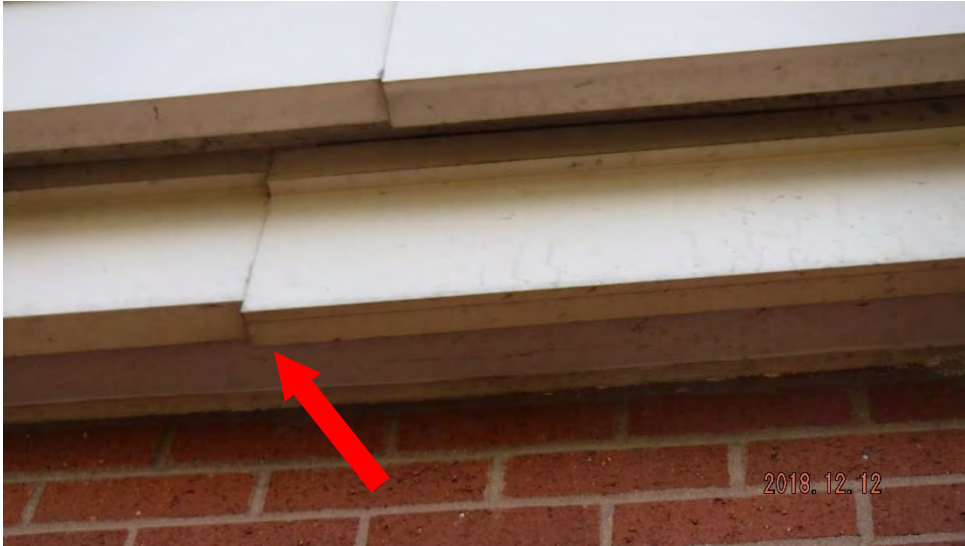
4. **Finding – Fascia Metal:** There are several sections of loose fascia metal located around the building.

4a. Unsecured/loose fascia metal (see #4 on elevation photo for location).

Recommendation – Fascia Metal: Re-secure the fascia metal or replace if needed.

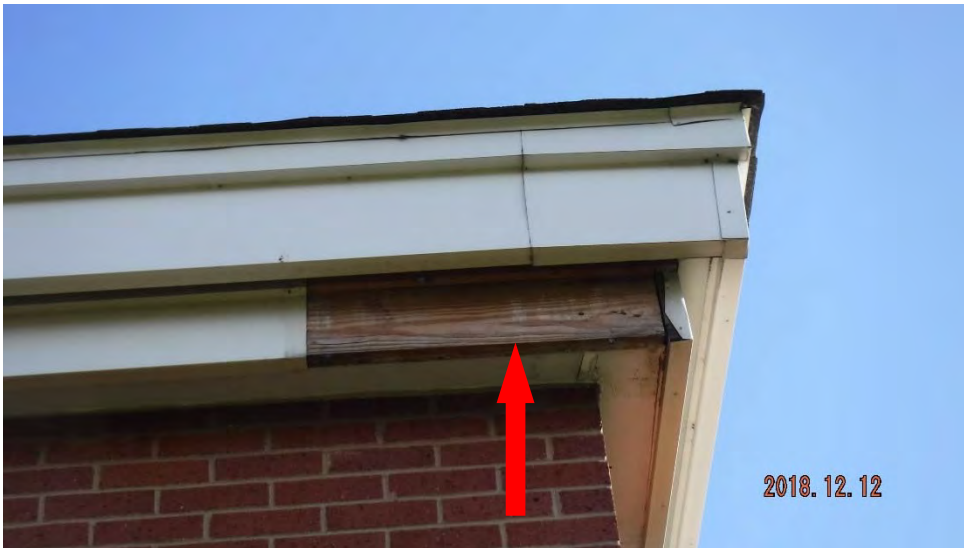
5b. Exposed wood member where fascia metal is missing (see #5 on elevation photo for location).

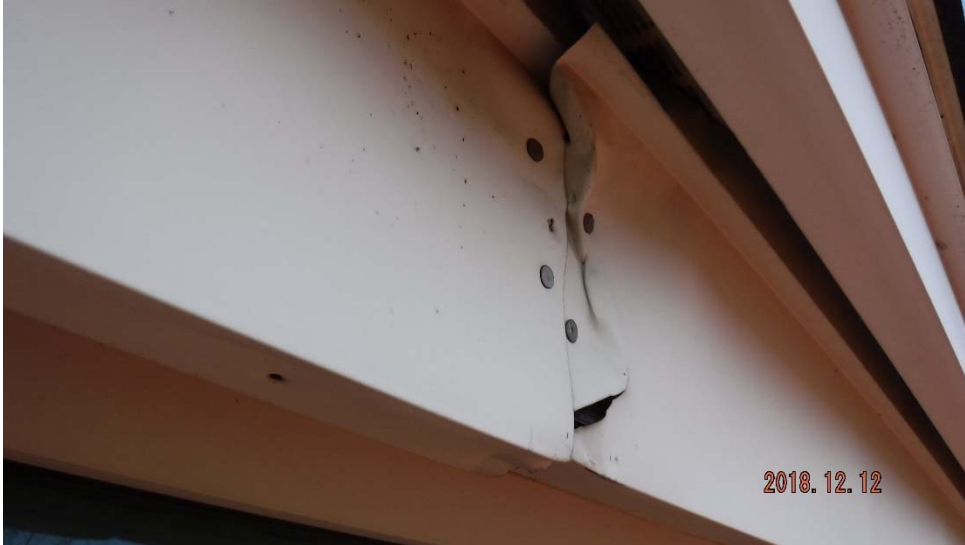
1. **Finding – Fascia Metal:** The fascia metal above clerestory windows is damaged at areas.

1a. Damaged fascia metal (see #1 on plan view for location).

Recommendation – Fascia Metal: Replace the damaged fascia metal where needed.

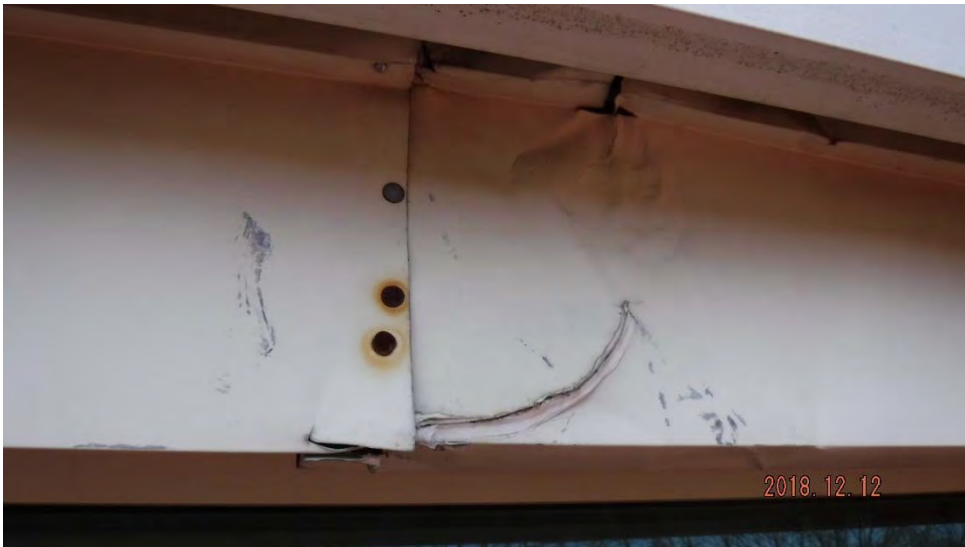
1b. Damaged fascia metal (see #1 on plan view for location).

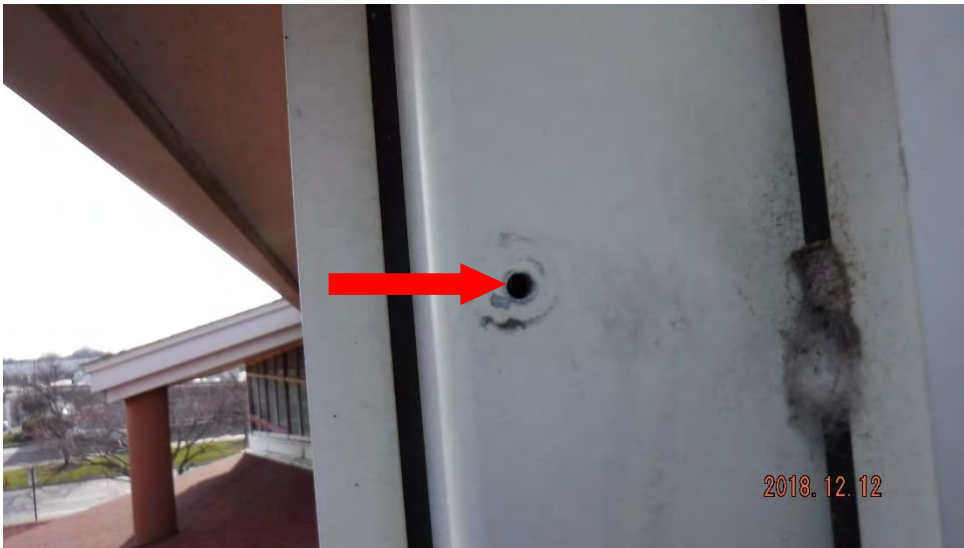
2. Finding – Steel Members at Clerestory: There are some steel members located at clerestory area where items had been removed and left open holes in the steel tubing.

2a. Hole in steel member where item was removed (see #2 on plan view for location).

Recommendation – Steel Members at Clerestory: Seal the holes to prevent water from migrating into the steel tubing.

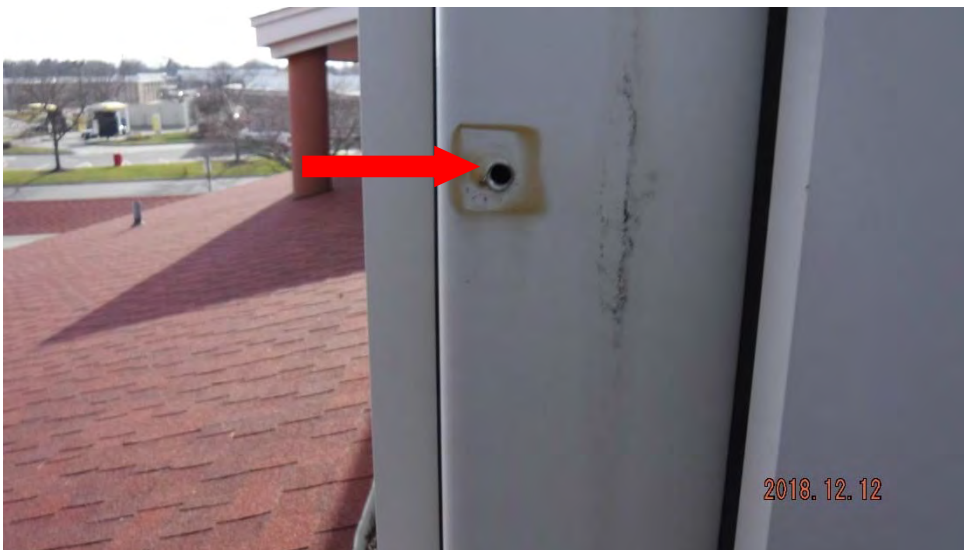
2b. Hole in steel member where item was removed (see #2 on plan view for location).

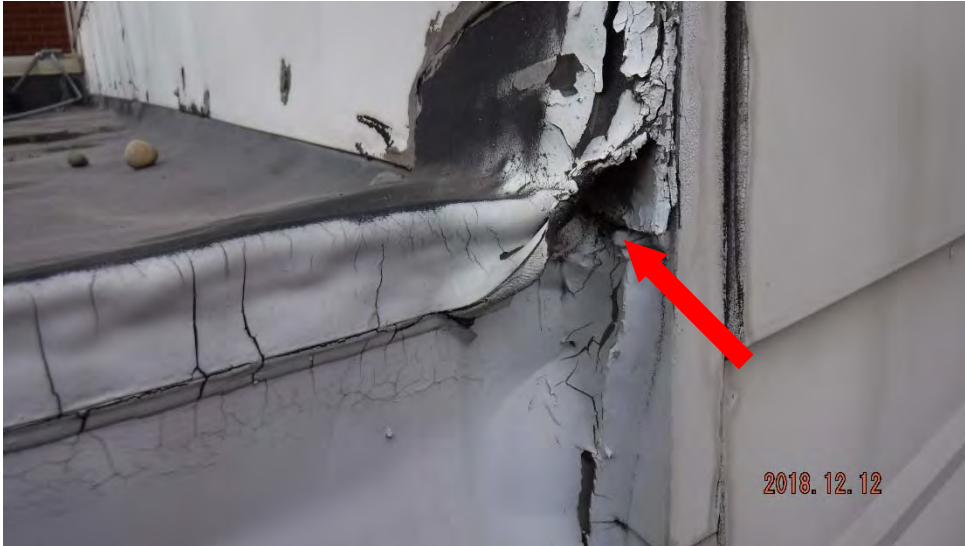
4. **Finding – EPDM Roof Flashing:** There is an open flashing on the EPDM roof where the roof edge and the wall come together.

4a. Open flashing at roof edge to wall (see #4 on plan view for approximate location).

Recommendation – EPDM Roof Flashing: Patch the open flashing to get roof watertight.

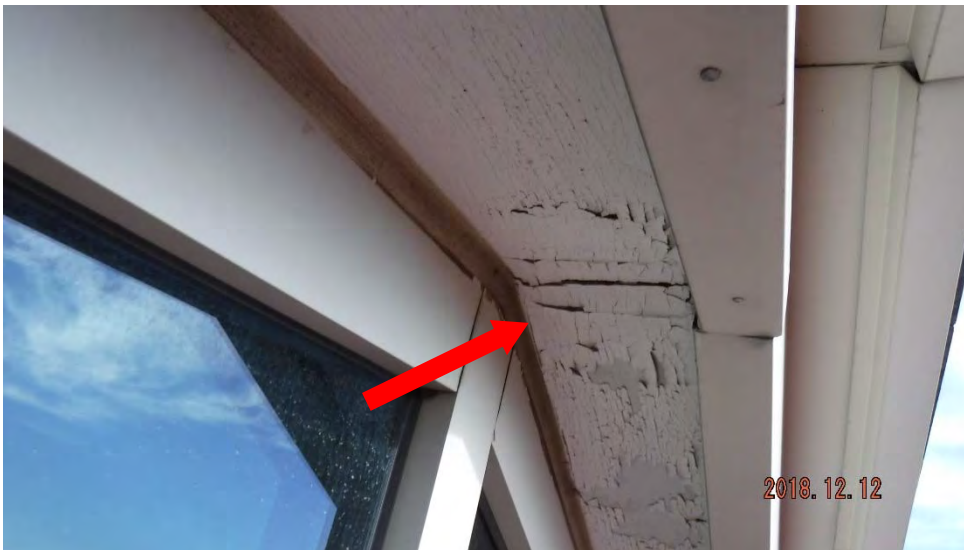
1. Finding – Overhang Soffit: The overhang soffits at the clerestory are in disrepair. There is deterioration, exposed fasteners, cracked joints, and chipping/flaking paint.

1b. Chipping/flaking paint (see #1 on elevation photo for typical location).

Recommendation – Overhang Soffit: Repair or replace deteriorated areas, fix cracked joints, properly prepare all surfaces and then re-paint.
