Re: Historic Preservation Report for
McIndoes Academy, Academy Lane, McIndoe Falls (Barnet), VT
Feasibility Study for Renovation & Adaptive Re-use Project

McIndoes Academy – Historic Preservation Letter, April 25, 2018

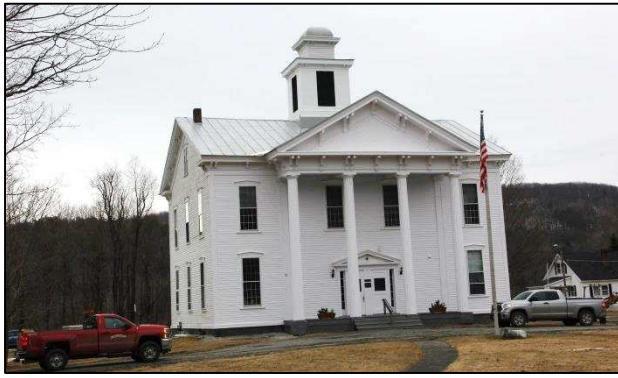
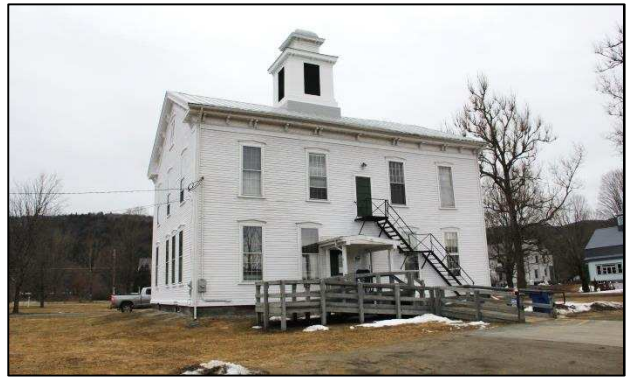
Top left: (5) McIndoes Academy front (west) & north elevations, looking east; Top right (6) Academy south & east (rear) elevations, looking west

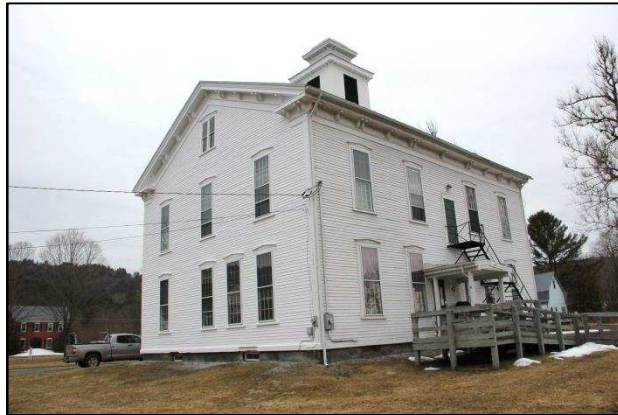
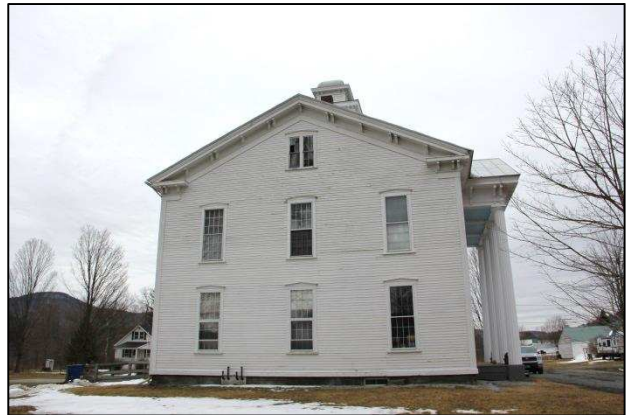
Left: (7) Academy south & rear elevations, looking northwest; Right: (8) North elevation, looking south

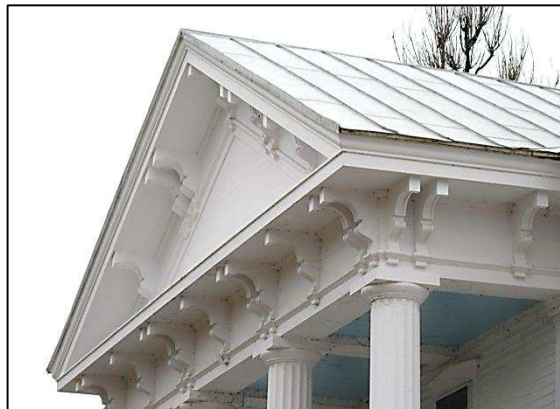
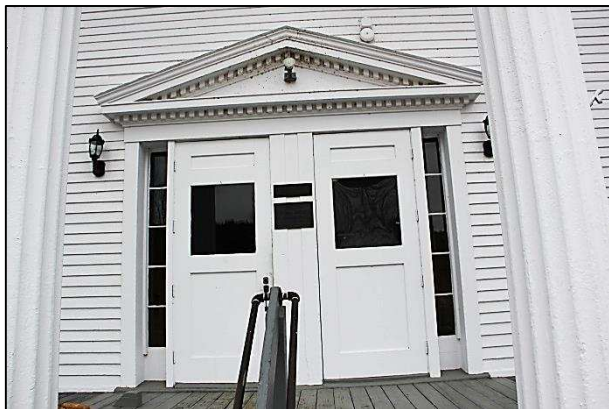
Two rows above (clockwise from upper left): (9) Detail of front pediment; (10) detail of front entry and doors; (11) Detail of cupola/belfry and gable raking cornice; (12) Detail of northern chimney on standing seam roof

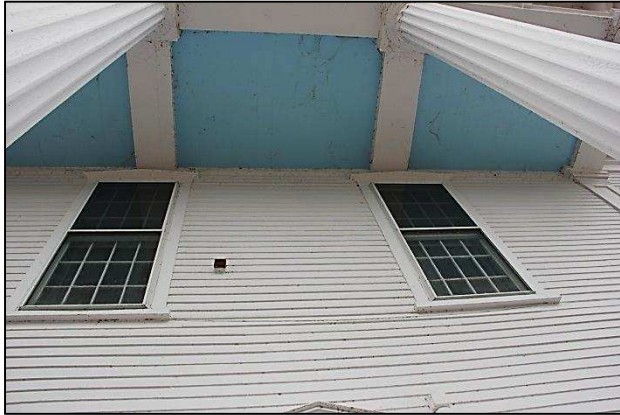
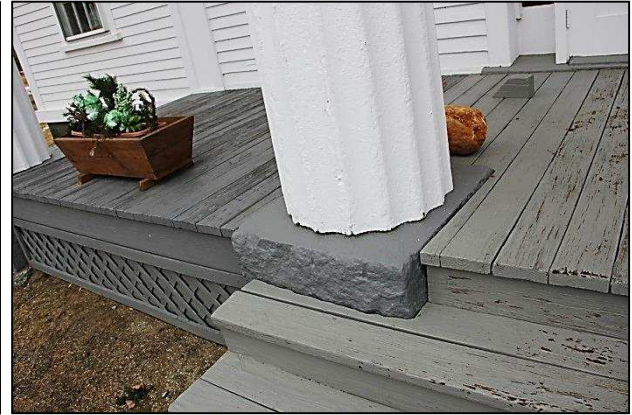
Left: (13) detail of portico ceiling and front elevation; Right: (14) detail of portico porch and column

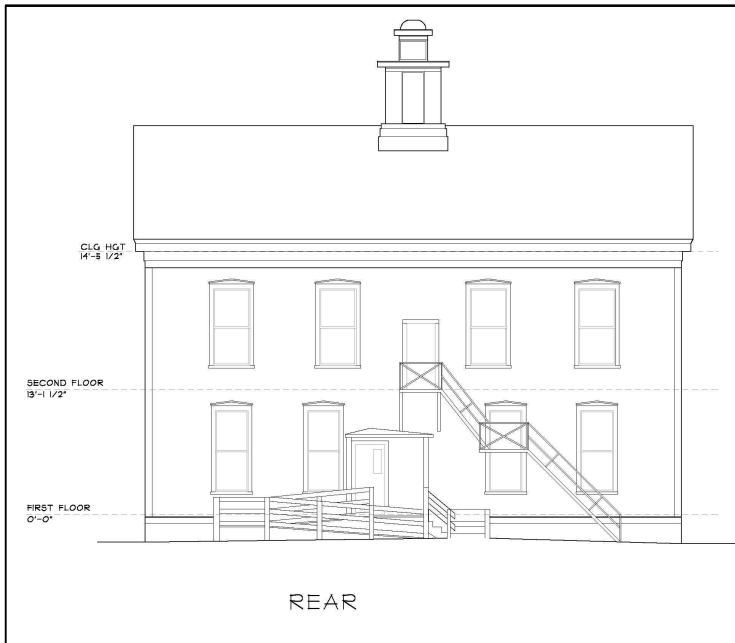
The rear (east) elevation has undergone the most alteration by the addition of an early 20th century metal fire escape from the second floor – through a door that appears to have been added between the center two window bays. The wooden door has 5 stacked panels, typical of c. 1900 – 1920 doors. The open tread metal stair leads down to the north with one landing that crosses a first floor window. A rear, off-center new ground floor entrance doorway has been added in the late 20th century along with a large wooden ramp and gable canopy over an entrance deck. The door is metal with a small off center window. Neither doorway on the rear façade has the peaked lintel trim of the windows but rather plain board trim.

Left: (15) Detail of first and second floor windows; Upper right: (16) Detail of rear second floor fire stair; Lower right: Existing rear (east) elevation (Arnold & Scangas Arch.)
