MEMORANDUM FOR FILES

SUBJECT: Ambler Asbestos Piles Superfund Site, OU1 & OU2, Ambler, PA – Site Inspection Report

1. **DATE OF INSPECTION:** 8 December 2015, 0900 HRS to 1200 HRS.

4. **PURPOSE:** Conduct a quarterly site inspection.

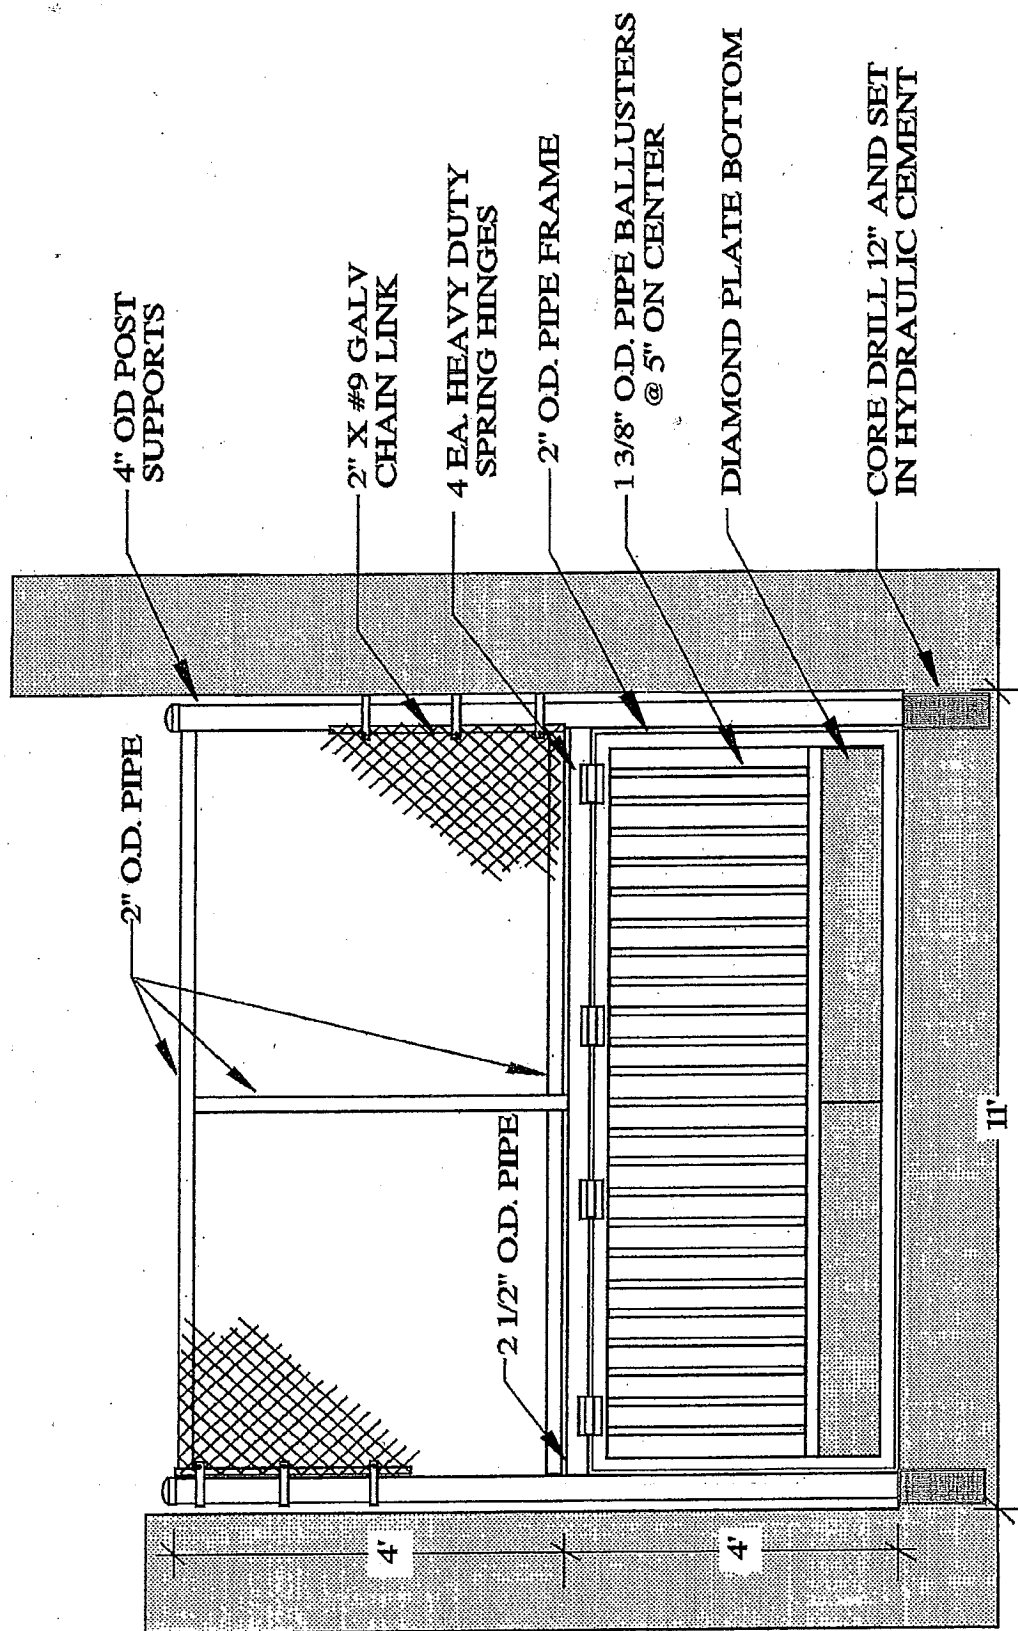
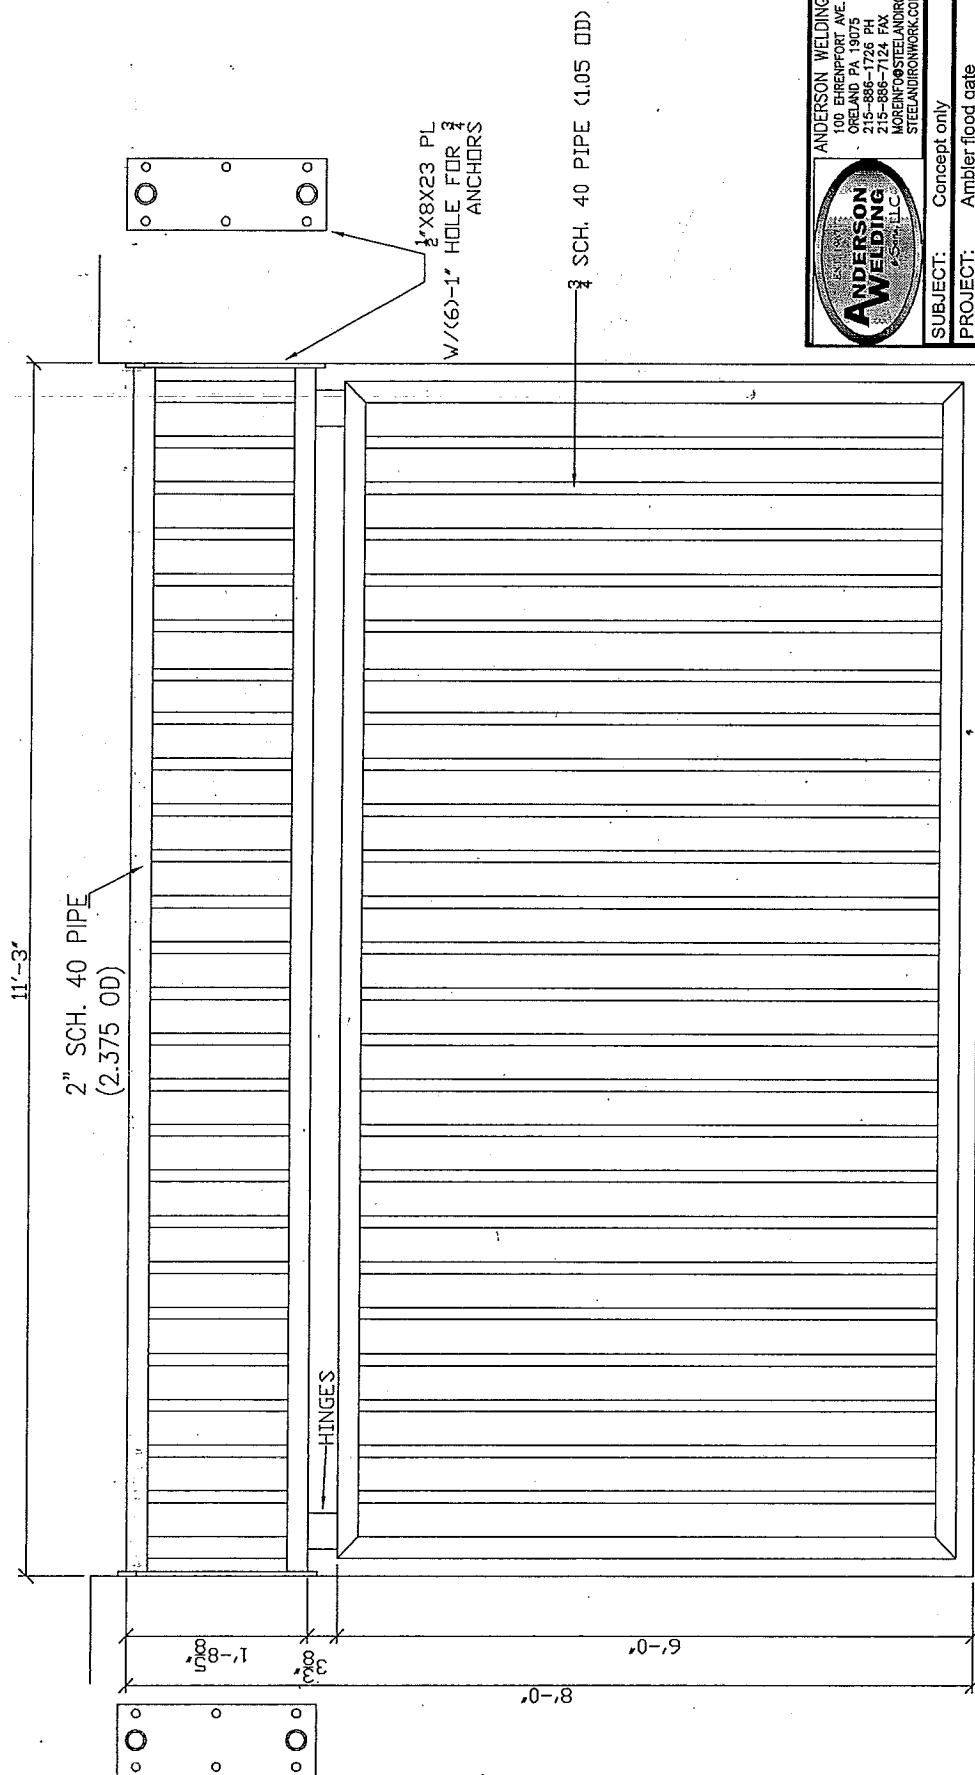
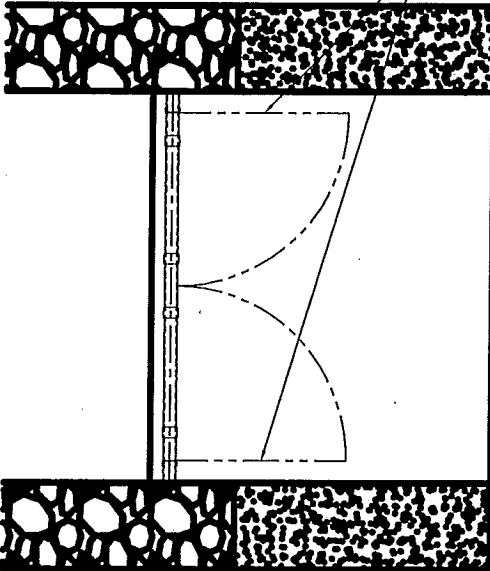
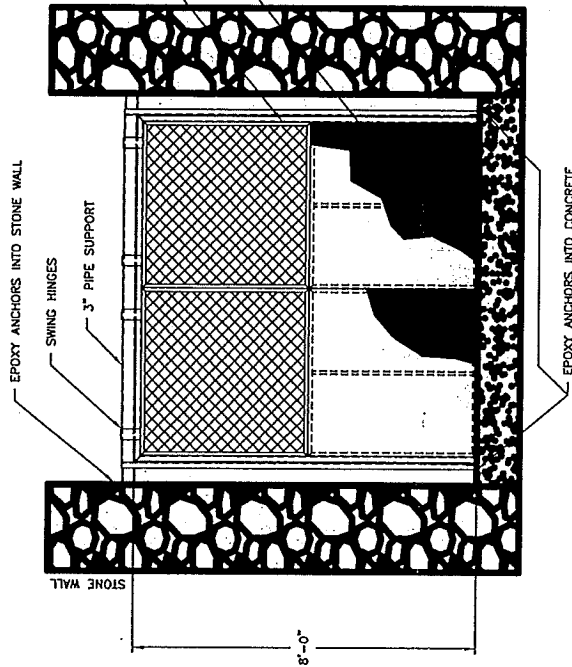
FLOOD RELEASE GATE

APEX FENCE

(1) FLOOD GATE GALVANIZED STEEL

DOUBLE DOOR FOR MAINTENANCE
(LOCKABLE)

EPOXY ANCHORS INTO STONE WALL

SWING HINGES

7.3 The clogged fence at the drainage outlet should be removed and a swing gate should be installed on the stone culvert. The site should be secured by adding fence or making it higher as required. The erosion at the outlet should be repaired using geotextile/rip rap and possibly some fill to reestablish the eroded subgrade. (Figure 6)
