Engine Wiring Harness Chafing Repairs

TECH LINK

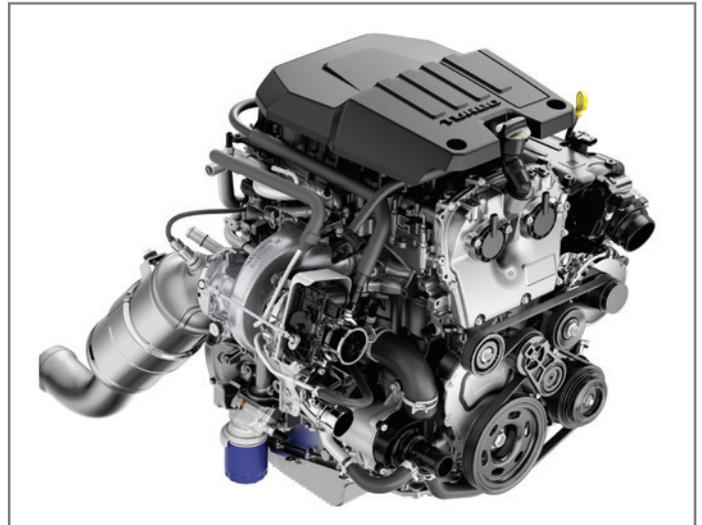
2.7L turbocharged engine

When diagnosing engine oil leaks on 2019-2022 Silverado, Sierra; and 2020-2022 CT4-V models equipped with the 2.7L turbocharged 4-cylinder engine (RPO L3B), inspect the dipstick tube (indicator tube) O-ring and areas above the composite oil pan sealing surface. These potential oil leak areas should be checked before determining the lower composite oil pan as the source of the engine oil leak. The oil leak may have a similar appearance to an engine oil cooler leak.

Signs of oil spray may be seen on the left side of the engine or the oil leak may only occur after a road test on the left side of the engine.

Check for an oil leak from the dipstick tube O-ring with an inspection mirror. There may not be any oil residue around the dipstick tube O-ring area.

Remove the dipstick tube and inspect the dipstick tube O-ring for damage. Replace as necessary. Use extra care when replacing the dipstick tube. There may be sharp edges on the lower crankcase extension that could potentially damage the O-ring during installation.

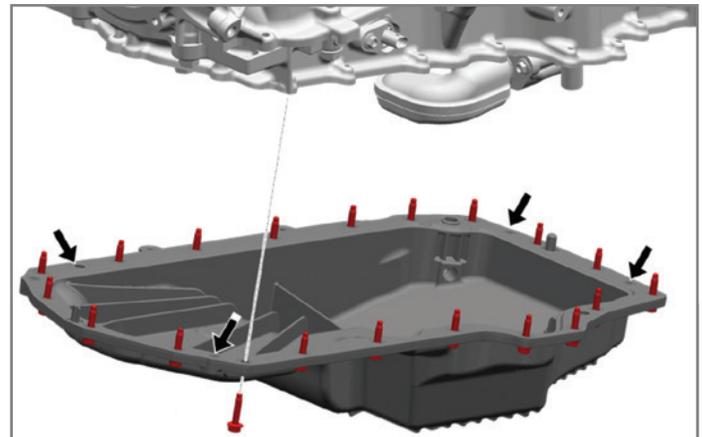
The oil pan incorporates four jack screws to help with removal.

The composite oil pan is attached at the engine block lower structural extension (LCE). The oil pan incorporates four jack screws (threaded inserts) that need to be used during the removal procedure. Tighten the jack screw by hand 1 to 2 turns. Turn each uniformly and move to the next screw until the oil pan has full separation from the LCE. Do not pry on the oil pan to LCE or the sealing surface may be damaged.

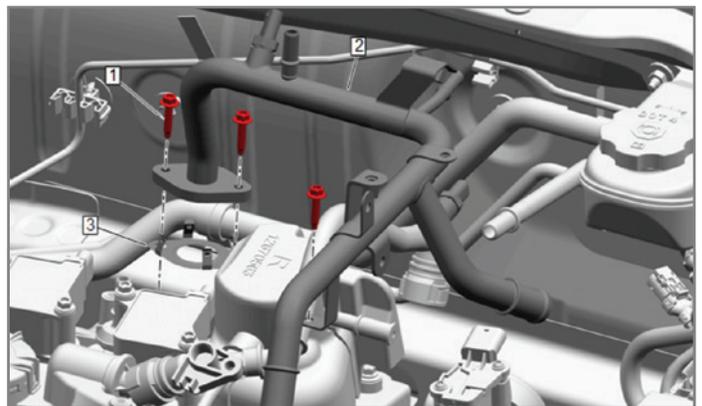
Exhaust manifold outlet pipe

During diagnosis, GDS 2 Engine Cooling and HVAC Data may show that the temperature difference between the heater inlet (ECT sensor 3) and heater outlet (ECT sensor 4) is over 30°C (86°F) when the engine is warmed fully. If this temperature difference between the heater inlet (ECT sensor 3) and heater outlet (ECT sensor 4) is found, use a general boroscope to check for a blocked exhaust manifold outlet pipe. Allow enough time for the engine cooling system to cool before opening.

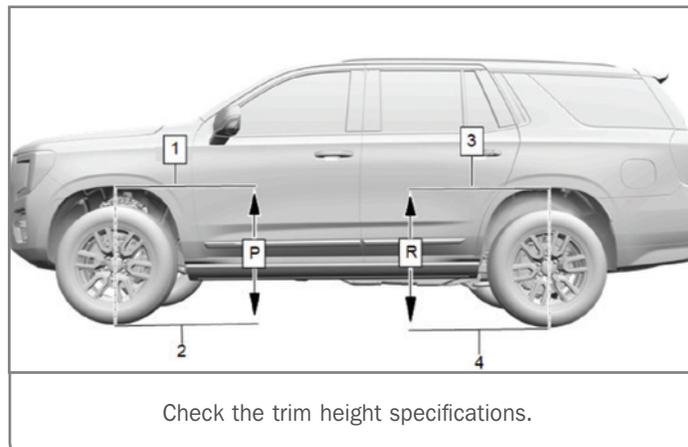
If these DIC messages are displayed, check if the vehicle ride height has been altered. Refer to the Trim Height Inspection procedure in the appropriate Service Information. Trim height is a predetermined measurement relating to vehicle ride height and incorrect trim heights can cause the vehicle to bottom over bumps, damage the suspension components, and show symptoms similar to wheel alignment problems. Always check the trim heights when diagnosing suspension concerns and before checking the wheel alignment.

Check the trim height specifications.

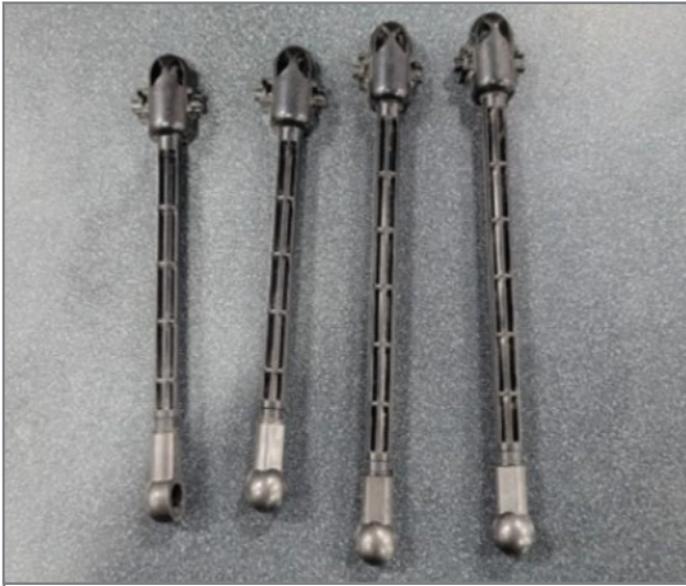
Aftermarket adjustable suspension height sensor links

The factory suspension height sensor links are not adjustable.

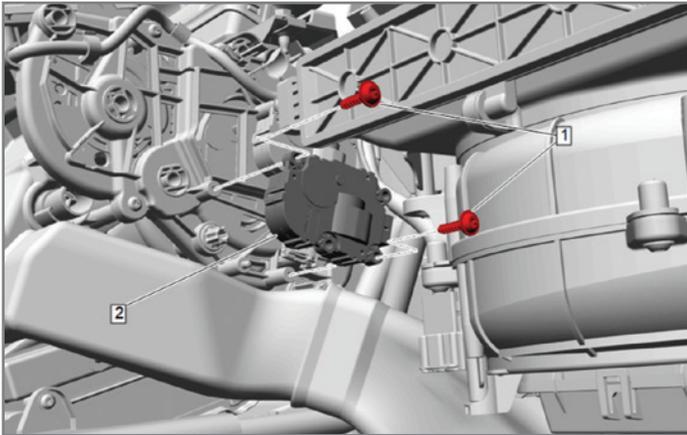
Programmable temperature valve actuator – right side on the 3.0L engine

The Check Engine MIL may be illuminated on some 2020-2021 CT4 models equipped with the 2.0L engine (RPO LSY) or 2.7L engine (RPO L3B) and some 2020-2021 CT5 models equipped with the 3.0L engine (RPO LGY) when operated in cold climates. The HVAC module temperature actuators stall detection can be unstable at times in cold climates (less than 59°F or 15°C), resulting in incorrect stall detection and several DTCs set.

Actuator Replacement procedure for the left or right side in the appropriate Service Information.
