Mill River Stream Team Shoreline Survey Report & Action Plan June 30, 2007

**Mill River Shoreline Survey Findings
By
Section**

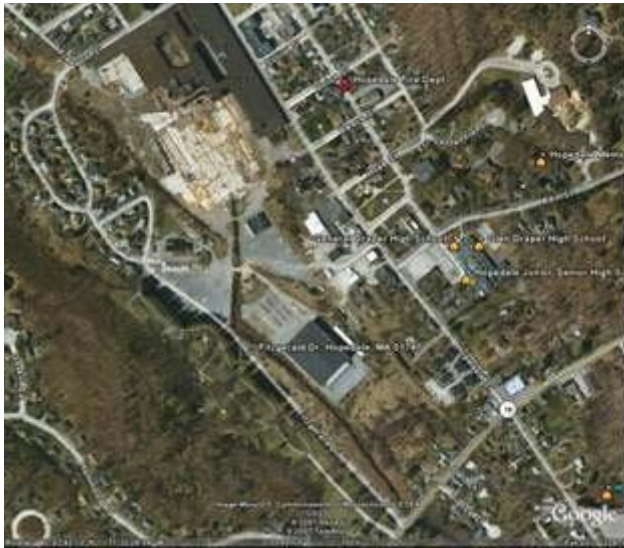
Section 2

Behind Draper Mill on Fitzgerald Street
to
Mendon Street (Route 16) in
Hopedale, MA

South of the Hopedale Pond, the River flows under the old Draper Mill building down to Route 16 in Hopedale. The mill building is vacant but the town is trying to lease out the space. South of the mill, the area is mainly industrialized with several parking lots and a couple of roads. The surveyor noted that this section of the Mill River was in bad shape due to trash such as machinery parts, metal handrails, and several abandoned booms. It was also noted that many small business dumpsters overflow near the River Bank. Roadside Trash was noted as well. Historically, the water level has never exceeded 2.5 feet and phosphorous suds were accumulating in this location. No wildlife was evident. The surveyor observed River Bank erosion and limited vegetation. Pipe runoff was found on Fitzgerald Street. The discharge from the pipe looked clear and the structure surrounding it was good, but the road area around the storm drain was not maintained.

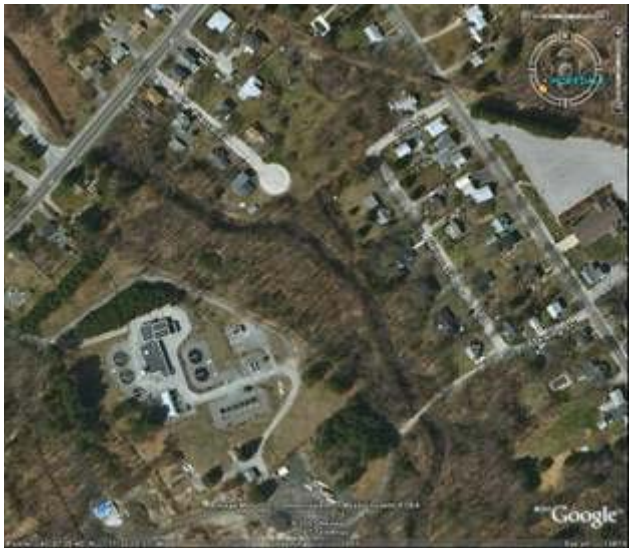
Section 3

Mendon Street (Route 16)
Hopedale, MA
to
Thwing Street, Mendon, MA

The surveyor noted that both sides of the River Bank were eroding and didn't have much vegetative protection. The water flow was slow. Trash such as bags and orange cones were found near the Hopedale Wastewater Treatment Facility. An abandoned boom was located here as well.

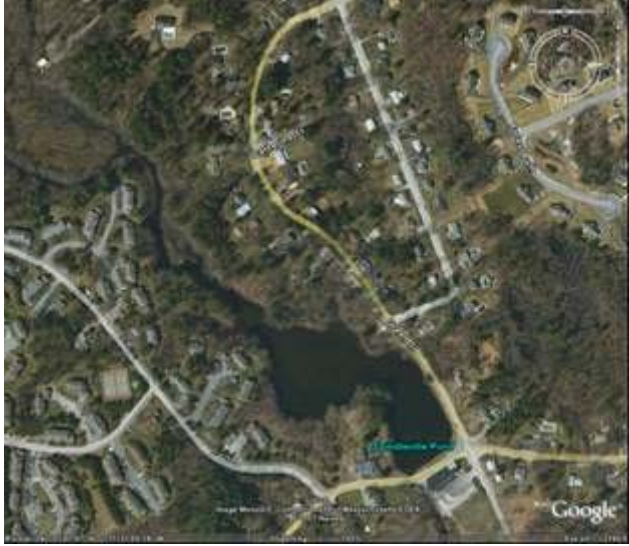
Section 4

Green Street side of Spindleville Pond, Hopedale, MA

The surveyor resides near Spindleville Pond and, over the years, has observed a significant decrease in the water level. Located upstream is the Hopedale Wastewater Treatment Facility.

The surveyor noted several locations with serious runoff and erosion issues. The prevalent invasive plant here is milfoil found in large quantities throughout the Pond.

Sudsy water was observed and seen discharging from a pipe on the Green Street side of the Pond. The surveyor noted that the Town would be installing new wells in this area soon that could further impact the water level.

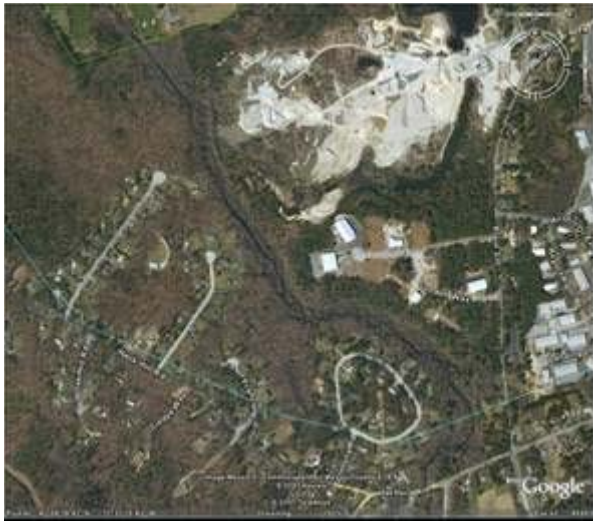
Section 6

Southern portion of Hopedale Golf Course
to
Hartford Avenue East, Mendon, MA

This section is split between residential, golf, and industrial areas. It runs .65 miles long. The surveyor noted a conservation restriction area off of Plain Street Industrial Park. Garbage such as bottles, tires, and tennis and golf balls were found caught up in the Red-Osier Dogwood as well as foam accumulation.

Invasive vegetation such as Oriental Bittersweet and Japanese Barberry were located on the left bank within 500 feet of the golf course. The surveyor noted that these were not fully established and could be managed if something was done by next season.

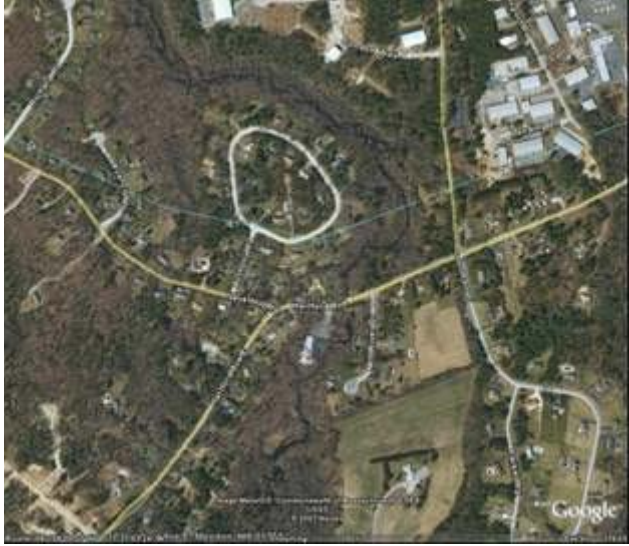
Section 7

Part One: Mill River at Hartford Avenue East, Hopedale, MA

This section runs parallel to Plain Street and is downstream from the Rosenfeld Cement Plant. Wetlands and undisturbed forest lay beyond the left bank of the River. Beyond the right bank, a residential home was located about 150 feet from the River. Several mature trees with exposed roots were noted, but smaller trees, shrubs, and undergrowth was cleared away leaving grasses and wildflowers at the edge of extensive lawn area. At this location, a manmade waterfall was made out of rocks that created pools in some areas.

Evidence suggested that stormwater runoff is a problem at this culvert. The surveyor observed the culvert and felt it was good enough to allow fish passage.

Around the back of the building, the sound of rushing water was quite loud. One side of the building lay close to the Riverbank, where several holes were made by stormwater and roof runoff.
