## New Tire Fill Alert System Pumps Up Tire Inflation

New Tire Fill Alert System Pumps Up Tire Inflation . . . . .	1
Download the Latest AFIT Software Update . . . . .	2
Camaro Convertible Folding Top Front Latch Rebalance . . . . .	3
Camaro Convertible Rear Quarter Glass Wind Noise . . . . .	4
Using the Correct AFIT Power Adapter . . . . .	5

GM TechLink is published for all GM retail technicians and service consultants to provide timely information to help increase knowledge about GM products and improve the performance of the service department.

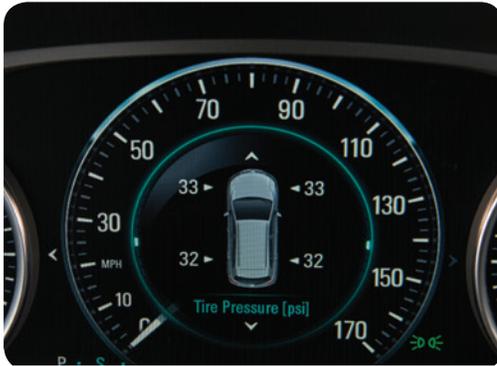
If the tire filling continues and a tire is overinflated by more than 5 psi (35 kPa), the vehicle will notify the driver by sounding three short horn chirps. To release and correct the pressure, while the turn signal lamp is still flashing, briefly press the center of the valve stem. When the recommended pressure is reached, the horn will chirp once.

DIC tire pressure readings
