# SERVICE BULLETIN

Classification: EC16-034b	Reference: NTB17-082b	Date: January 29, 2019
------------------------------	--------------------------	---------------------------

## NISSAN; DTC P0456 CAUSED BY EVAP LEAK AT VENT CONTROL VALVE O-RING

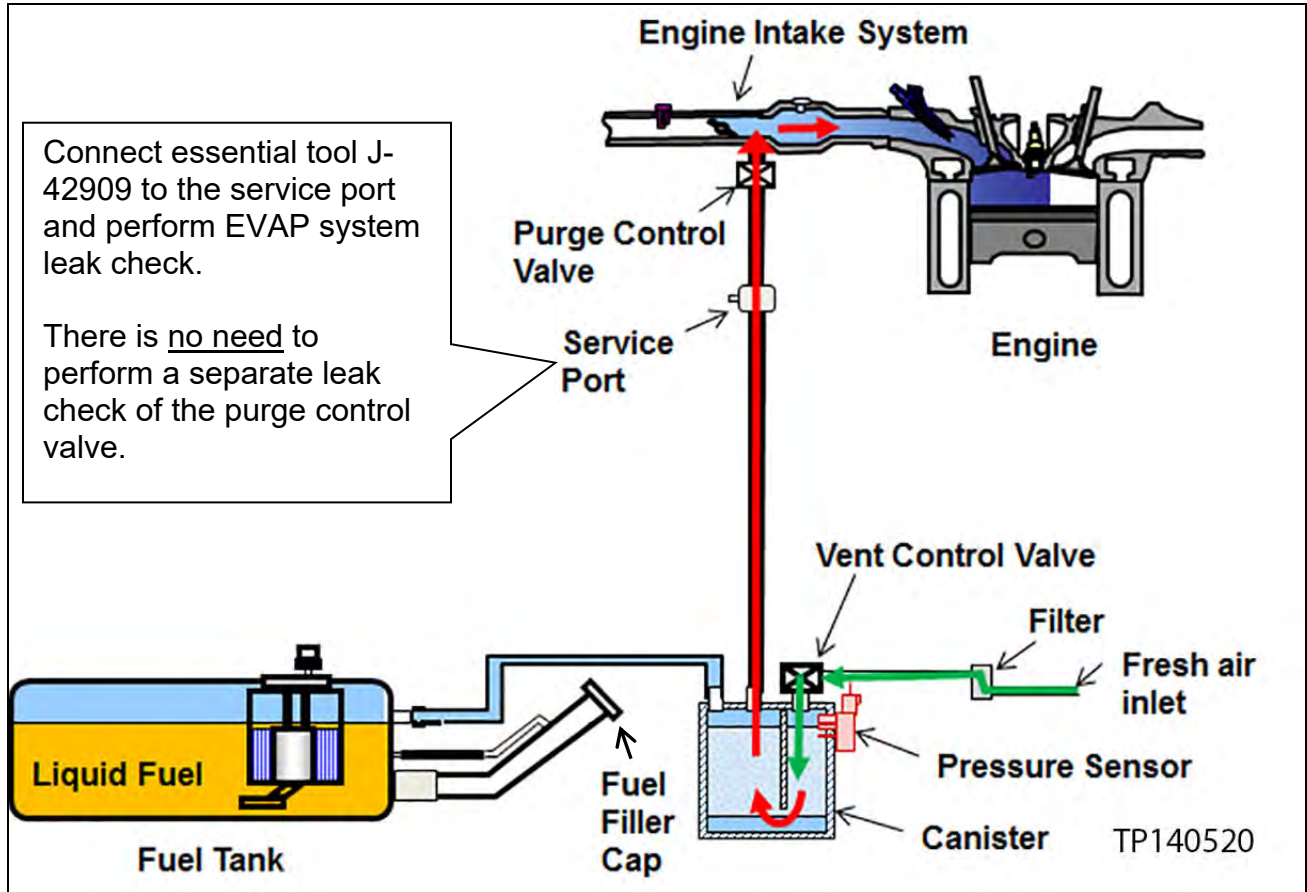
Figure 8

### EVAP System Basic Operation

- Fuel vapor flows from fuel tank into canister (light blue area)
- Vapor flows from canister through purge control valve (red line)
- Fresh air flows into canister (green line)

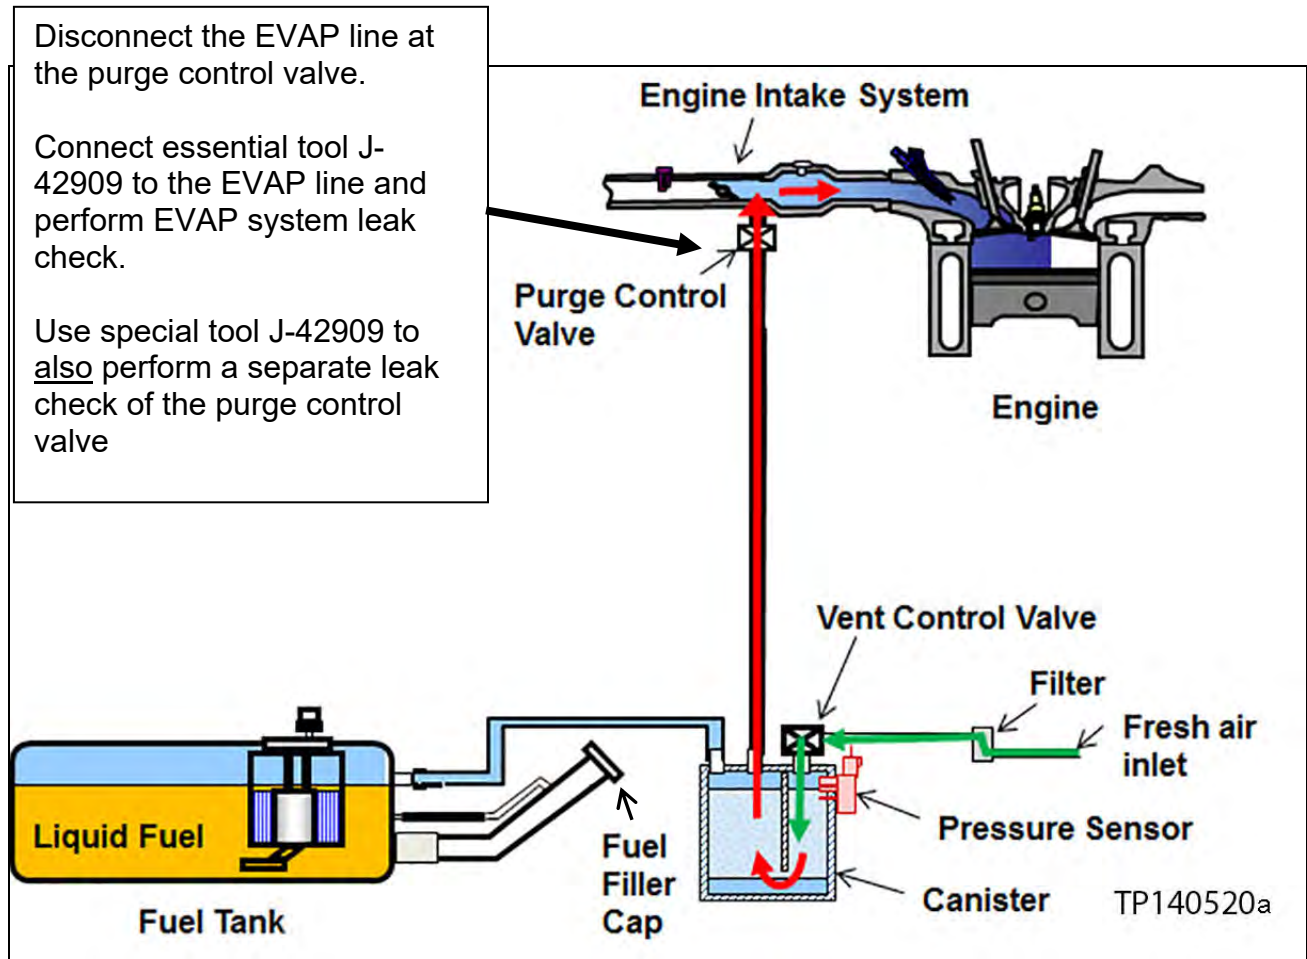
Figure 9

**EVAP System Basic Operation**
