WATERSHED SURVEY REPORT

NORTH POND

JANUARY 2017

NORTH POND WATERSHED SURVEY REPORT

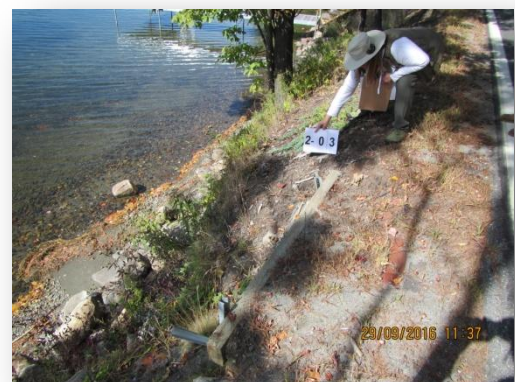
Example of a narrow stretch of land between the state road and the lake used for beach/boat access.

- **Beach & Boat Access:** Easy access to our lakes is an important consideration for shoreland residents and recreational enthusiasts alike. However, the soil in these areas can become compacted over time as a result of vehicle and foot traffic over many years and can result in a direct route for soil erosion to get into the lake. Combined, beach and boat access sites on North Pond ranked third behind residential and road sites (17 sites or 13% of the total), and nine of the 13 sites ranked high or medium impact. Portions of North Shore Dr. and Lake View Dr. are challenging from a management perspective due to a split between the house (on the north side of the road), and boat access within a steep, narrow right-of-way between the road and the lake.

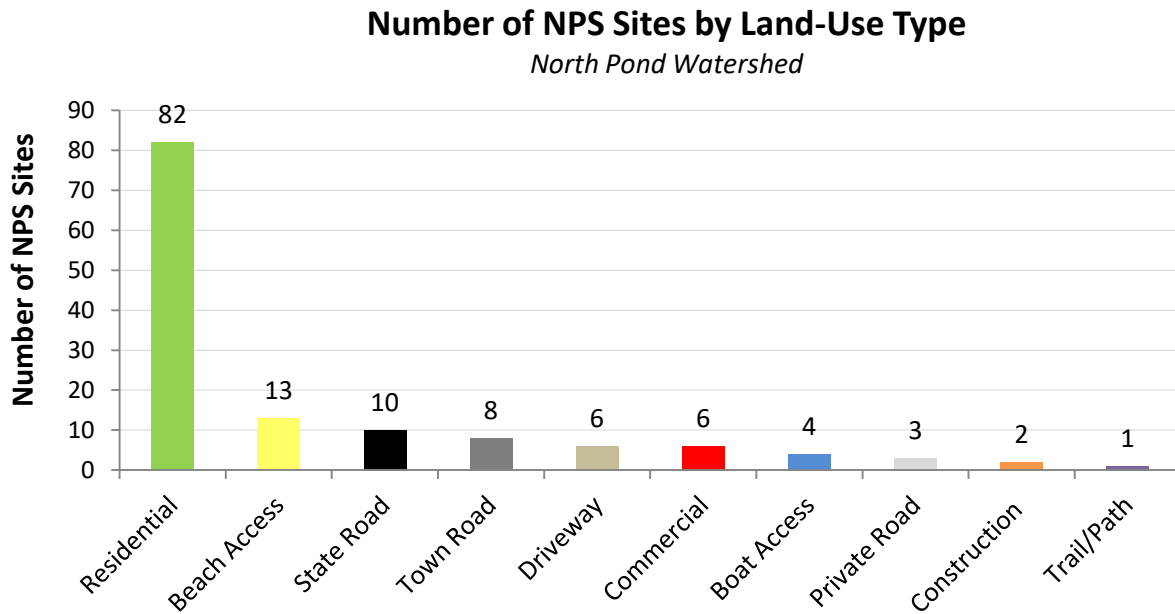
Figure 6. NPS sites in the North Pond watershed by land-use type.

A total of 135 NPS sites were documented in the North Pond watershed across ten different land-use types (Figure 6). (Note: residential homes and driveways were documented separately in the field for tracking purposes.) The number of residential properties far outweighed the other land-use types.

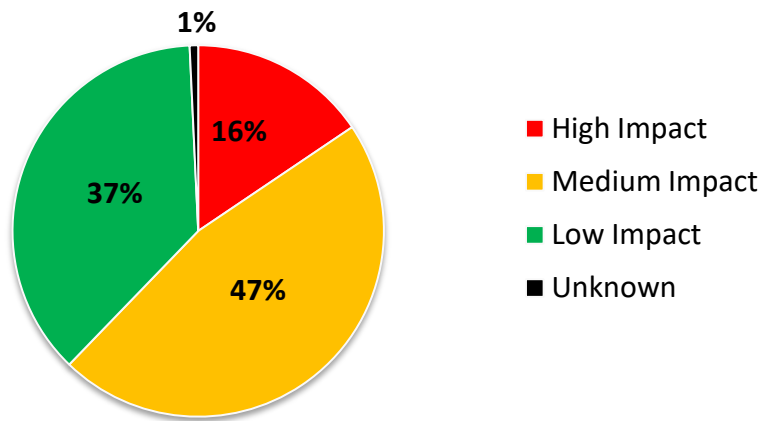
Figure 9. *Estimated impact of NPS sites in the North Pond watershed.*

Low impact sites are those with limited transport of soil off-site.

Medium impact sites exhibit sediment transportation off-site, but the erosion does not reach high magnitude.

High impact sites are those with large areas of significant erosion and direct flow to water.

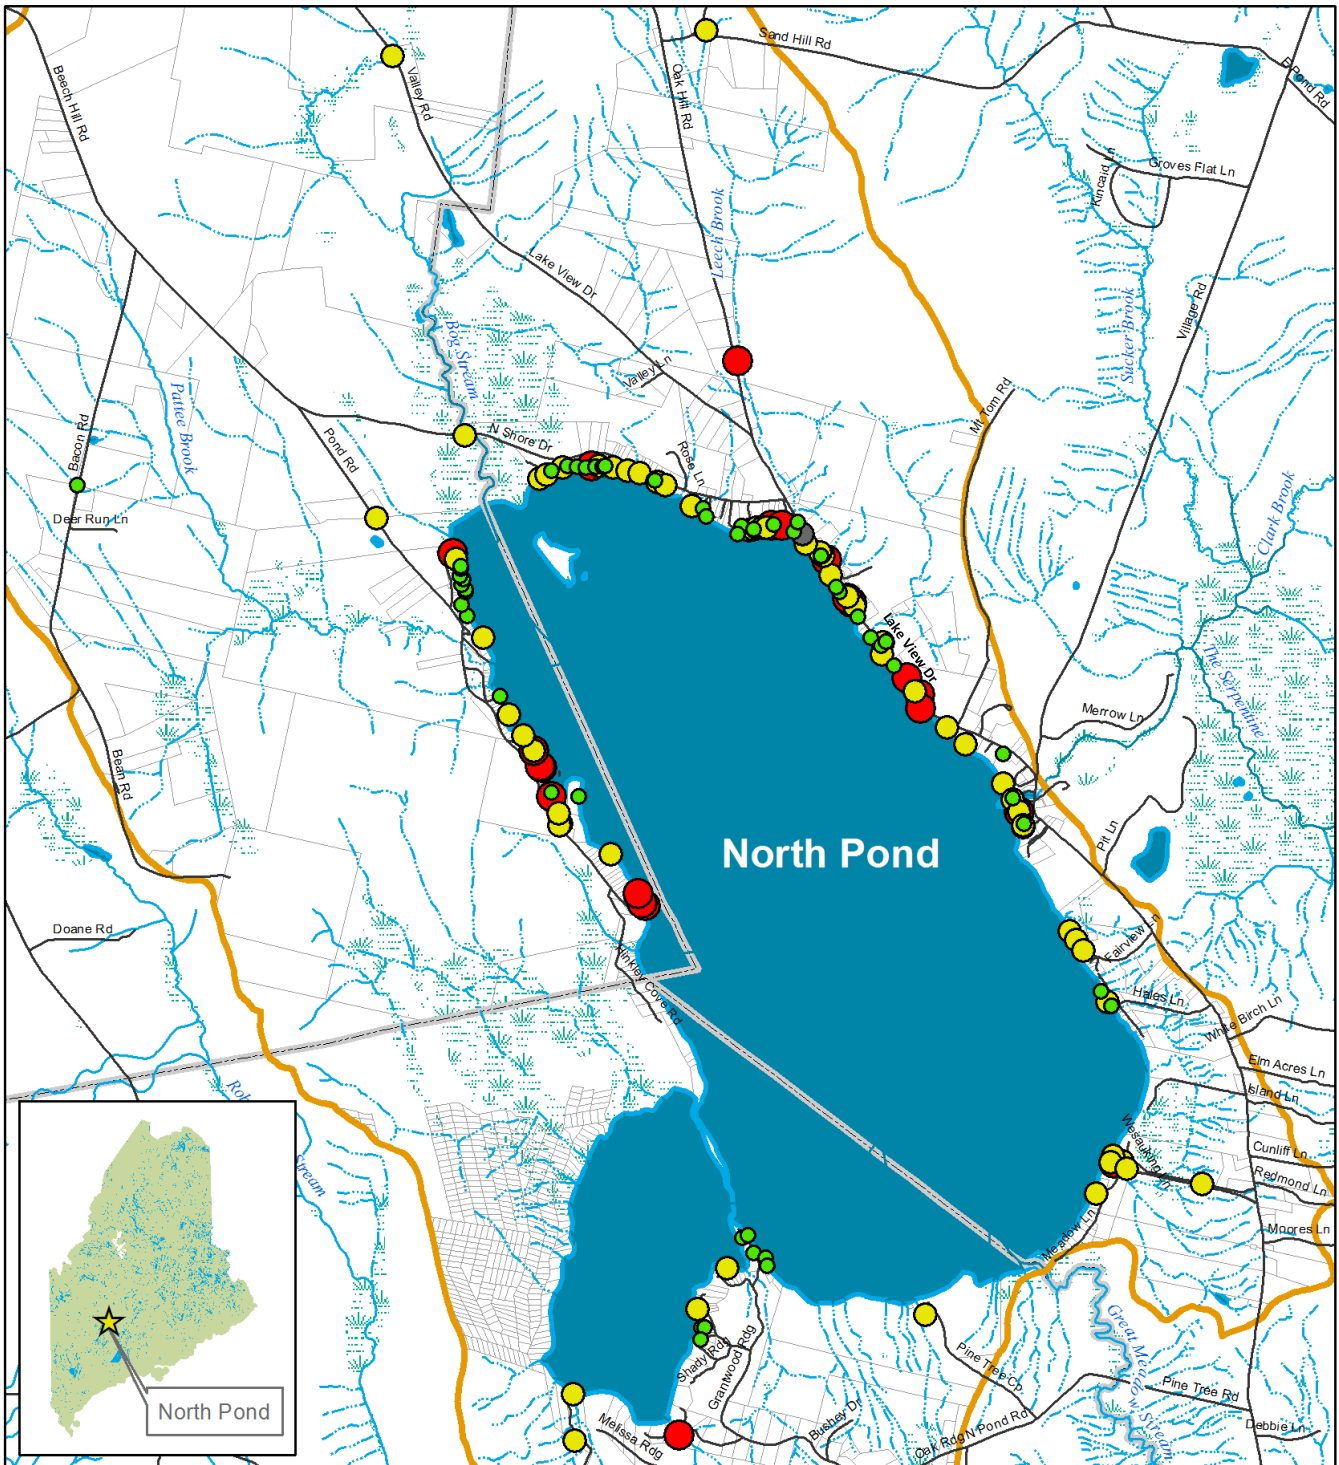
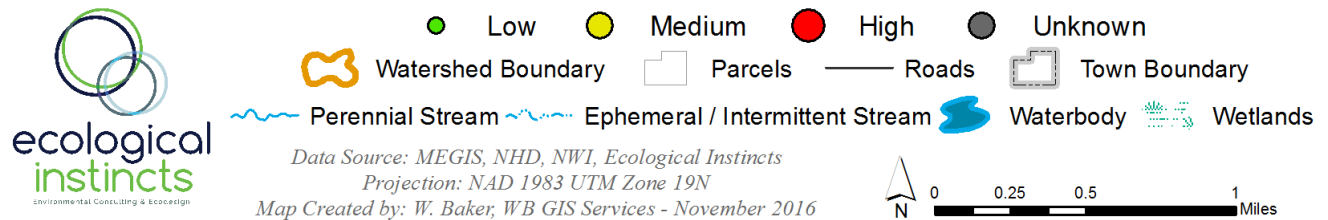
Figure 10. Map of NPS sites in the North Pond watershed by impact ranked low to high.

All told, the majority of sites are ranked medium or low impact (84%), while only 16% of sites are ranked high impact. A residential site in Sector 1 was ranked unknown for impact and requires follow-up. High impact sites were fairly evenly split between the east and west shores of the lake (Figure 10).

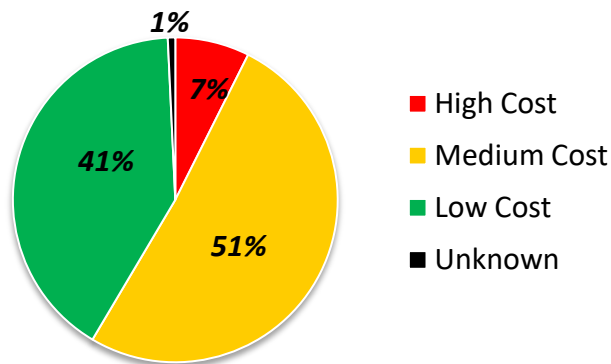
Figure 11. *Estimated cost of NPS sites in the North Pond watershed.*

Cost of NPS Sites: Recommendations were made for improving each site, along with the estimated cost of labor and materials for all 135 sites (Figures 11 & 12). Only 10 of these sites are estimated to incur a high cost (over \$2,500), while the remainder of sites were split between low (less than \$500) and medium cost (\$500- \$2,500). One site in Sector 1 was ranked unknown and requires follow-up. Five of the 10 high-costs sites are associated with residential properties (failing retaining walls, steep slopes that require engineering, etc.), as well as two beach access sites one commercial site, a private road and a state road site. Only four of the 21 high impact sites are also high-cost. High impact sites that are low (2) or medium cost (16) may be prioritized for remediation first.

Low cost sites were estimated to cost less than \$500.

Medium cost sites range from \$500 to \$2,500.

High cost refers to sites estimated to cost more than \$2,500.

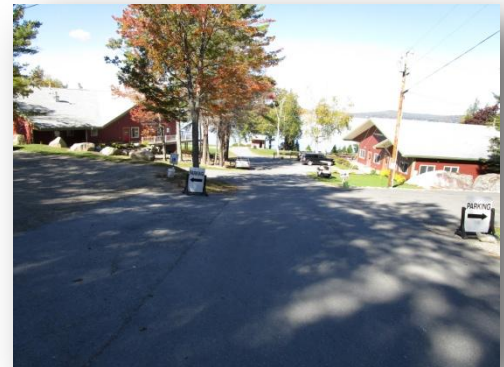
Private summer camp in Sector 5.

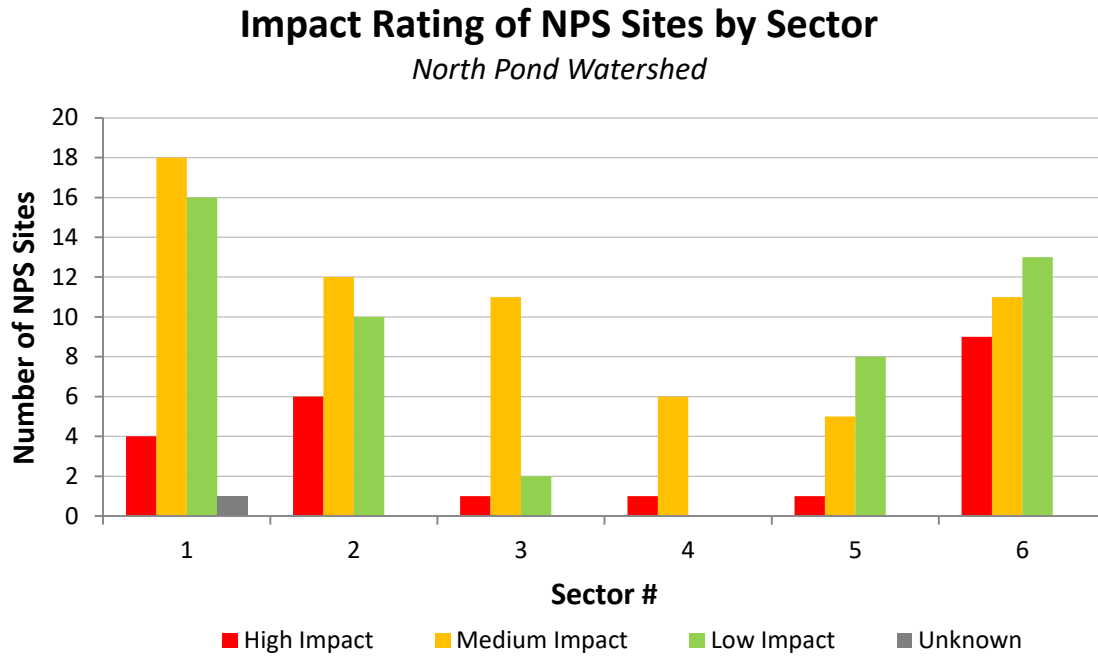
Figure 13. NPS sites in the North Pond watershed by impact rating and sector.

Figures 13 and 14 (next page) show a breakdown of impact and cost by survey sector. These figures show that Sector 6 has the most number of high impact sites, whereas Sector 1 has the most number of both medium and low impact sites. However, despite having the greatest number of high impact sites, Sector 6 (as well as Sector 3) has no high cost sites. Sector 1 has the most number of medium impact sites and is tied with Sector 6 for the most number of low impact sites. Figure 15 shows a breakdown of NPS sites by land-use type and sector. Residential sites were documented in all six sectors and clearly shows the cumulative impact of residential development in the watershed.
