Ocean Water Desalination Intake Biofouling and Corrosion Study

January 15, 2016

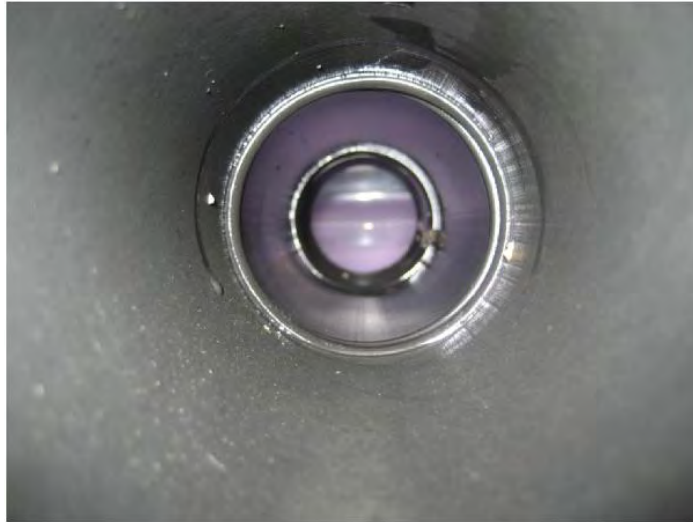
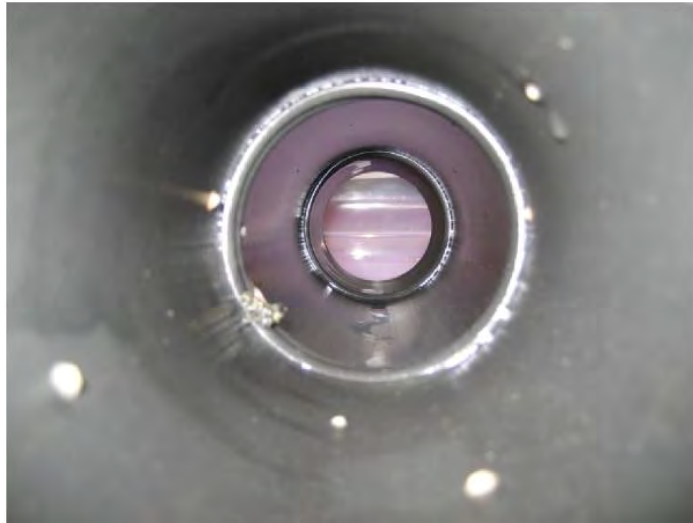
Figure 3-3. Pipe spool C3 (Shock Chlorination) October 28, 2014. Inlet (top) and Outlet (bottom).

- This is the third pipe spool in spool row C and received a weekly shock treatment with sodium hypochlorite.
- Photos taken from inlet and outlet ends (**Figure 3-3**).
- The pipe walls have a slight brown tinge, but do not feel slimy to the touch. The material can be easily removed with a tissue wipe. This could be fine silt trapped in a bacteria layer, or a thin layer of diatoms
- 9 small acorn barnacles (Balanidae) were observed; 3 in the inlet section and 6 in the outlet section.
 - Size (basal diameter) ranged from about 1 mm to 3 mm.
 - No barnacles found in the middle section of the spool.
- A small ball of plastic shavings was found at the ring between the middle and outlet section.
- No sand

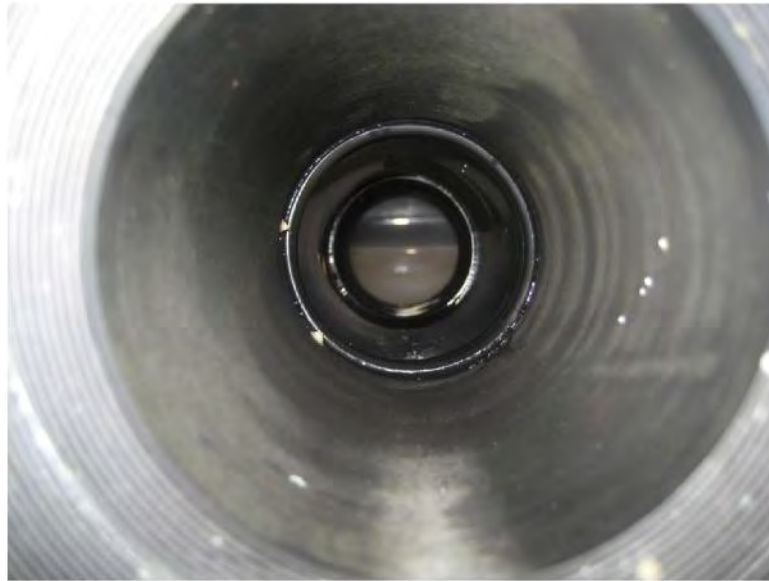
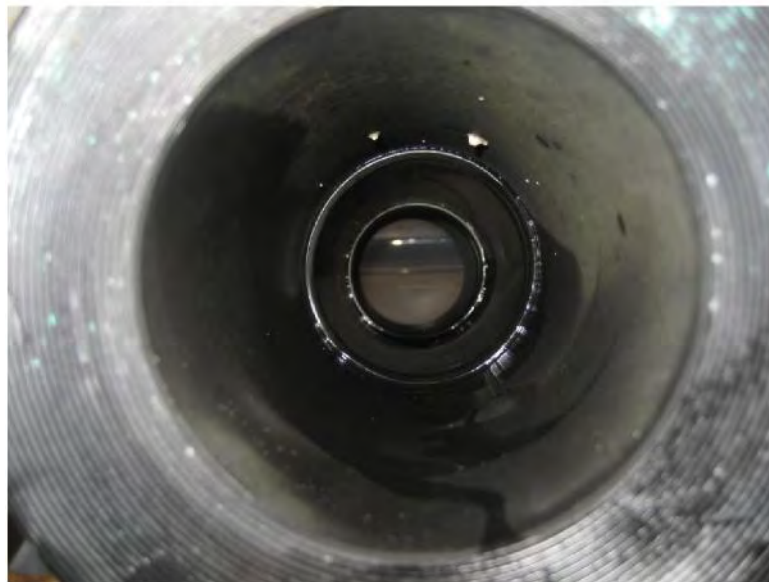
Figure 3-6. Pipe spool C4 (Shock Chlorination) December 23, 2014. Inlet (top) and Outlet (bottom).

- This is the fourth pipe spool in spool row C and received a weekly shock treatment with sodium hypochlorite.
- Photos taken from inlet and outlet ends (**Figure 3-6**).
- No slime/diatoms detected by touch or tissue wipe.
- 9 small acorn barnacles (Balanidae) were observed; 5 in the inlet section, 2 in the middle section, and 2 in the outlet section.
 - Size (basal diameter) ranged from about <1 mm to 3 mm.
- No sand or other debris was observed.

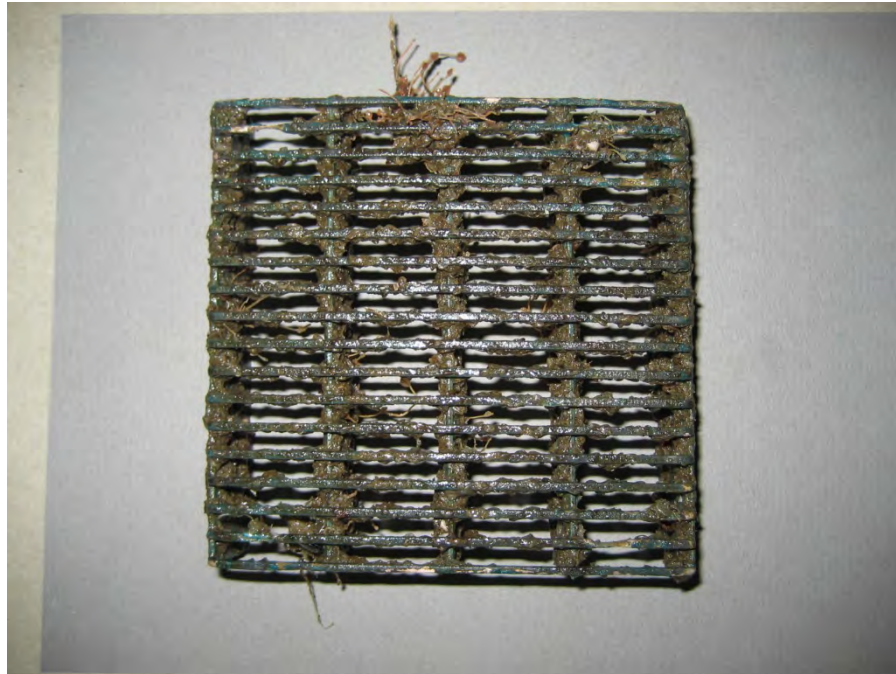
Figure 4-1: 90/10 Cu/Ni (CDA706) Wedgewire sample, photographed 06/17/15.

Test Material	Biofouling Notes	
PVC test rack	<p>The PVC test rack was heavily fouled to the point where almost none of the PVC was visible.</p>	
CDA 706 (90 – 10 Copper Nickel)	<p>Wedgewire sample: Relatively clean, with only a few hydroids, mostly concentrated by the sites of the plastic cable ties used to secure the sample to the rack. A green patina covered most of the surface. About 80 percent of the surface had a very light covering of diatoms and short filamentous algae along with entrapped silt. All fouling and debris was easily removed with a soft nylon brush after photographing and inspection. (See Figure 4-1)</p>	<p>Coupon: Quite clean, with no hydroids, no barnacles or any other attached macrofouling. About 90 percent of the surface had a light covering of diatoms, some filamentous red algae and entrapped silt. There was a green/brown patina on most of the surfaces. All silt and fouling was easily removed with a soft nylon brush after photographing and inspection. (See Figure 4-2)</p>

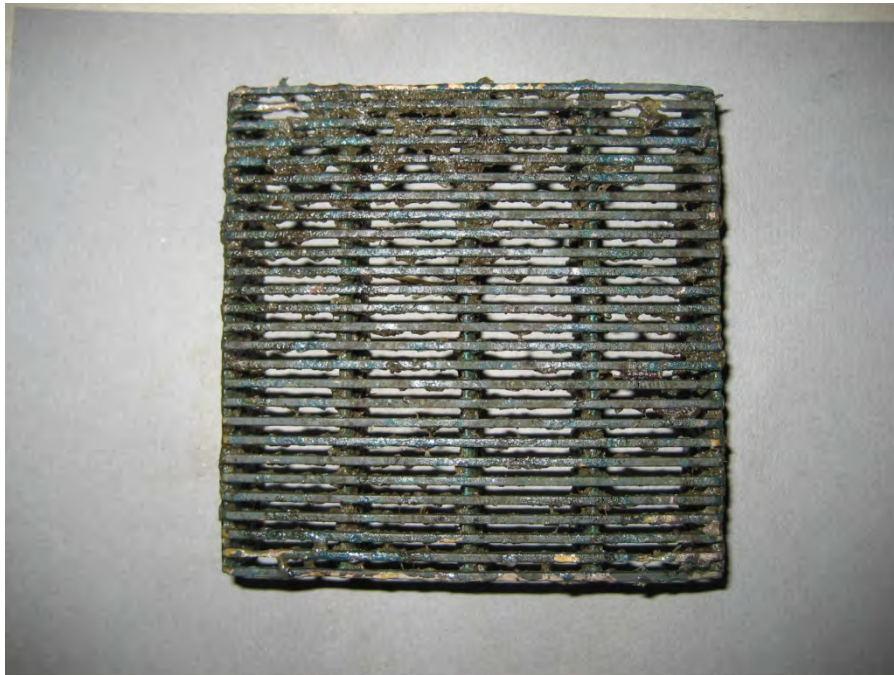
Figure 4-3: Z-alloy Wedgewire sample, photographed 06/17/15.

Z-Alloy	<p>Wedgewire sample: Quite clean, similar to the CDA 706 (IVA1) with only three individual hydroids covering less than 1 percent of the surface. The surface had a green patina. About 60 percent of the Wedgewire (outer) surface had a very light covering of diatoms, filamentous red algae, and entrapped silt. All fouling and debris was easily removed with a soft nylon brush after photographing and inspection. Some of the patina was removed by the</p>	<p>Coupon: No hydroids or other macrofouling invertebrates. There was a layer of diatoms, filamentous red algae, and entrapped silt that covered about 65 percent of the surface. No green patina. All fouling was easily removed with soft nylon brush. (See Figure 4-4)</p>

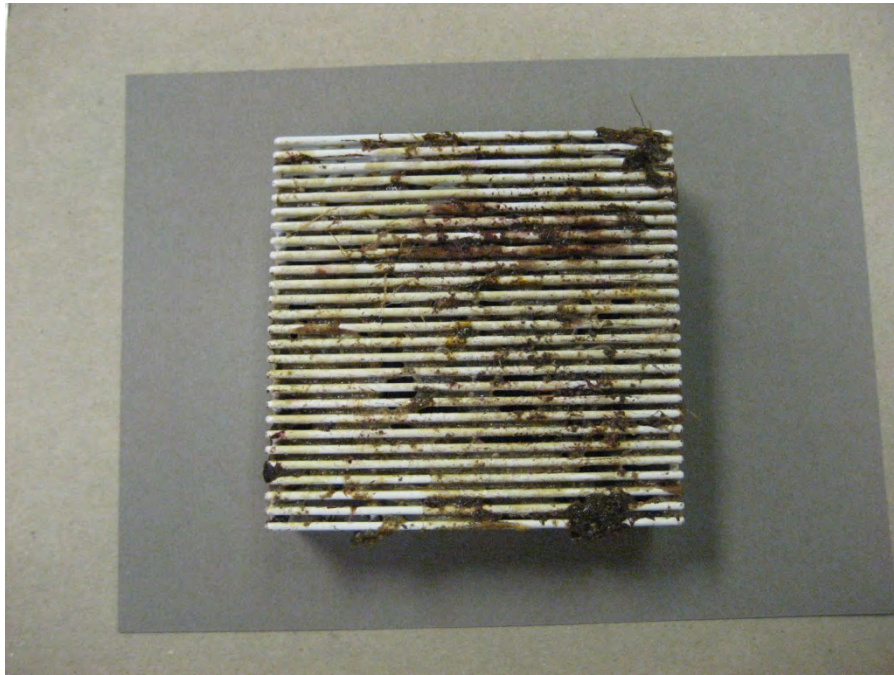
Figure 4-5: 2205 stainless steel Wedgewire sample with foul release coating, photographed 06/17/15.

Test Material	Biofouling Notes	
	brushing, exposing fresh metal. (See Figure 4-3)	
2205 SS (stainless steel) with antifouling coating	<p>Wedgewire sample: About 50 percent of the sample’s outer surface had a light covering of diatoms and filamentous red algae. About 50 percent of the inner ribs were cover with what appears to be gastropod eggs. Another 25 percent of the inner ribs was covered with a combination of a few individual hydroids, 12 half-slipper shells, or slipper limpets, 10 mussels (4-20 mm), 6-8 barnacles (<i>M. californicus</i>), 4 worm tubes, 4 small white bivalves (3 mm), and a crab . The foul-release coating was in very good shape even at the cable tie sites. All of the fouling was removed with light brushing using a soft nylon brush or, in the case of the limpets, with light finger pressure. (See Figure 4-5)</p>	<p>Coupon: Very clean. About 50 percent of the surface had a very light film of diatoms and a little silt. The foul-release coating was in very good shape and all of the fouling was removed with just a light brushing using a soft nylon brush. (See Figure 4-6)</p>

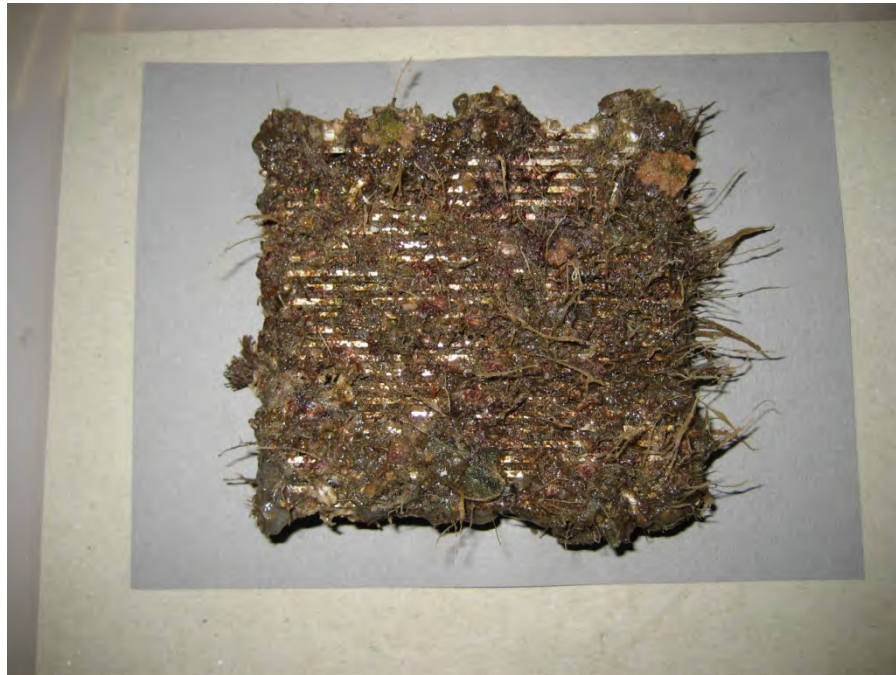
Figure 4-7: 2205 stainless steel Wedgewire sample, photographed 06/17/15.

2205 SS (stainless steel) uncoated	<p>Wedgewire sample: Very heavily fouled with little of the metal visible. The fouling was firmly attached and was not removed. (See Figure 4-7)</p>	<p>Coupon: Very heavily fouled with hydroids and red algae covering most of its surface. The fouling was firmly attached and was not removed. (See Figure 4-8)</p>
CDA 715 (70 – 30 Copper Nickel)	<p>Wedgewire sample: Similar to the CDA 706 and Z-Alloy samples, but with more of the surface, about 60 percent, covered by amphipod tubes and filamentous red algae. There was also more of a diatom and silt film/layer, and only a little green patina on the metal’s surface. Eight very small mussels. There were no barnacles or other macrofouling aside from the hydroids and mussels. All fouling and</p>	<p>Coupon: Similar to the CDA 706 and Z-Alloy coupons. A few hydroids, without polyps, were attached near the holes in the coupon. Amphipod tubes, diatoms and entrapped silt covered about 80 percent of the surface. The coupon had more green patina than the CDA 715 Wedgewire sample, especially on the test</p>

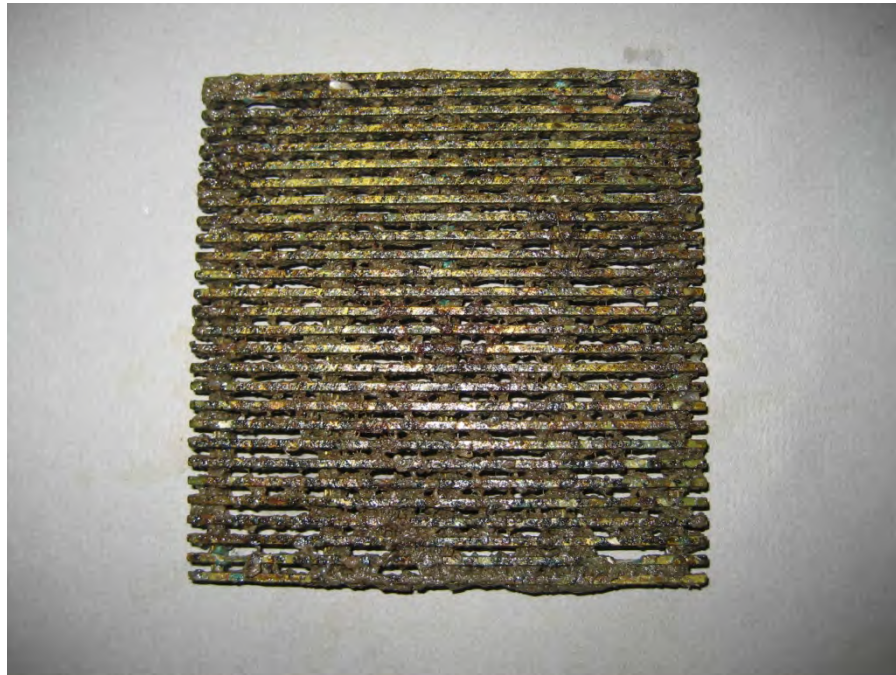
Figure 4-9: 70/30 Cu/Ni (CDA715) Wedgewire sample, photographed 06/17/15.

Test Material	Biofouling Notes	
	debris was easily removed with a soft nylon brush after photographing and inspection. (See Figure 4-9)	welds. All fouling and debris was easily removed with a soft nylon brush after photographing and inspection. (See Figure 4-10)

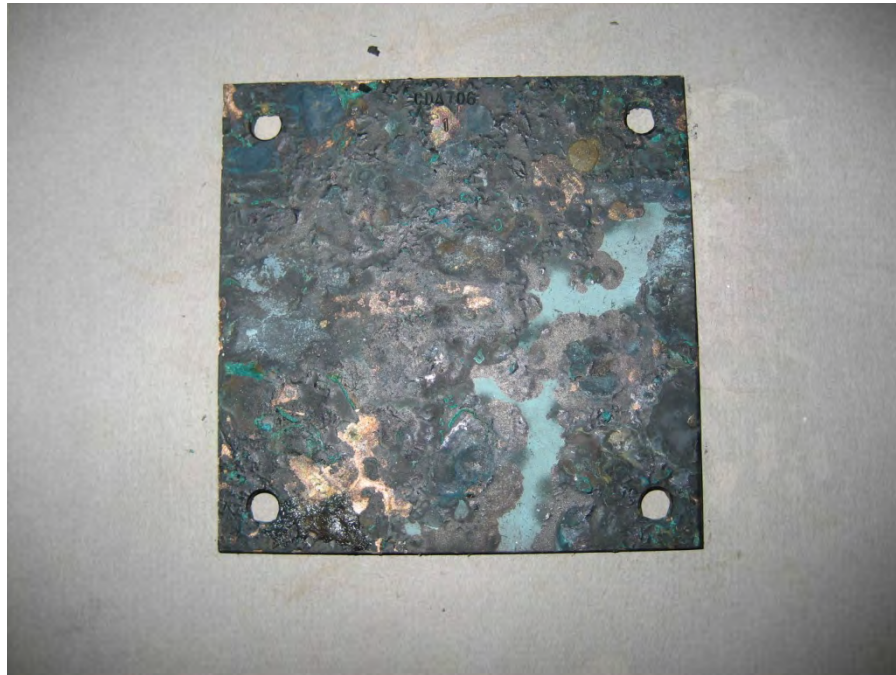
- **CDA 706 (90/10 Copper/Nickel), Plate 1, (Figures 4-11)**
 - The plate is almost entirely covered with a dark blue-green patina. This tends to flake off when the plate is handled.
 - No attached macrofouling.
 - No slime detectable
 - No algae, diatoms, or silt.

**Figure 4-11: 90/10 Cu/Ni (CDA706) test plate (Test Plate 1),
photographed 06/18/15 prior to biofouling inspection.**

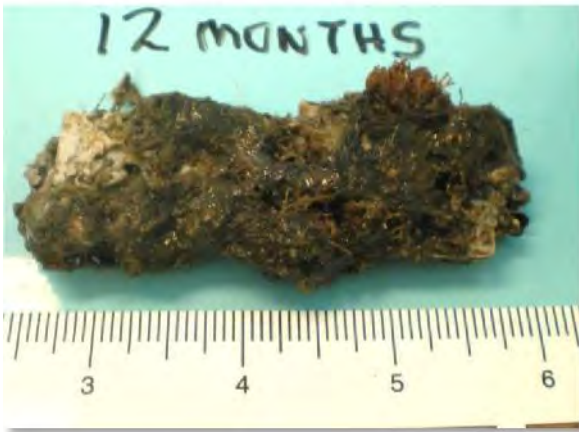
Figure 4-19: Marine life attached to uncoated 2205 Duplex stainless steel coupon with a weld.

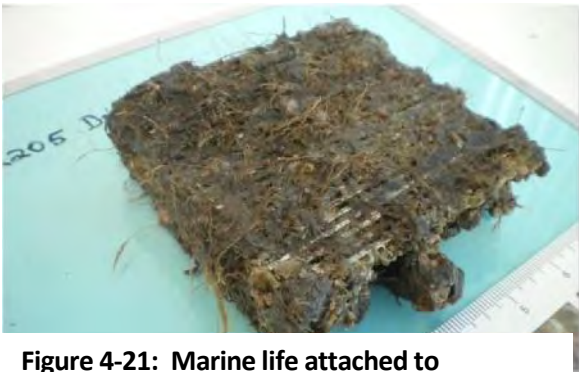
Figure 4-21: Marine life attached to uncoated 2205 Duplex stainless steel wedge wire screen.

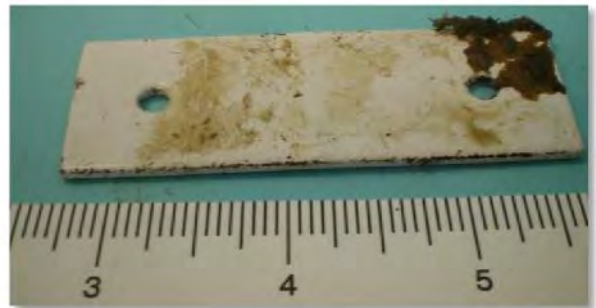
Figure 4-22: Slight damage to coating on edge and initiation of biofouling on corner of coated 2205 Duplex stainless steel coupon.

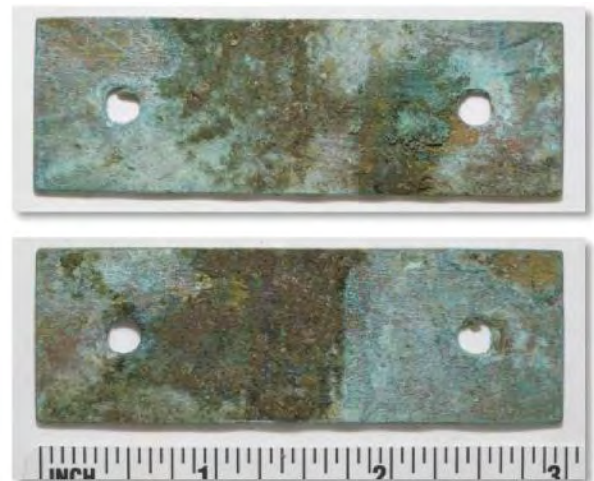
Figures 4-26, 4-29, 4-31, 4-35, and 4-36 show some further oxidation and discoloration of the copper alloy sample surfaces after being exposed to the atmosphere for up to 7 days.

Figure 4-26: Development of copper patina on 70-30 Cu-Ni coupon, front (top), back (bottom).

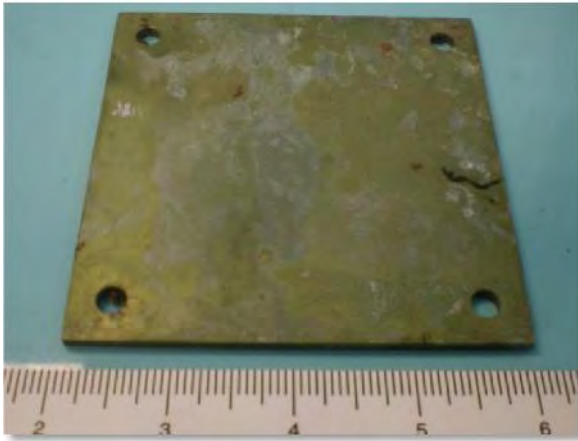
Figure 4-27: Surface discoloration of 70-30 Cu-Ni flat plate.

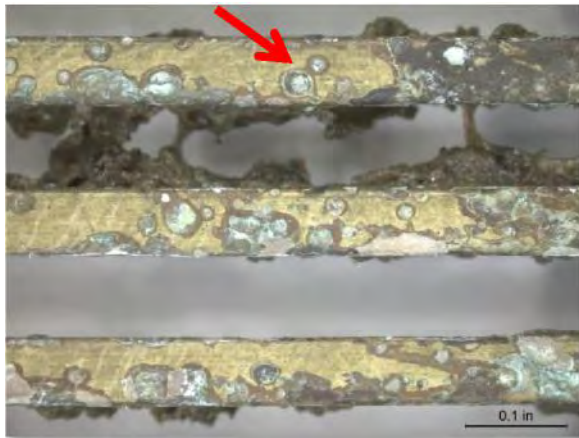
Figure 4-29: 70-30 Cu-Ni wire screen at 10X magnification, pitting and discoloration.

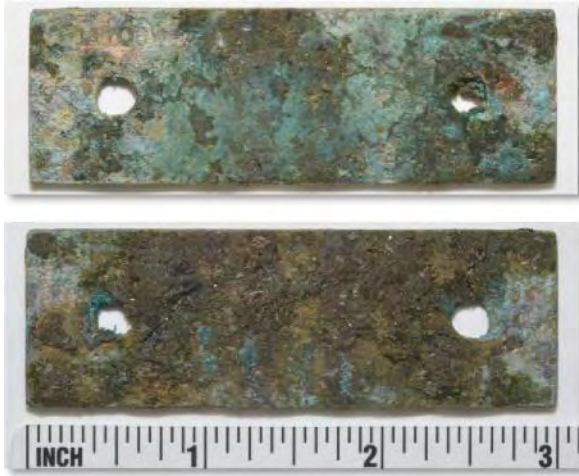
Figure 4-31: Development of patina on 90-10 Cu-Ni coupon, front (top), back (bottom).

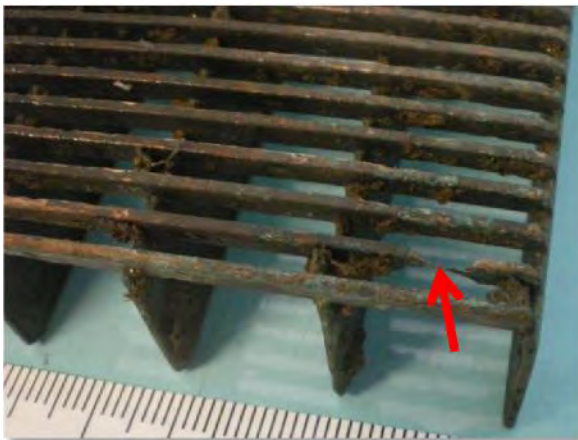
Figures 4-28, 4-33, and 4-38 show some typical mechanical damage to the screen wires that was observed on the 70-30 Cu-Ni, 90-10 Cu-Ni, and Z Alloy screens. The damage was observed at each corner of the screen where the screens were secured to the test rack. The mechanical damage may have been caused by the turbulence in the water and the abrasion by the zip ties that prevented the passivation of the metal at those locations. The exposed metal was corroded and metal loss occurred.

Figure 4-33: Mechanical damage to 90-10 Cu-Ni wedge wire screen.

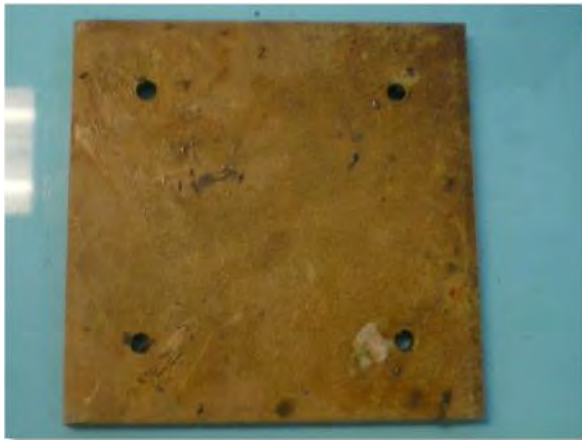
Figure 4-35: Surface discoloration of Z alloy coupon. front (top). back (bottom).

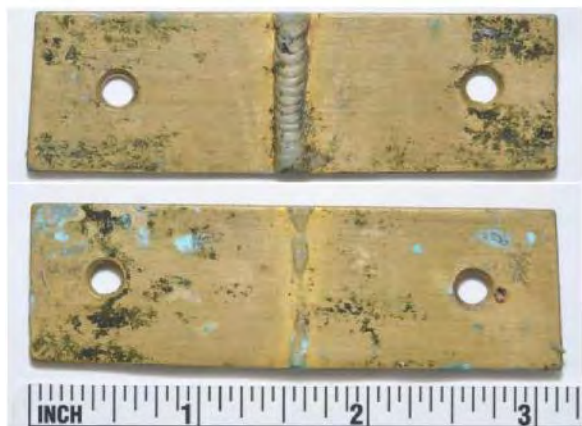
Figure 4-37: Minimal corrosion was observed on the Z alloy flat plate.

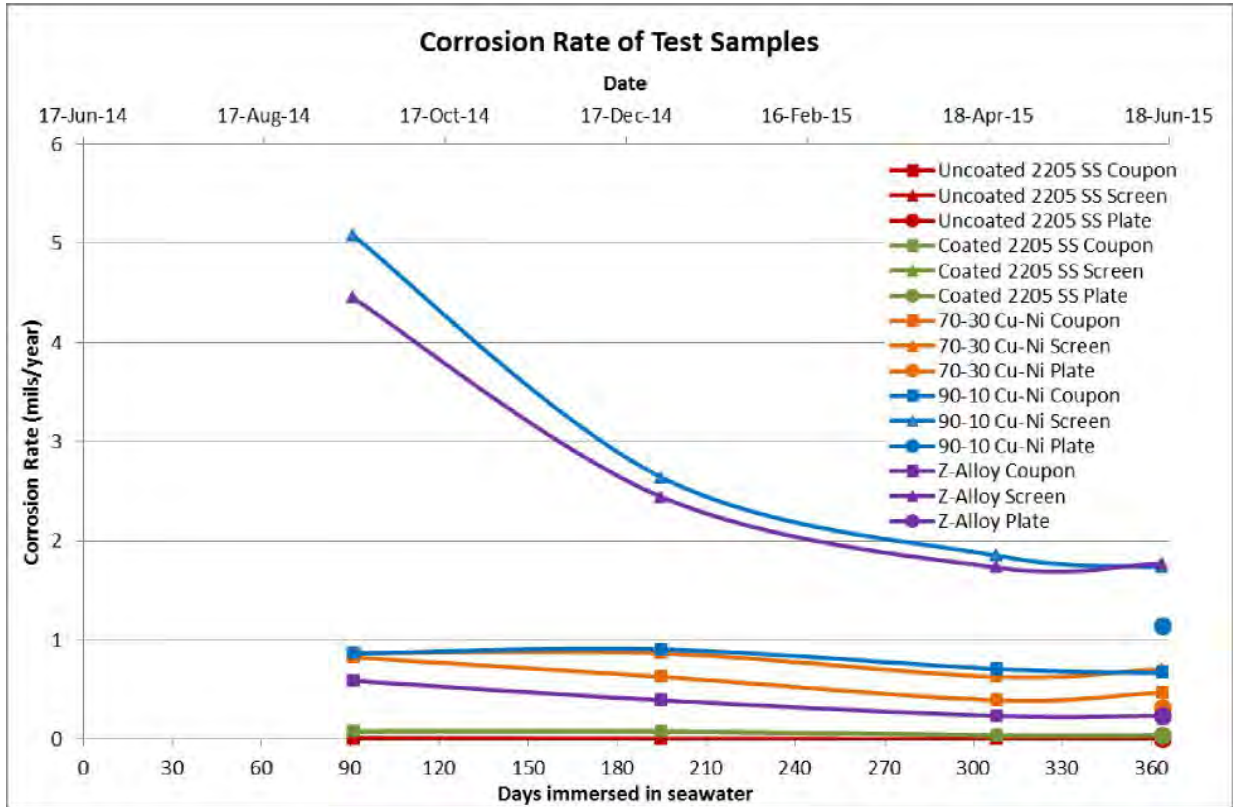
Figure 4-39. Corrosion Rates of Four Alloys over 12 months in Seawater Exposure

The average corrosion rates of the 12-month samples were similar to the 10-month samples; approximately half even had slightly higher rates however the difference was less than 0.0001 inches. This was unlike how the 10-month sample corrosion rates were all lower than the 6-month samples; which in turn had lower corrosion rates than the 3-month samples (except for the 3 and 6-month 90-10 Cu-Ni coupons).

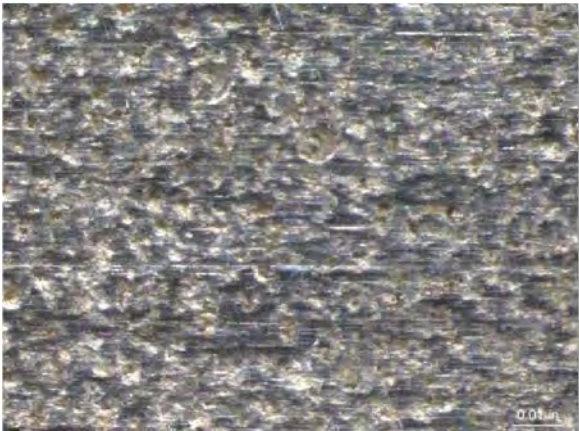
Figure 4-42: Uncoated 2205 Duplex SS coupon surface after cleaning at 50X magnification.

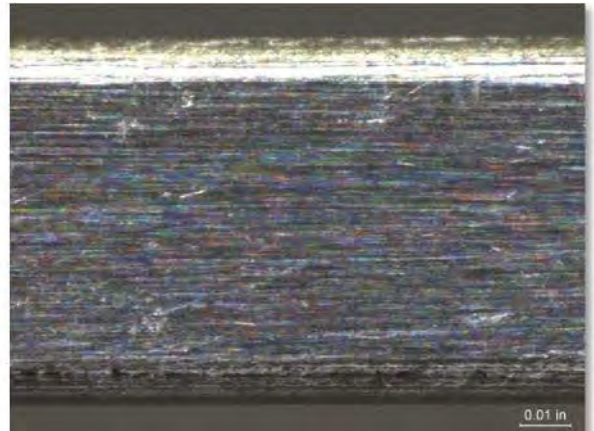
Figure 4-43: Uncoated 2205 Duplex SS screen surface after cleaning at 50X magnification.

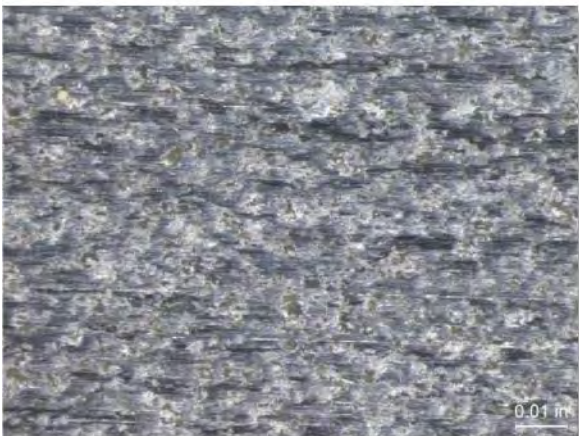
Figure 4-44: Uncoated 2205 Duplex SS plate surface after cleaning at 50X magnification.

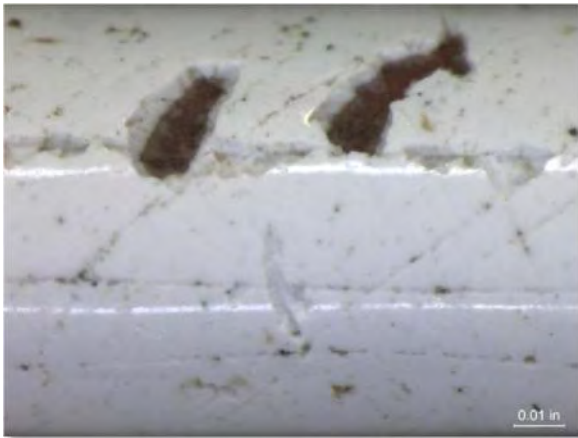
Figure 4-46: 2205 Duplex SS wedge wire screen surface exposed at an area of coating damage. Plate surface after cleaning at 50X

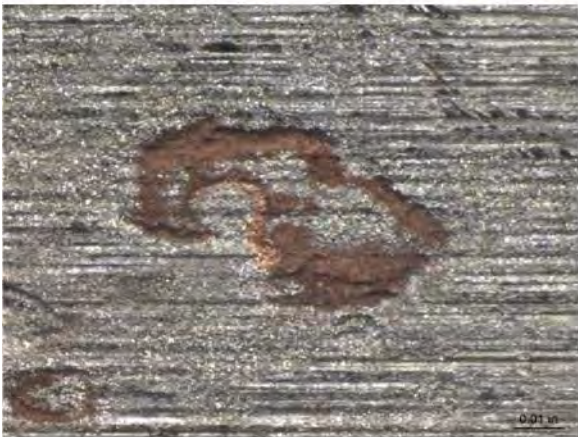
Figure 4-48: CDA 715 coupon at 50X magnification after cleaning.

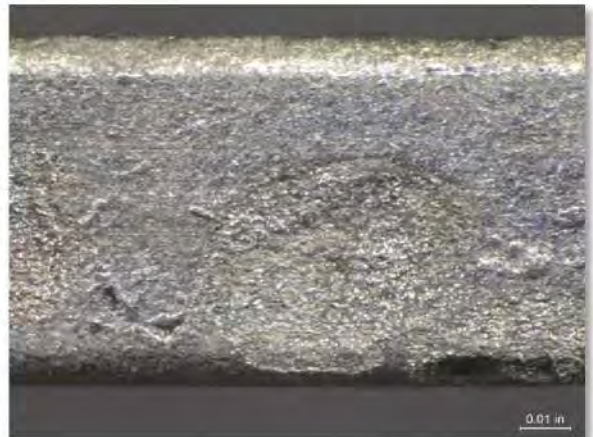
Figure 4-49: CDA 715 screen at 50X magnification after cleaning.

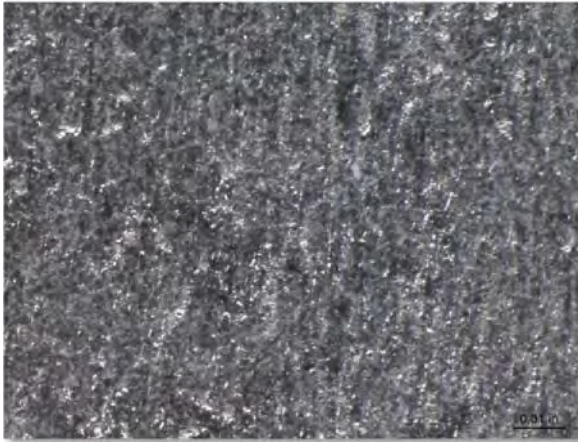
Figure 4-52: CDA 706 screen at 50X magnification after cleaning.

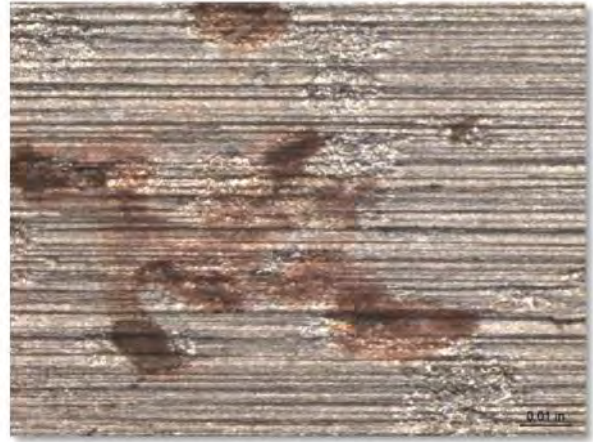
The highest pitting rate was observed on the 90-10 Cu-Ni coupon. Pits on the small cross sectional areas of the wire screens were difficult to measure, but were all less than 20 mils and appears to follow the same trend between the different alloys as the coupons. The plates were also not metallographically mounted, but all pits were less than 20 mils.

Figure 4-51: CDA 706 coupon at 50X magnification after cleaning.

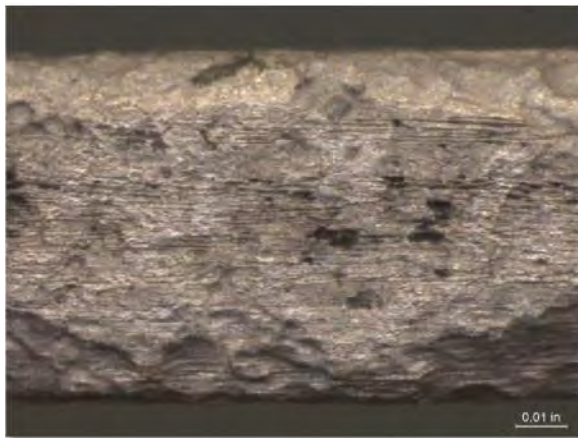
Figure 4-50: CDA 715 plate at 50X magnification after cleaning.

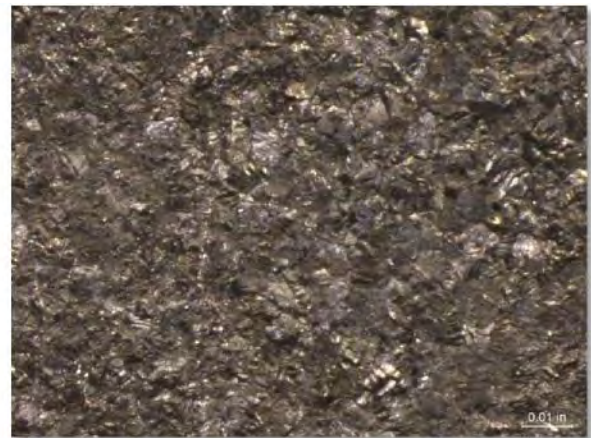
The corrosion rate analysis on the 4-inch by 4-inch flat plates revealed similar results as the screens and coupons. The 90-10 Cu-Ni plate indicated the highest average overall corrosion rate followed by the 70-30 Cu-Ni plate. In general, the copper alloy plates (70-30 Cu-Ni, 90-10 Cu-Ni, and Z Alloy) indicated

Figure 4-53: CDA 706 plate at 50X magnification after cleaning.

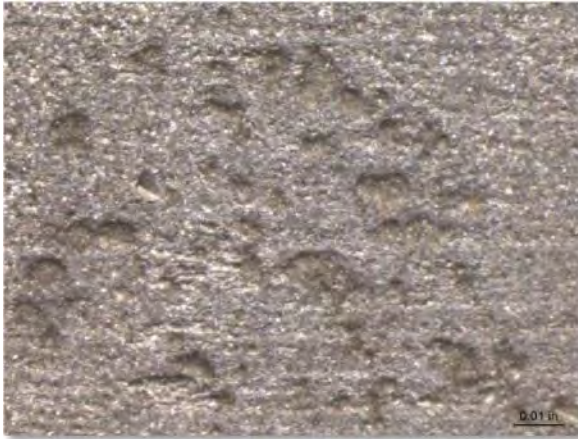
Figure 4-54: Z alloy coupon at 50X magnification after cleaning.

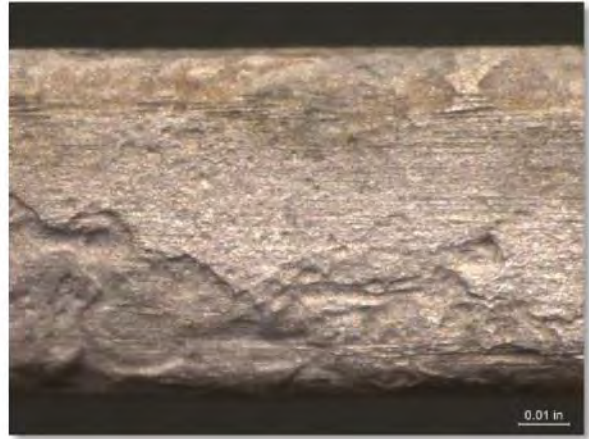
Figure 4-55: Z alloy screen at 50X magnification after cleaning.

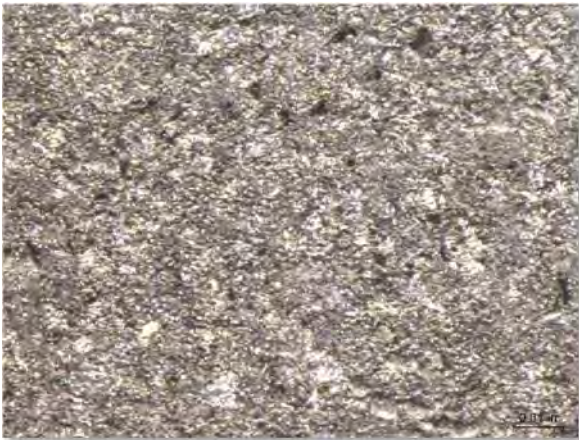
Figure 4-56: Z alloy plate at 50X magnification after cleaning.

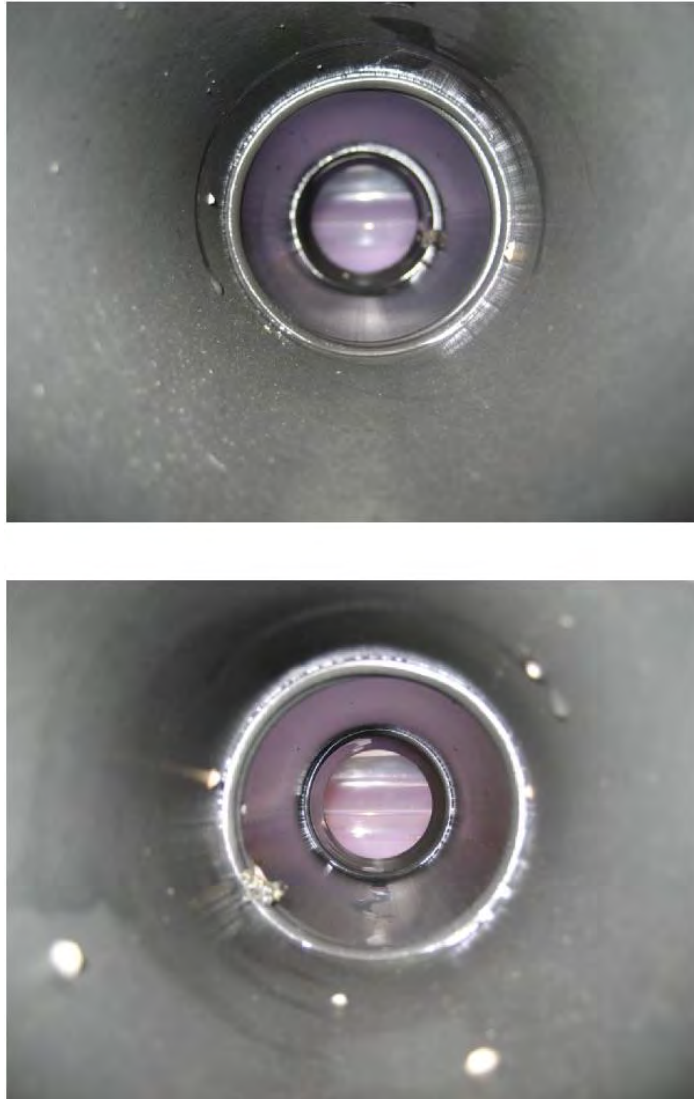
Figure 3-3. Pipe spool C3 (Shock Chlorination) October 28, 2014. Inlet (top) and Outlet (bottom).

- This is the third pipe spool in spool row C and received a weekly shock treatment with sodium hypochlorite.
- Photos taken from inlet and outlet ends (**Figure 3-3**).
- The pipe walls have a slight brown tinge, but do not feel slimy to the touch. The material can be easily removed with a tissue wipe. This could be fine silt trapped in a bacteria layer, or a thin layer of diatoms
- 9 small acorn barnacles (Balanidae) were observed; 3 in the inlet section and 6 in the outlet section.
 - Size (basal diameter) ranged from about 1 mm to 3 mm.
 - No barnacles found in the middle section of the spool.
- A small ball of plastic shavings were found at the ring between the middle and outlet section.
- No sand

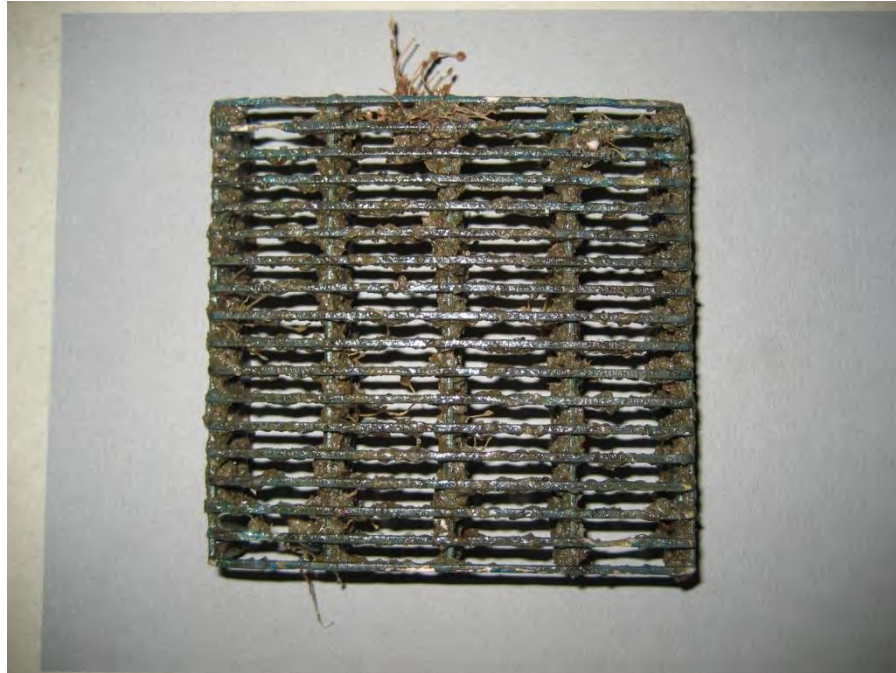
Figure 4-1: 90/10 Cu/Ni (CDA706) Wedgewire sample, photographed 06/17/15.

Test Material	Biofouling Notes	
PVC test rack	The PVC test rack was heavily fouled to the point where almost none of the PVC was visible.	
CDA 706 (90 – 10 Copper Nickel)	Wedgewire sample: Relatively clean, with only a few hydroids, mostly concentrated by the sites of the plastic cable ties used to secure the sample to the rack. A green patina covered most of the surface. About 80 percent of the surface had a very light covering of diatoms and short filamentous algae along with entrapped silt. All fouling and debris was easily removed with a soft nylon brush after photographing and inspection. (See Figure 4-1)	Coupon: Quite clean, with no hydroids, no barnacles or any other attached macrofouling. About 90 percent of the surface had a light covering of diatoms, some filamentous red algae and entrapped silt. There was a green/brown patina on most of the surfaces. All silt and fouling was easily removed with a soft nylon brush after photographing and inspection. (See Figure 4-2)

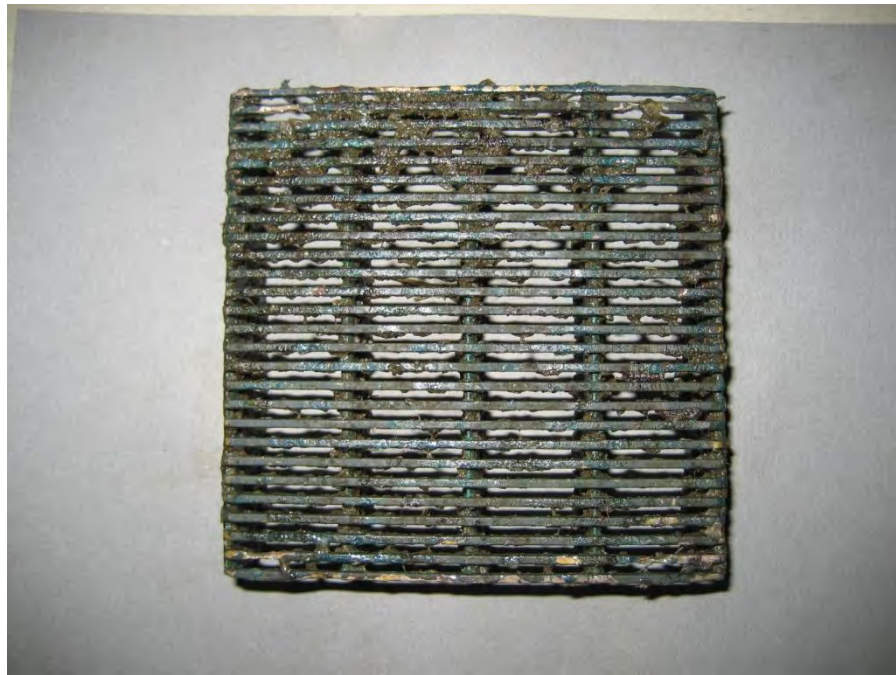
Figure 4-3: Z-alloy Wedgewire sample, photographed 06/17/15.

Z-Alloy	Wedgewire sample: Quite clean, similar to the CDA 706 (IVA1) with only three individual hydroids covering less than 1 percent of the surface. The surface had a green patina. About 60 percent of the Wedgewire (outer) surface had a very light covering of diatoms, filamentous red algae, and entrapped silt. All fouling and debris was easily removed with a soft nylon brush after photographing and inspection. Some of the patina was removed by the brushing, exposing fresh metal. (See Figure 4-3)	Coupon: No hydroids or other macrofouling invertebrates. There was a layer of diatoms, filamentous red algae, and entrapped silt that covered about 65 percent of the surface. No green patina. All fouling was easily removed with soft nylon brush. (See Figure 4-4)
2205 SS (stainless steel) with antifouling coating	Wedgewire sample: About 50 percent of the sample's outer surface had a light covering of diatoms and filamentous red algae. About 50 percent of the inner ribs were cover with what appears to be	Coupon: Very clean. About 50 percent of the surface had a very light film of diatoms and a little silt. The foul-release coating was in very good

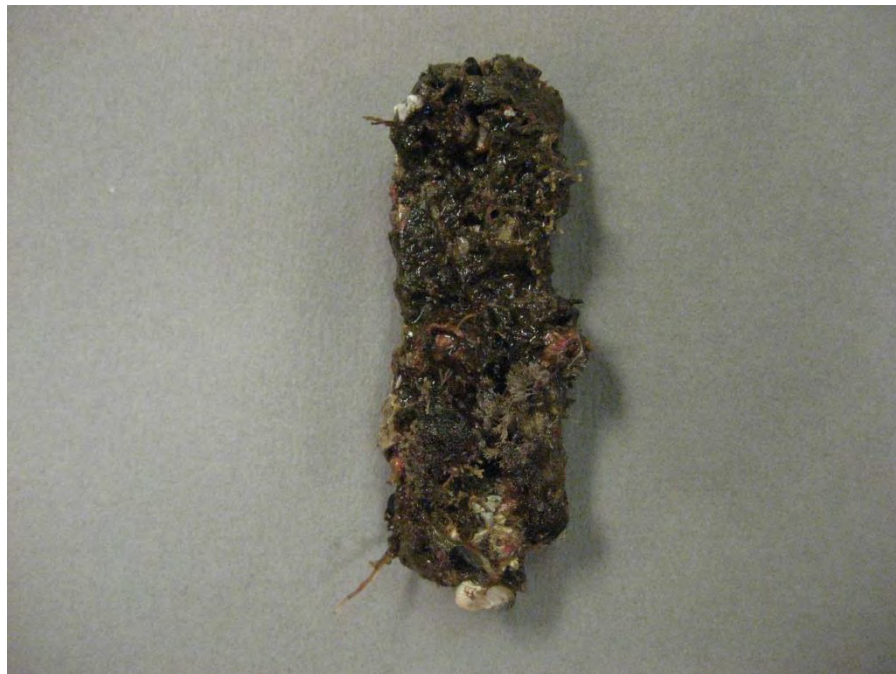
Figure 4-8: 2205 stainless steel coupon, photographed 06/17/15.

Test Material	Biofouling Notes	
	<p>gastropod eggs. Another 25 percent of the inner ribs was covered with a combination of a few individual hydroids, 12 half-slipper shells, or slipper limpets, 10 mussels (4-20 mm), 6-8 barnacles (<i>M. californicus</i>), 4 worm tubes, 4 small white bivalves (3 mm), and a crab . The foul-release coating was in very good shape even at the cable tie sites. All of the fouling was removed with light brushing using a soft nylon brush or, in the case of the limpets, with light finger pressure. (See Figure 4-5)</p>	<p>shape and all of the fouling was removed with just a light brushing using a soft nylon brush. (See Figure 4-6)</p>
<p>2205 SS (stainless steel) uncoated</p>	<p>Wedgewire sample: Very heavily fouled with little of the metal visible. The fouling was firmly attached and was not removed. (See Figure 4-7)</p>	<p>Coupon: Very heavily fouled with hydroids and red algae covering most of its surface. The fouling was firmly attached and was not removed. (See Figure 4-8)</p>

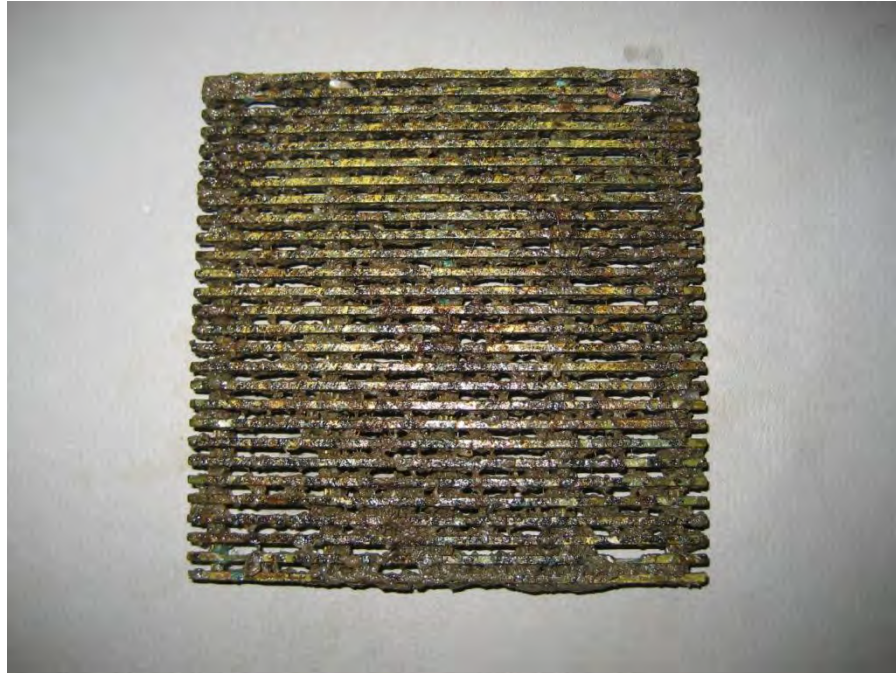
Figure 4-9: 70/30 Cu/Ni (CDA715) Wedgewire sample, photographed 06/17/15.

<p>CDA 715 (70 – 30 Copper Nickel)</p>	<p>Wedgewire sample: Similar to the CDA 706 and Z-Alloy samples, but with more of the surface, about 60 percent, covered by amphipod tubes and filamentous red algae. There was also more of a diatom and silt film/layer, and only a little green patina on the metal's surface. Eight very small mussels. There were no barnacles or other macrofouling aside from the hydroids and mussels. All fouling and debris was easily removed with a soft nylon brush after photographing and inspection. (See Figure 4-9)</p>	<p>Coupon: Similar to the CDA 706 and Z-Alloy coupons. A few hydroids, without polyps, were attached near the holes in the coupon. Amphipod tubes, diatoms and entrapped silt covered about 80 percent of the surface. The coupon had more green patina than the CDA 715 Wedgewire sample, especially on the test welds. All fouling and debris was easily removed with a soft nylon brush after photographing and inspection. (See Figure 4-10)</p>

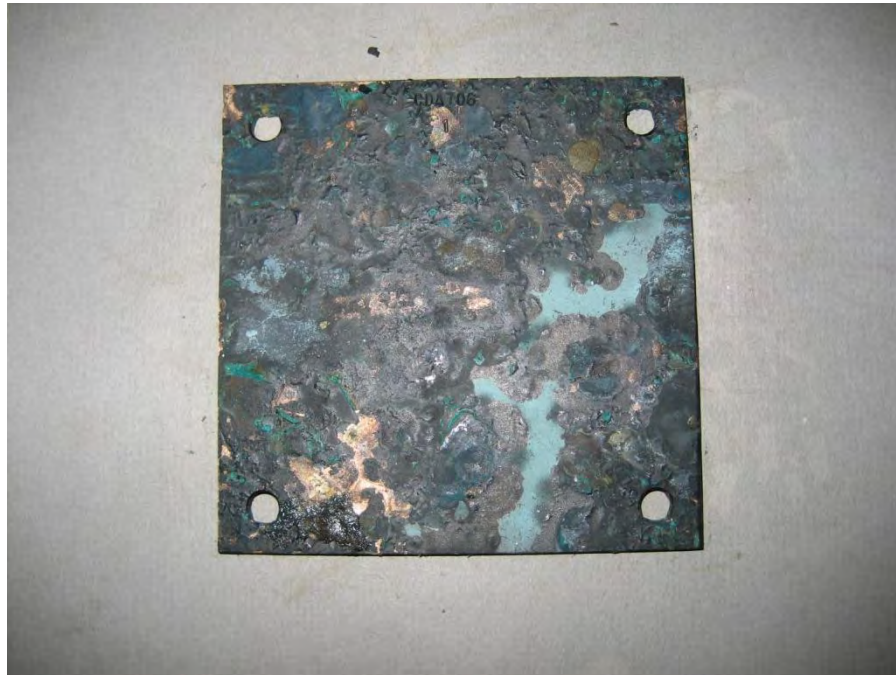
Figure 4-11: 90/10 Cu/Ni (CDA706) test plate (Test Plate 1), photographed 06/18/15 prior to biofouling inspection.

- **CDA 706 (90/10 Copper/Nickel), Plate 1, (Figures 4-11)**
 - The plate is almost entirely covered with a dark blue-green patina. This tends to flake off when the plate is handled.
 - No attached macrofouling.
 - No slime detectable
 - No algae, diatoms, or silt.

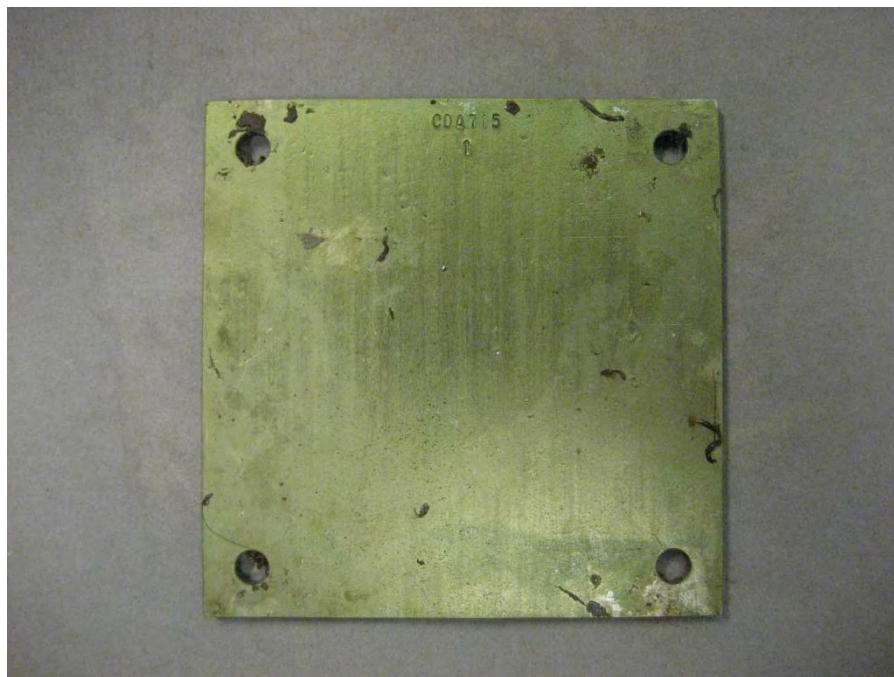
- **CDA 715 (70/30 Copper/Nickel), Plate 2, (Figures 4-12)**
 - The plate is very clean with almost no discoloration or oxidation visible (a very slight, light-green discoloration). The plate looks almost new.
 - No attached macrofouling.
 - No algae.
 - A little debris near the cable tie holes.
 - Motile species: one small polychaete and six small amphipods.
 - A little silt and perhaps some diatoms.

Figure 4-12: 70/30 Cu/Ni (CDA715) test plate (Test Plate 2), photographed 06/18/15 prior to biofouling inspection.

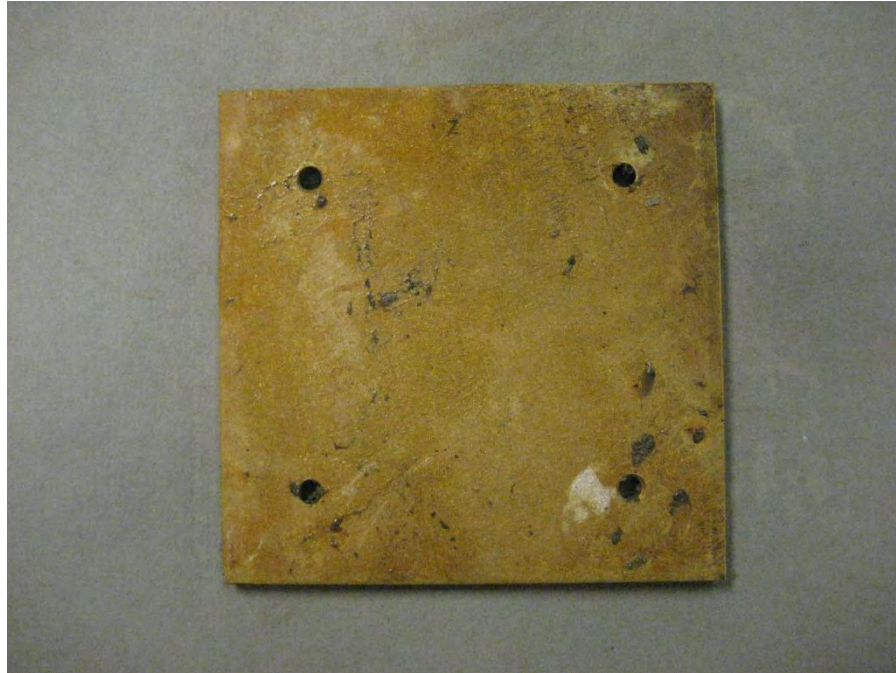
- **Z-alloy, Plate 3, (Figures 4-13)**
 - The plate is very clean, except for a single 19 mm mussel that had been attached to one of the cable ties. When the cable tie was removed, the mussel remained loosely attached to the plate by three byssal threads.
 - No attached macrofouling.
 - The plate has a light brown/gold patina. This is a duller finish than the CDA 715 plate, but does not have the patina of the CDA 706 plate.
 - Motile species: 8 small (3 mm) amphipods stranded on the plate.

**Figure 4-13: Z-alloy test plate (Test Plate 3),
photographed 06/18/15 prior to biofouling inspection.**

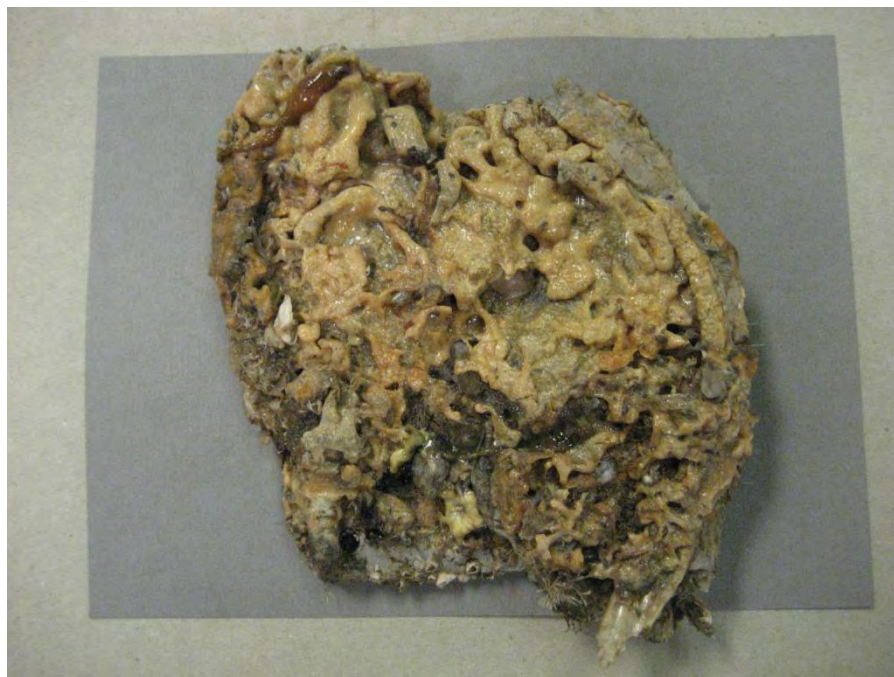
- **2205 Stainless Steel (uncoated), Plate 4, (Figures 4-14)**
 - This plate is very heavily fouled; almost completely covered with macrofouling, primarily a large, expansive encrusting sponge. Very little metal visible. Other species include:

- 7 Oysters (probably *Ostrea lurida*), 24 to 44 mm).
 - Hundreds of barnacles (*M. californicus*), 2 to 14 mm, diameter.
 - White bivalves (probably *Hiatella sp.*), up to 18 mm.

- Erect and encrusting bryozoans.
 - Calcareous worm tubes.
 - C/S tunicate.
 - Hydroids.
 - As with the other plates, a variety of encrusting invertebrates were attached to the PVC frame and the plastic cable ties that secure the plate to the frame. In this case, there is little to differentiate between the stainless steel plate and the plastic components.

Figure 4-14: 2205 stainless steel test plate (Test Plate 4), photographed 06/18/15 prior to biofouling inspection.
