Ocean Water Desalination Intake Biofouling and Corrosion Study

January 15, 2016

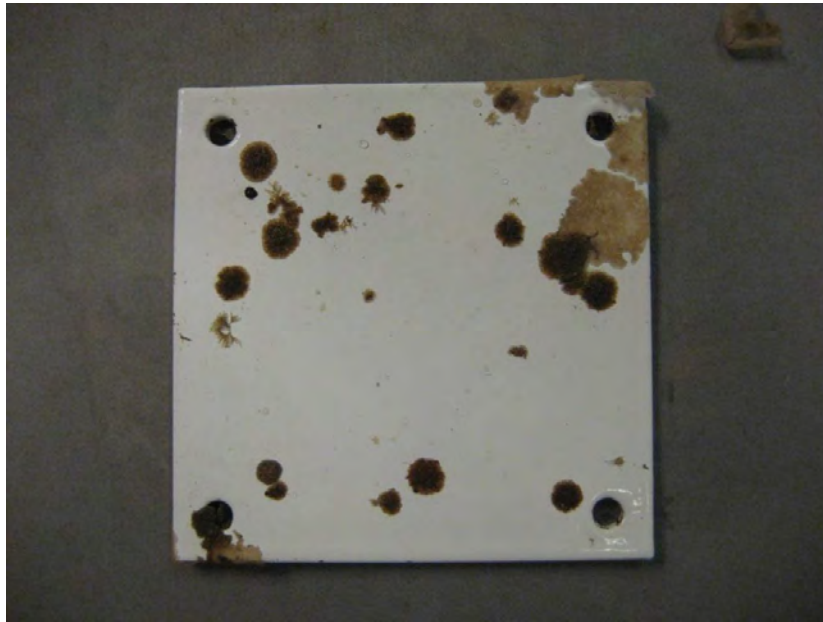
- **2205 Stainless Steel with foul release coating, Plate 5, (Figures 4-15)**
 - As stated earlier, this plate and its frame and bag were missing when the divers arrived at the WB intake in April 2015. The cords that suspended the frame may have failed, but remained intact on the other four plates. The plate was found lying in the soft sediment and was retrieved from inside the intake by the divers and returned to its original position. The cords were replaced on all five of the plate frames.

- The fouling that was observed growing on the plate and on the PVC frame in December 2014 was gone with the exception of some empty barnacle shells on the frame. The soft sediment at the bottom of the intake was probably anaerobic and the fouling probably suffocated, died, and decayed. The black coloration on the PVC frame supports the assumption that the sediment had gone anaerobic.

- This plate is of the same material as Plate 4, but has been coated with a silicone elastomer foul release coating.
 - On June 18, 2015:
 - The coating was intact and in good shape.

- The plate was very clean with the exception of some small patches of encrusting bryozoans and a few small patches of erect bryozoans.
 - All of the fouling slid off the plate/coating with just a slight finger pressure.

- The PVC frame was still much cleaner (less fouling) than the other four frames that had not dropped into the sediment within the intake structure.

Figure 4-15: 2205 stainless steel test plate with foul release coating (Test Plate 5), photographed 06/18/15 prior to biofouling inspection.

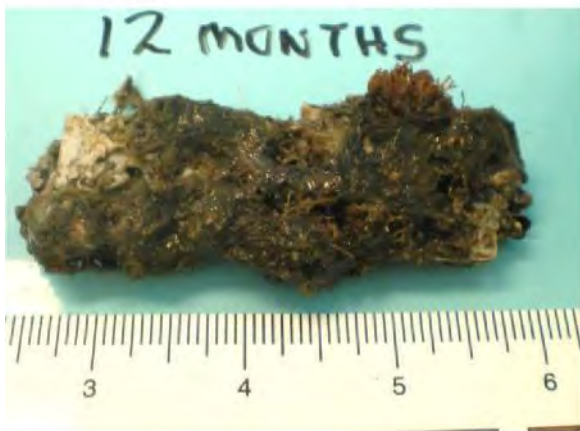
Figure 4-19: Marine life attached to uncoated 2205 Duplex stainless steel coupon with a weld.

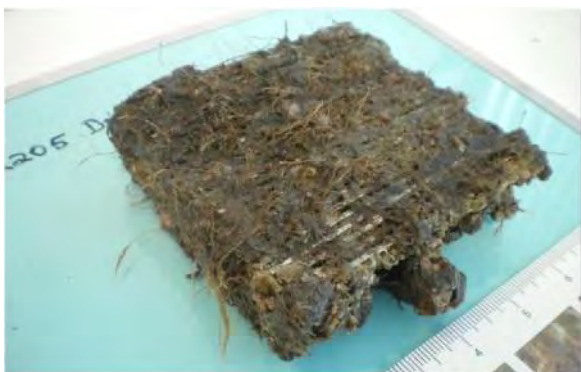
Figure 4-21: Marine life attached to uncoated 2205 Duplex stainless steel wedge wire screen.

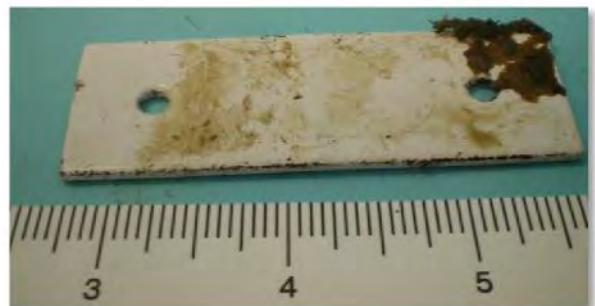
Figure 4-22: Slight damage to coating on edge and initiation of biofouling on corner of coated 2205 Duplex stainless steel coupon.

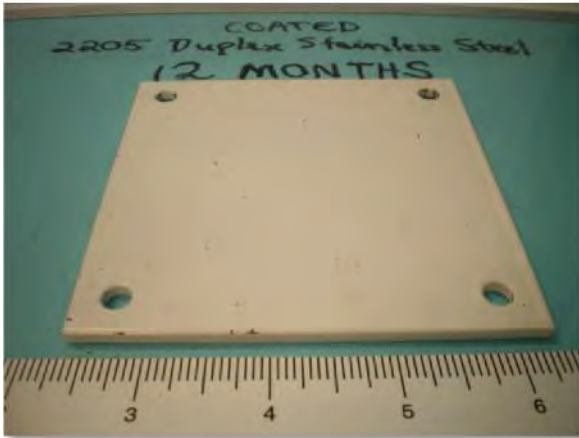
Figure 4-23: Coated 2205 Duplex stainless steel flat plate in good condition.

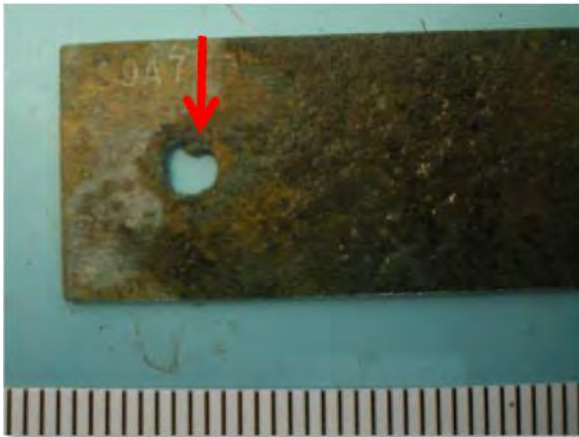
Figure 4-25: Detail view of hole and surface of 70-30 Cu-Ni coupon.

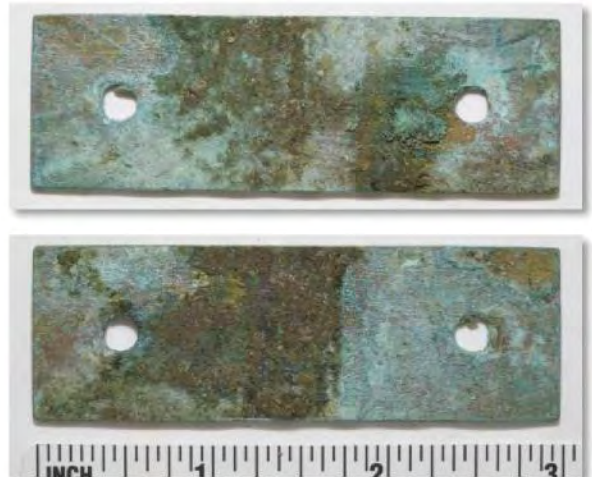
Figures 4-26, 4-29, 4-31, 4-35, and 4-36 show some further oxidation and discoloration of the copper alloy sample surfaces after being exposed to the atmosphere for up to 7 days.

Figure 4-26: Development of copper patina on 70-30 Cu-Ni coupon, front (top), back (bottom).

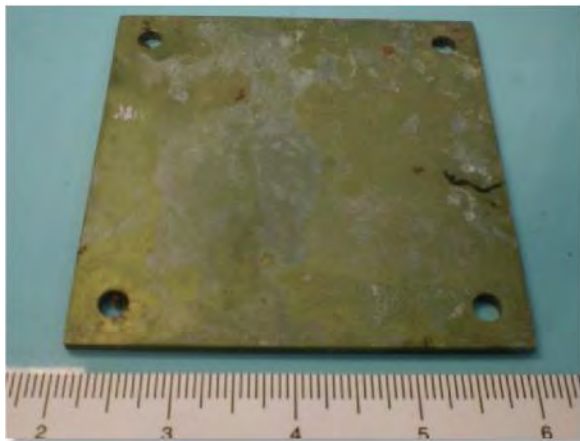
Figure 4-27: Surface discoloration of 70-30 Cu-Ni flat plate.

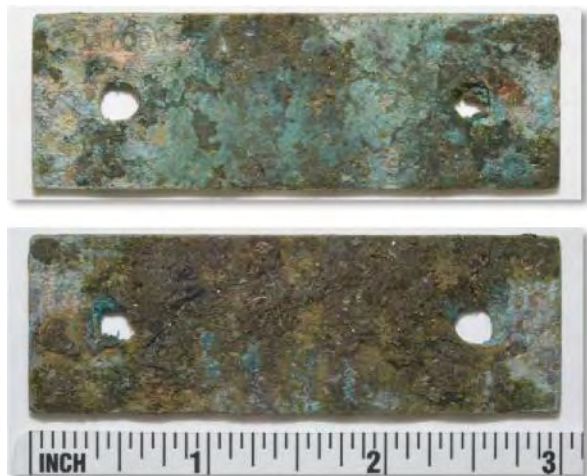
Figure 4-31: Development of patina on 90-10 Cu-Ni coupon, front (top), back (bottom).

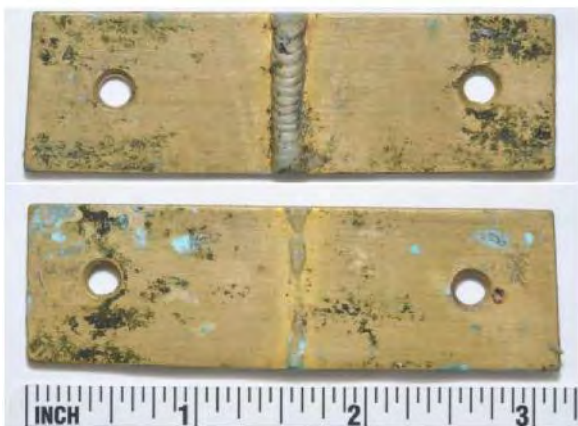
Figure 4-35: Surface discoloration of Z alloy coupon, front (top), back (bottom).

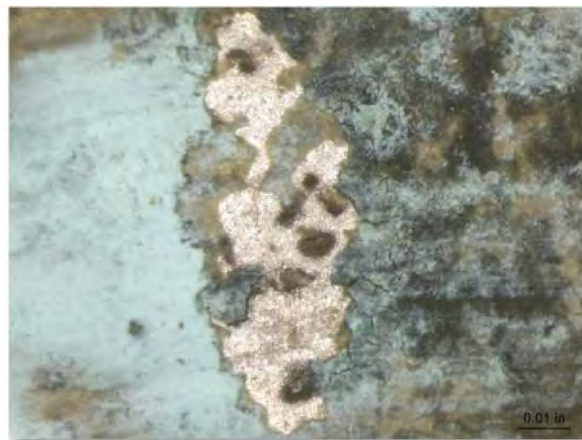
Figure 4-36: Surface discoloration of Z alloy coupon, shown at 50X magnification.

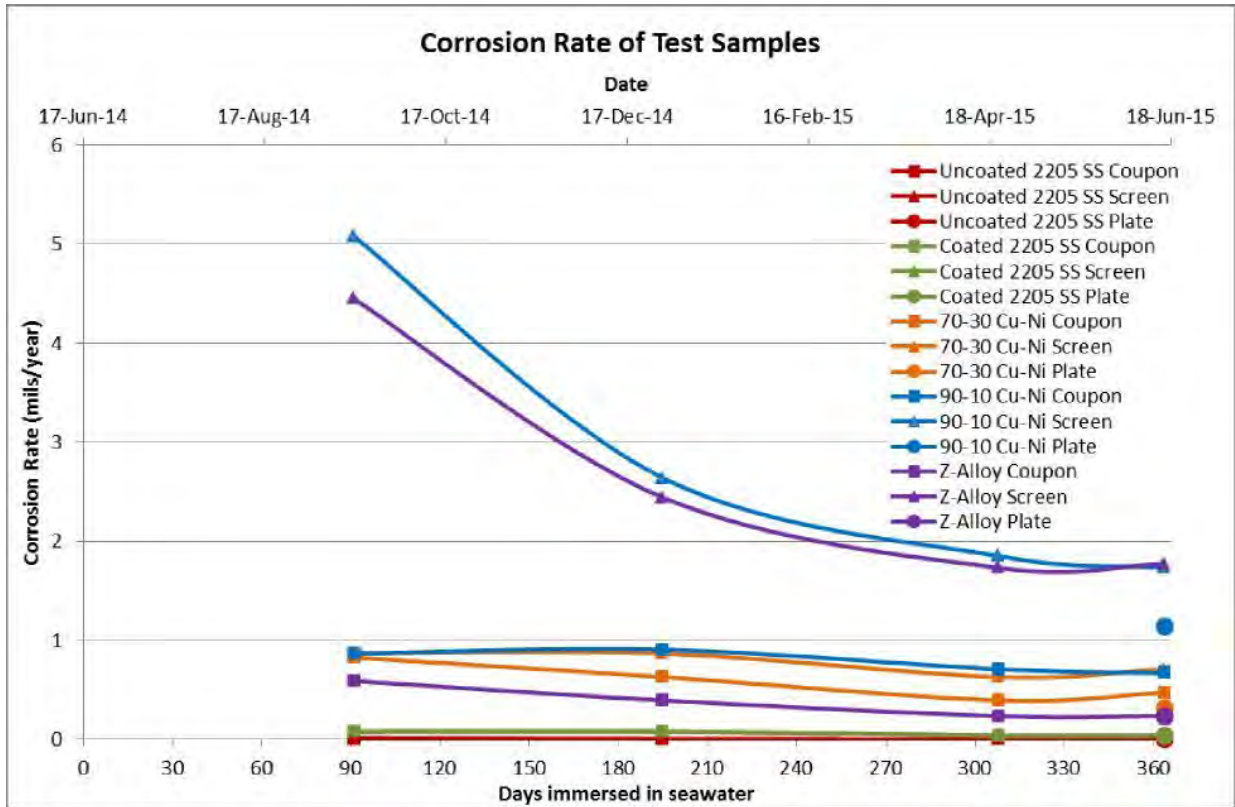
Figure 4-39. Corrosion Rates of Four Alloys over 12 months in Seawater Exposure

The average corrosion rates of the 12-month samples were similar to the 10-month samples; approximately half even had slightly higher rates however the difference was less than 0.0001 inches. This was unlike how the 10-month sample corrosion rates were all lower than the 6-month samples; which in turn had lower corrosion rates than the 3-month samples (except for the 3 and 6-month 90-10 Cu-Ni coupons).

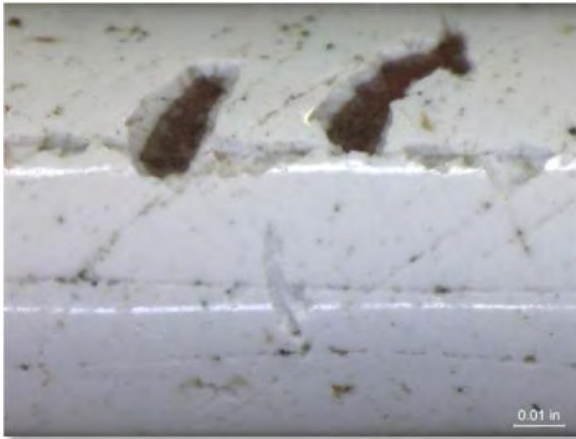
Figure 4-46: 2205 Duplex SS wedge wire screen surface exposed at an area of coating
