CONSTRUCTION PROGRESS REPORT – 2017 Minor Construction Works

Project:	Cobble Hill Landfill – Closure Plan	Date:	October 15 th , 2017
Subject:	Construction Progress Update		
Location:	Cobble Hill Landfill	File:	17039-2017-03

Cobble Hill Landfill Closure – 2017 Minor Construction Works

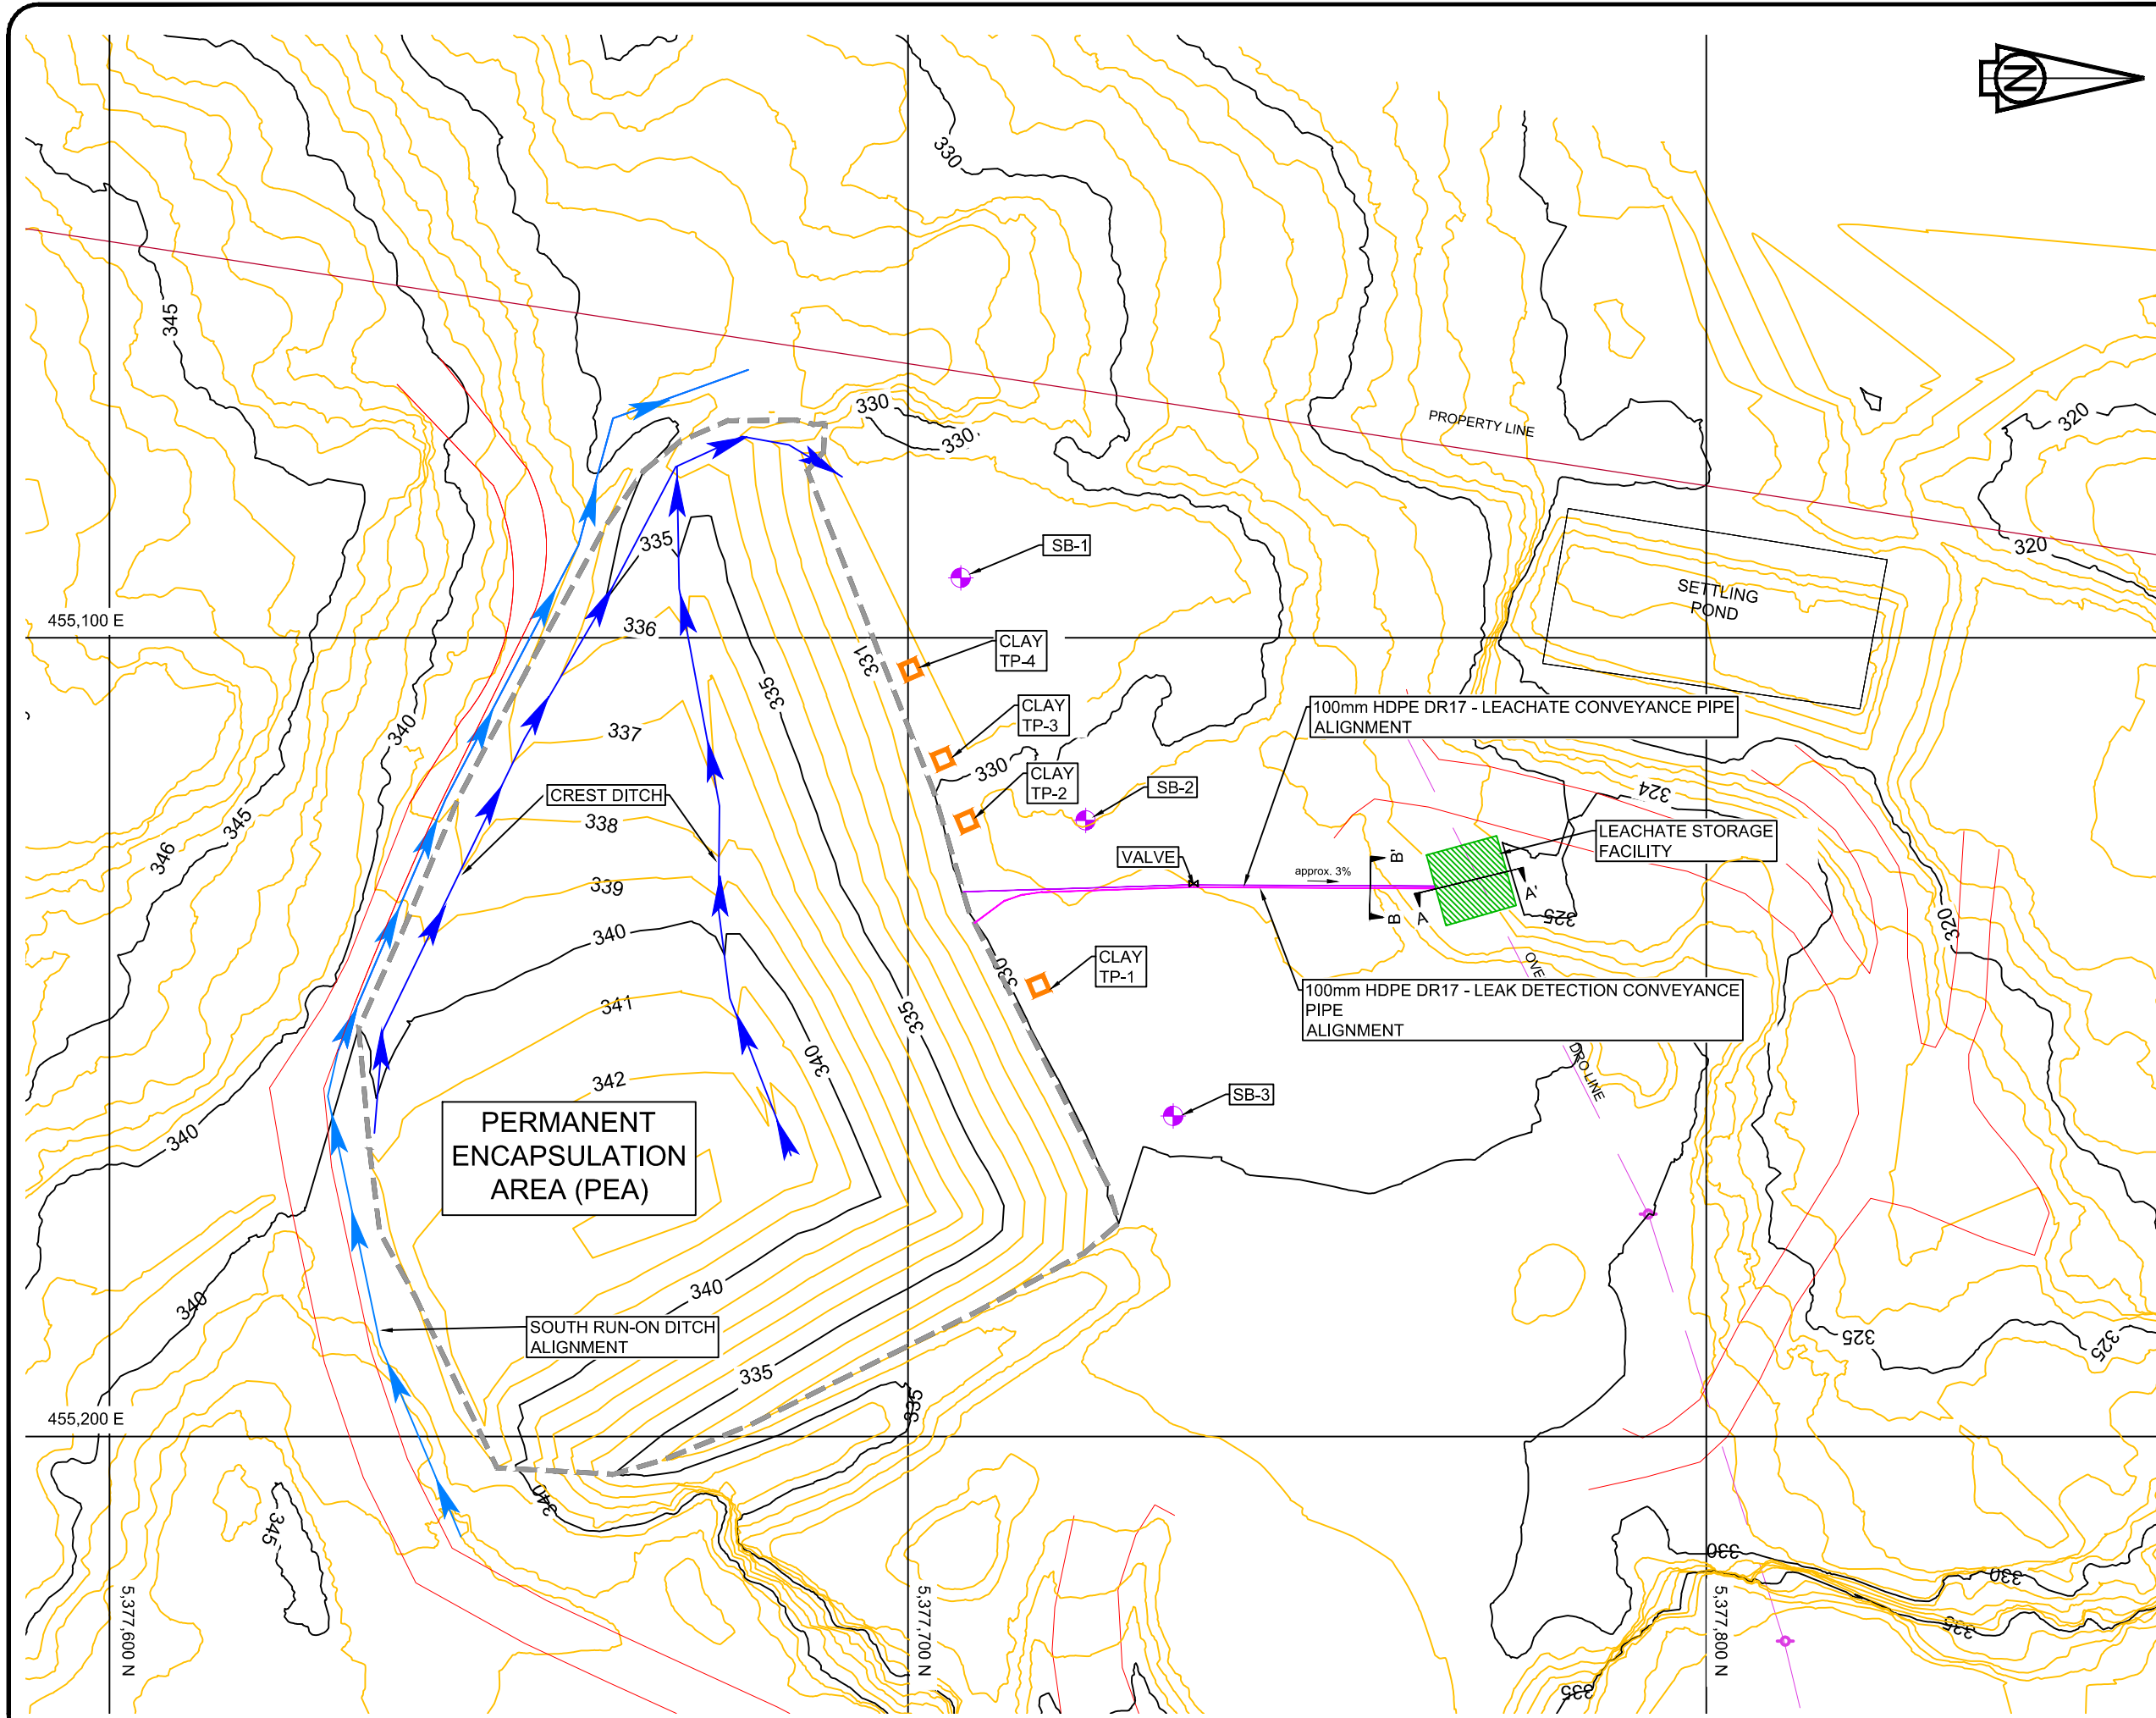
SCALE: 1:1,250	DATE: 2017/10/12 yyyy/mm/dd	PROJECT NO: PRJ 17039
DESIGNED	DRAWING NO:	
DRAWN	SG	FIGURE 1
CHECKED

TITLE:
**AS-BUILT
PLAN VIEW**

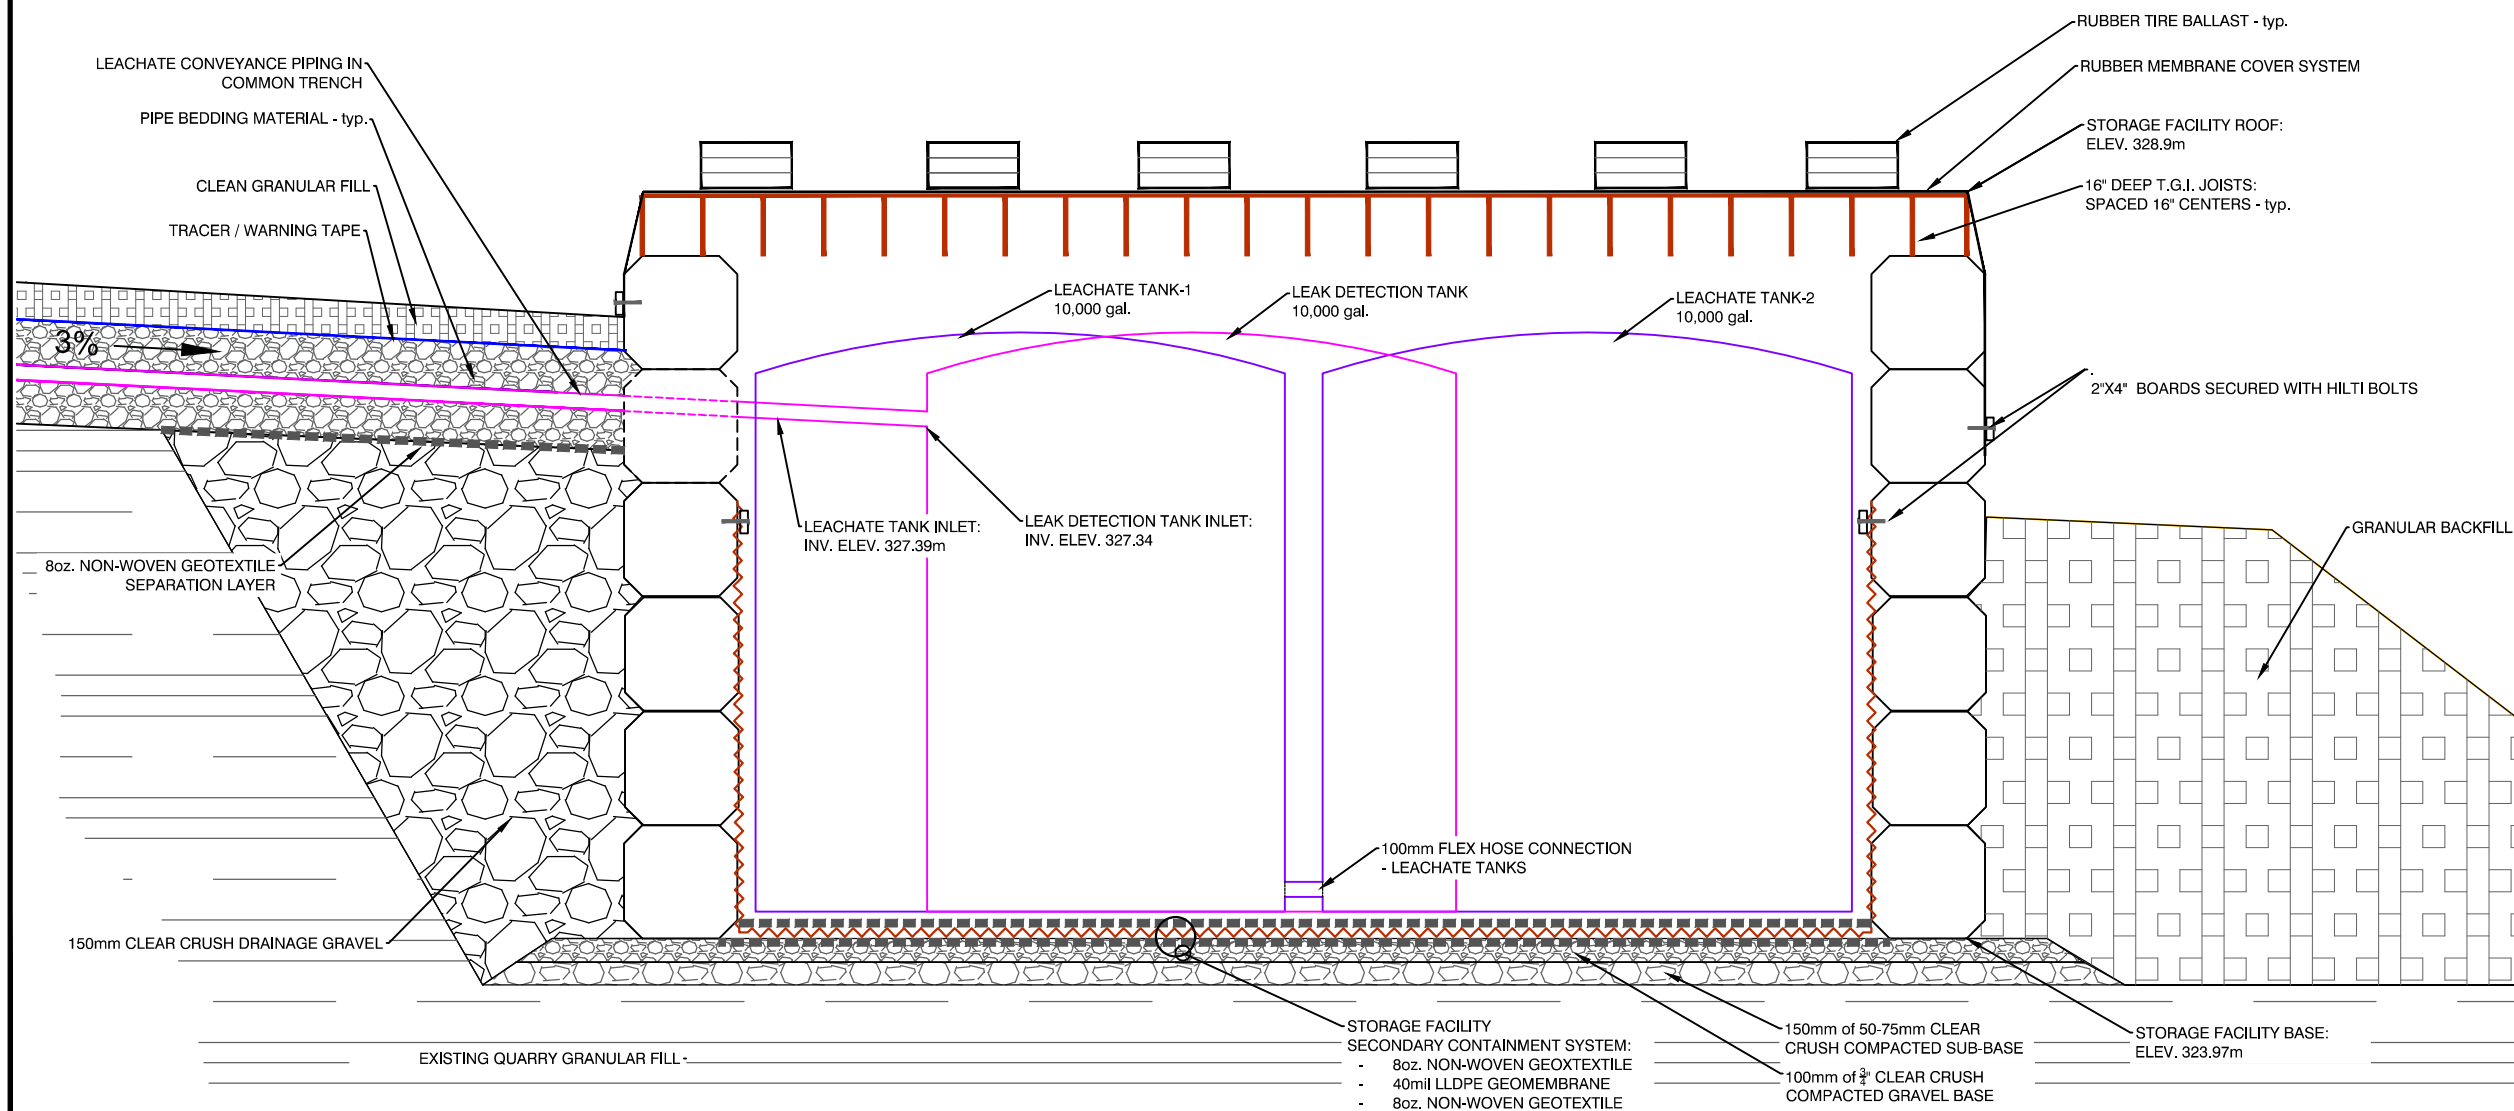
LEACHATE STORAGE FACILITY - SECTION A - A'
SCALE 1:50

- LEACHATE TANKS EQUIPPED WITH HIGH-LEVEL ALARM
- SOLAR PANEL POWER SUPPLY CONTROL PANEL INSIDE STORAGE FACILITY
- REMOTELY MONITORED LEVELS IN TANKS WITH SMARTPHONE APP. FOR REAL TIME READOUTS.

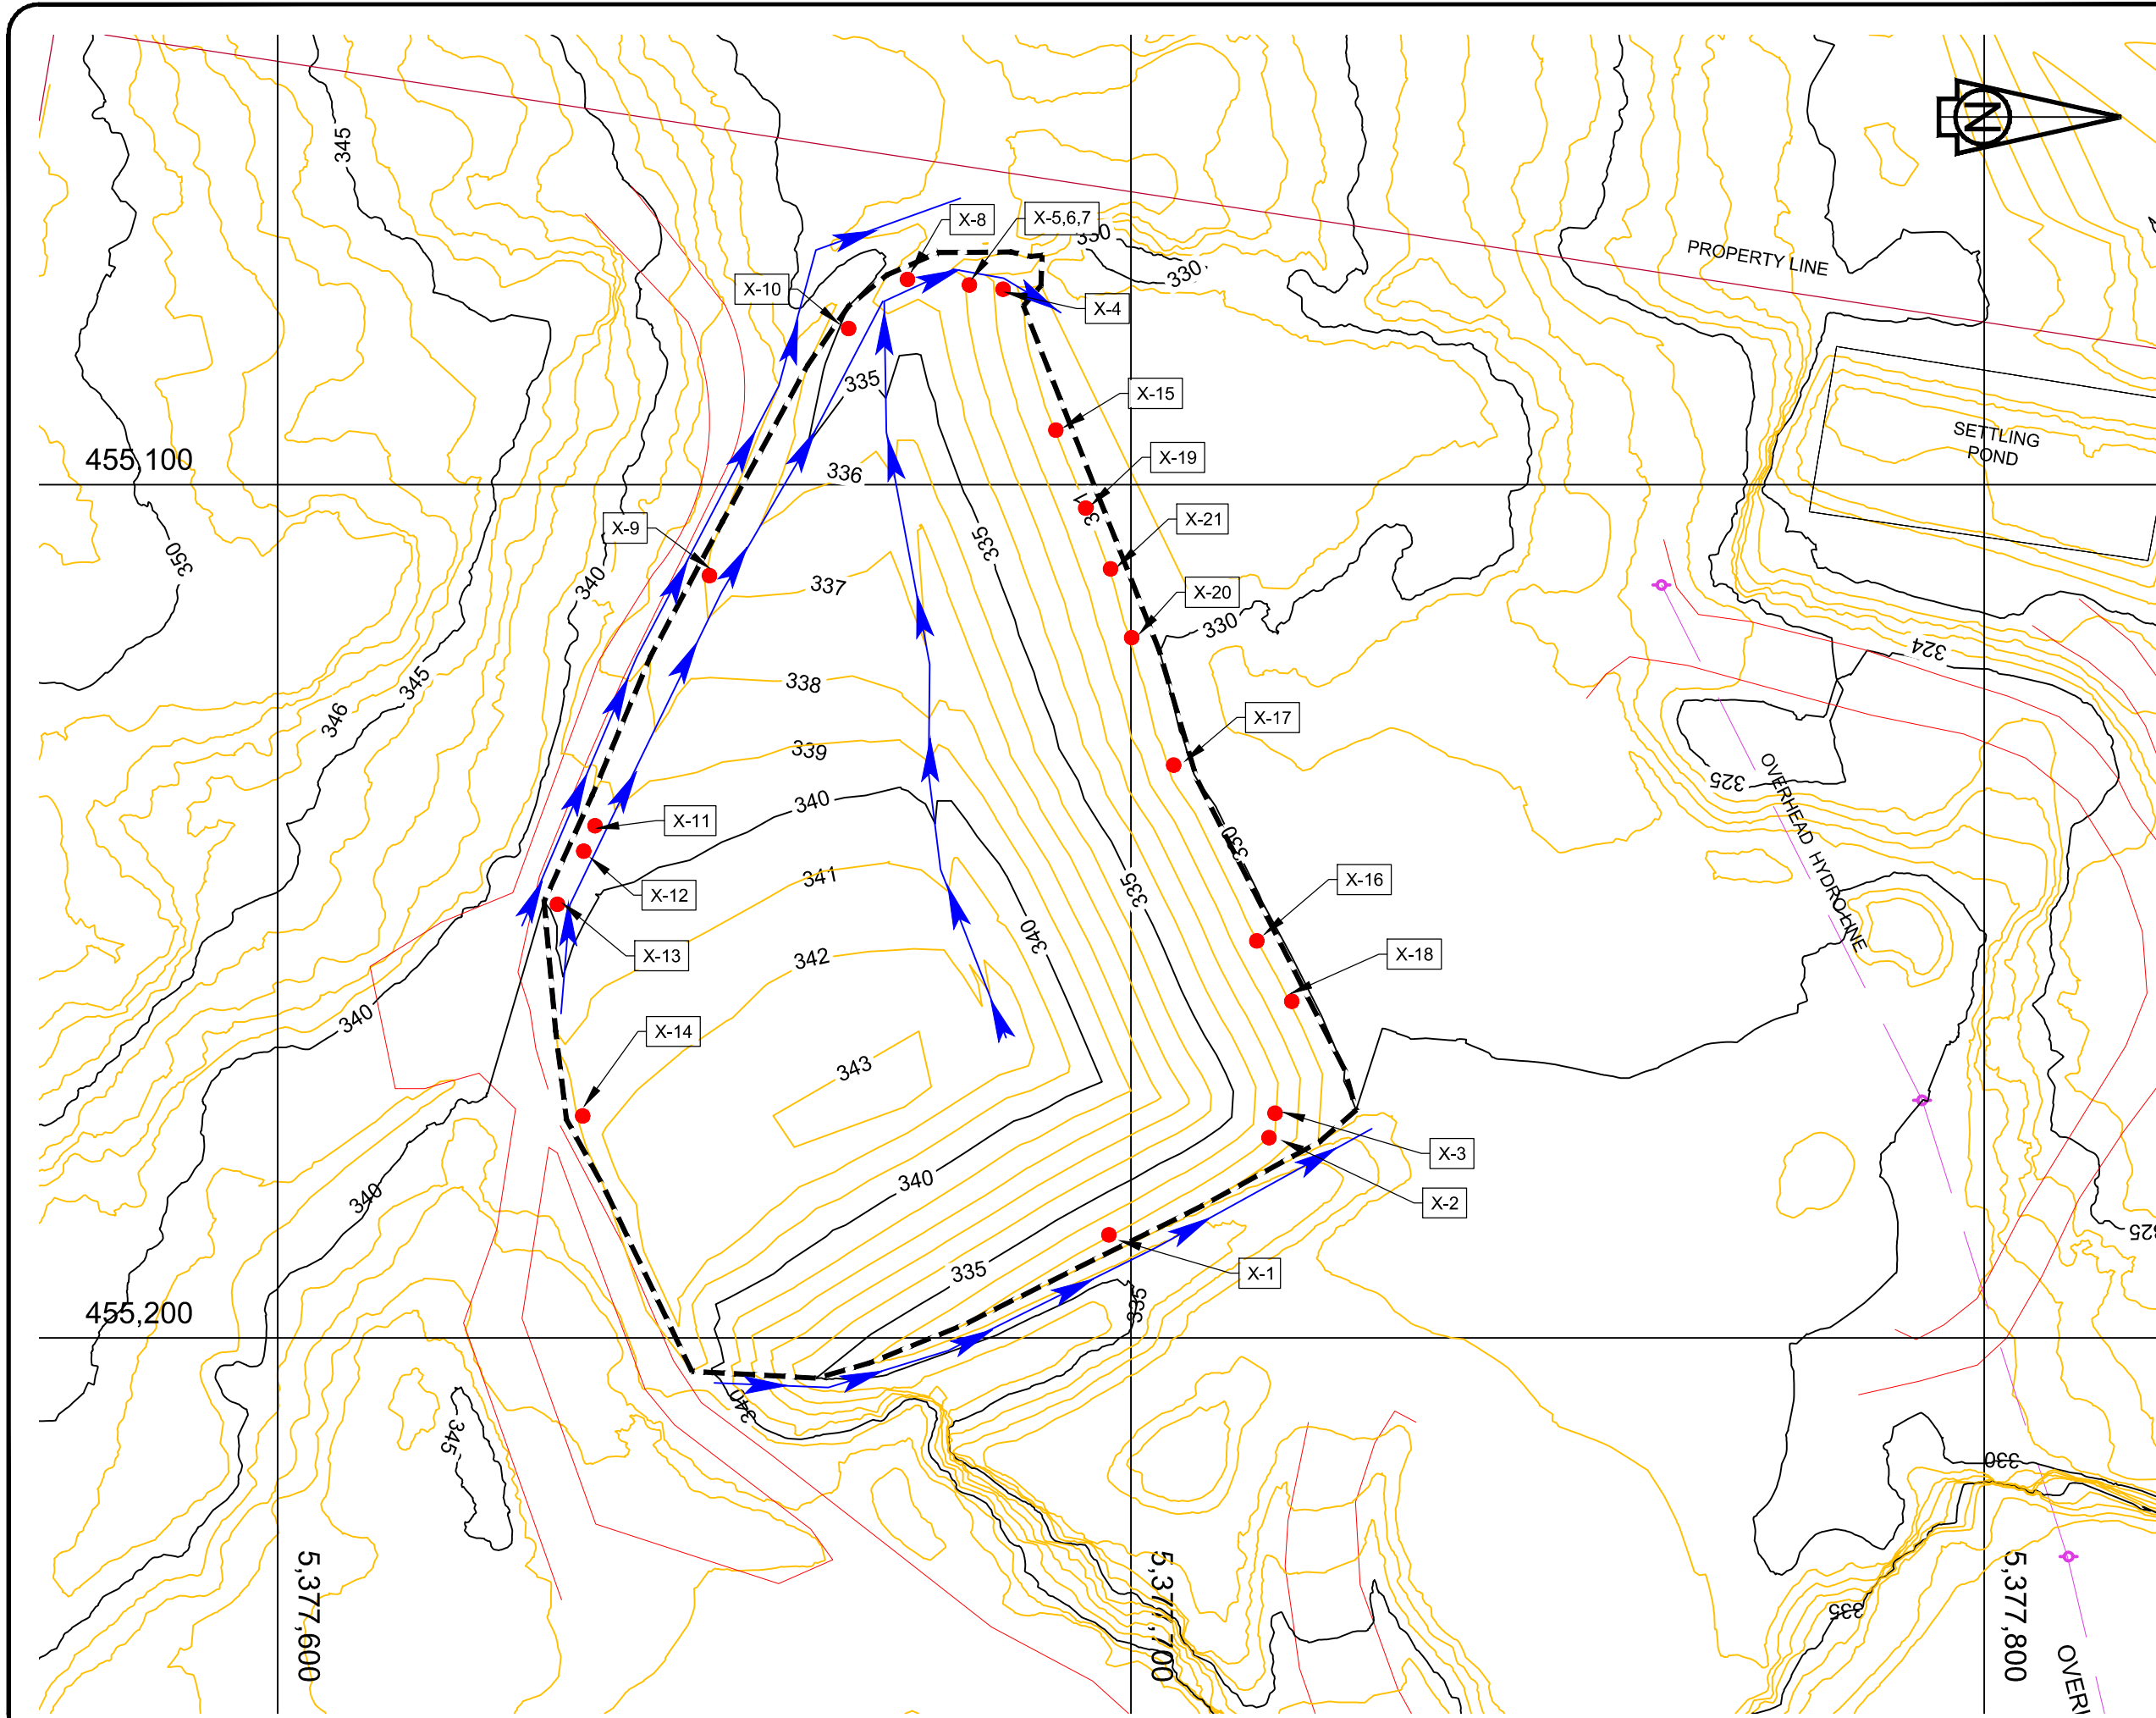
FIGURE 4

**PEA - AS-BUILTS
REPAIR WORK**

G. PEA Liner Repairs and Testing – **Complete** (Sept. 29th, 2017)
